RE: Complaint 200191862
Baseline Water Well Analysis
Well Permit 216298
SWSW 29 32S, 67W Las Animas County, Colorado

In response to your concerns regarding possible impacts to water quality from coal bed methane (CBM) operations in the area near your home, the Colorado Oil and Gas Conservation Commission (COGCC) conducted a field visit to your property on July 9, 2008. Water samples were collected for general organic and inorganic water quality testing as well as for analysis of dissolved methane and BART kit tests. A summary of the results of the chemical and bacterial analyses is presented below. The analytical results are also compared to published water quality standards and to results of prior testing of water from your well.

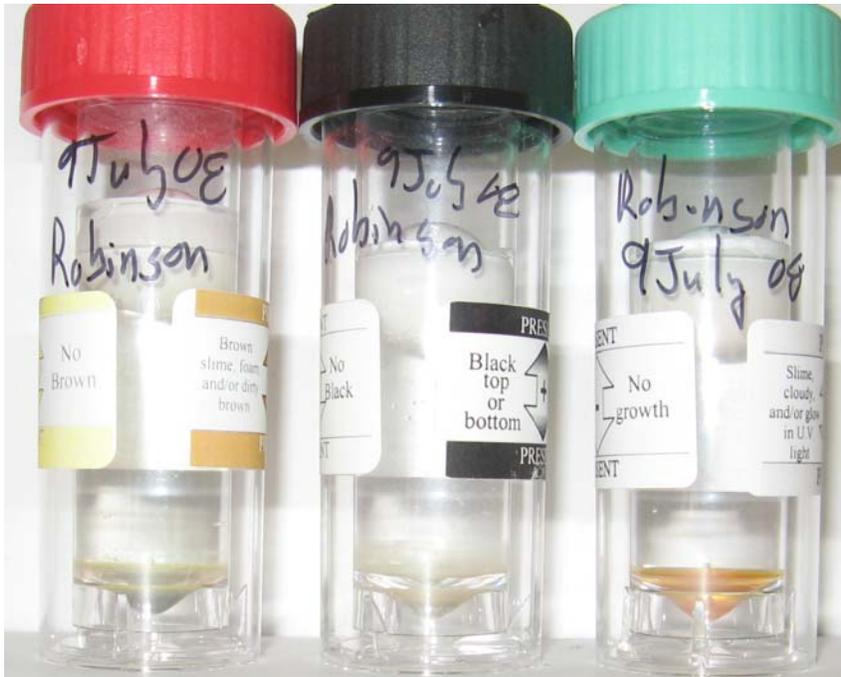
Photograph 1. BART Kits July 9, 2008

The COGCC collected samples to analyze for the presence of iron, slime and sulfur bacteria in your water well. Samples from your water well were tested for the presence of iron-related (IRB), sulfate reducing (SRB) and slime forming (SLYM) bacteria using Biological Activity Reaction Test (BART) kits. In addition to detecting the presence of bacteria the BART Kits allow for an estimation of the size of the population and/or the rate at which they can metabolize and/or grow through an observable change or reaction. This reaction rate is referred to as the “aggressivity” of the bacterial population. The aggressivity levels of the bacteria are described as **Not Detected, Background, Moderately Aggressive, Very Aggressive, or Extremely Aggressive Levels**. The results of the tests are provided below and documented in Photographs 1 and 2. The progress of the bacterial growth on the day the cultures were started is seen in Photograph 1. Photograph 2 shows the progress of the bacterial tests six days after the cultures were started. Photograph 3 shows the progress of the bacterial test 12 days after the cultures were started.

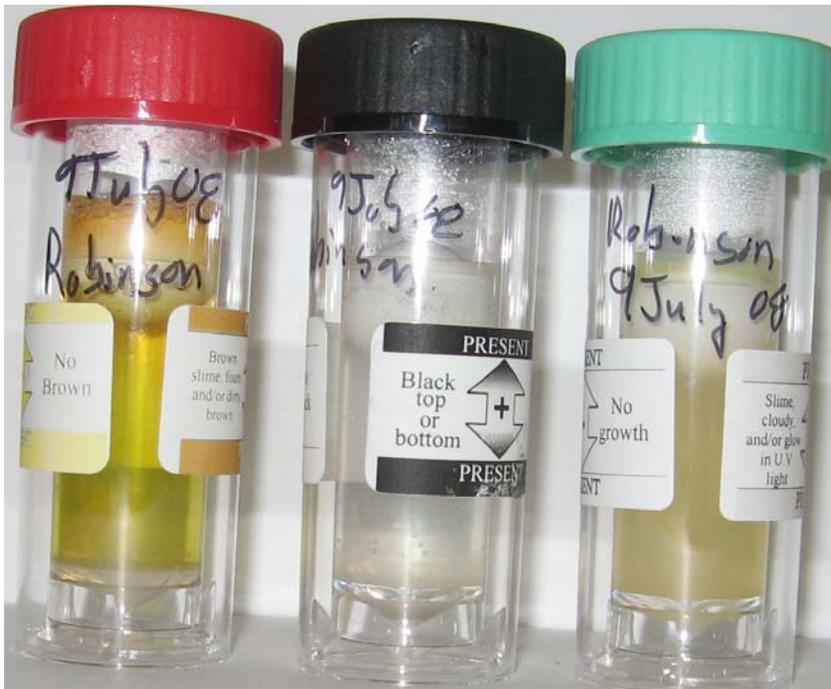
Photograph 2. BART Kits July 15, 2008

Moderately Aggressive levels of IRB bacteria were detected in the water sample collected at this well. The orange cloudy layer, at the bottom of the IRB tube (red cap) and the foam at the top in Photograph 2 developed after six days. This relatively rapid development of foam and orange color indicates Moderately Aggressive levels of IRB population present in the water from your well.

SLYM bacteria were detected at Moderately to Very Aggressive levels in the water sample collected from this well as indicated by the cloudy yellow liquid seen in the green capped vial in Photograph 2.

Iron related, sulfate reducing and slime bacteria were present in your well. Since three types of bacteria were detected in the water distribution system or the well you should consider treating the well and distribution system with disinfecting solutions in the near future. Once bacterial colonies are established they are difficult to eliminate; therefore, you may need to establish a schedule for periodic disinfection of your well system to help control the bacteria present in it. The chlorination process is more easily accomplished if you have a frost-proof hydrant near the well head that you can use to remove the chlorinated water from the well. One technique that water well professionals use is to re-circulate the chlorine solution down the sides of the well shortly after adding the chlorine. This helps to kill bacteria on the sides of the well and on the pipes in the well.

Pamphlets published by the CDPHE that provide more information concerning the treatment of iron and sulfur bacteria and shock chlorination treatment of bacteria are included as Attachment 3. You may also want to contact a licensed water well contractor for additional information or for help in disinfecting your well and distribution system. Additional information and assistance can be provided through the State of Colorado Health Department. Contact information for the agency is provided below.

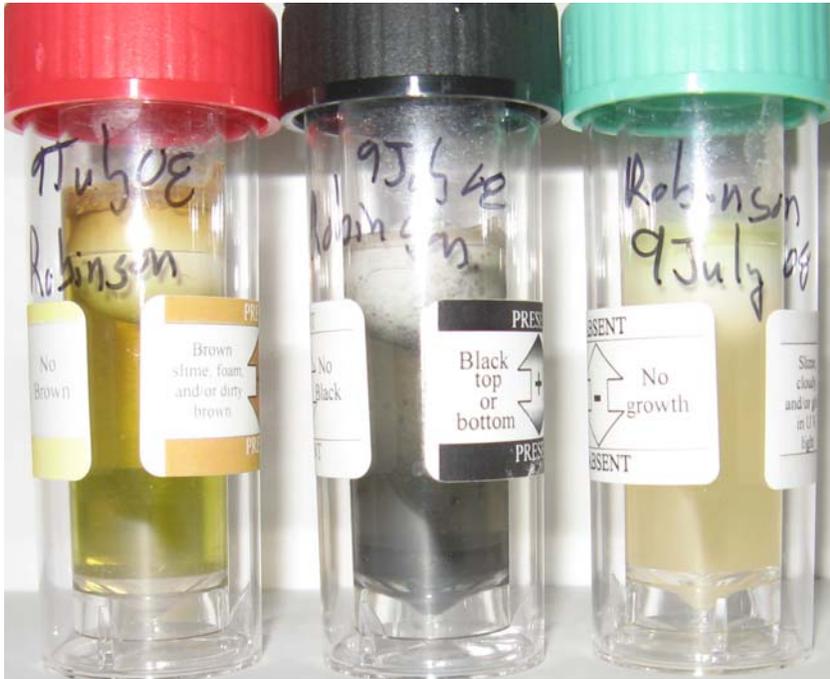
Photograph 3. BART Kits July 21, 2008

The test indicated that SRB were detected at Background levels in your well water as shown by the black liquids in the black capped vial in Photograph 3. The culture turns black if SRB are present and this culture turned black after nine days.
