VISIBLE IMPROVEMENTS
THIS MAP DOES NOT REPRESENT A BOUNDARY SURVEY

SECTION 7
TOWNSHIP 4 NORTH
RANGE 63 WEST

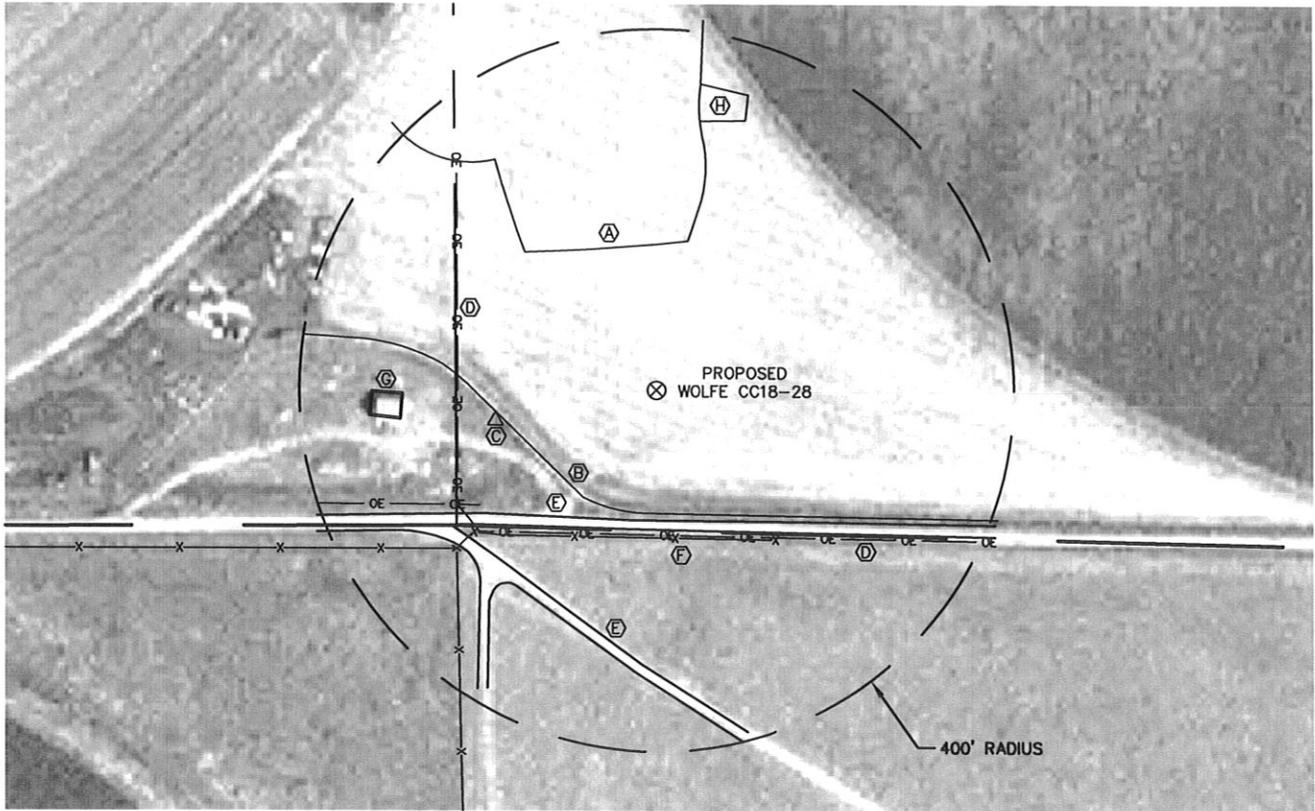
IMPROVEMENTS:

- (A) DETENTION POND - 161' NORTHWEST TO TOE OF SLOPE
- (B) CONCRETE DITCH - 136' SOUTH & 142' SOUTHWEST
- (C) IRRIGATION WELL - 184' SOUTHWEST
- (D) OVERHEAD POWER LINE - 160' SOUTH & 223' WEST
- (E) GRAVEL ROAD - 144' SOUTH & 255' SOUTHWEST
- (F) FENCE LINE - 163' SOUTH
- (G) HOUSE - 285' WEST
- (H) DIRT RAMP - 302' NORTHEAST

NEAREST OVERHEAD POWER LINE IS 160' TO THE SOUTH
