**FRAM OPERATING, LLC**

**LEGAL PLAT**

**AZCARRAGA 26-3**  
**WELL PLAT**  
**671' FSL, 649' FWL**

**SW 1/4 SW 1/4 OF SECTION 26, T2S, R2E,  
 UTE P.M., MESA COUNTY, COLORADO.**

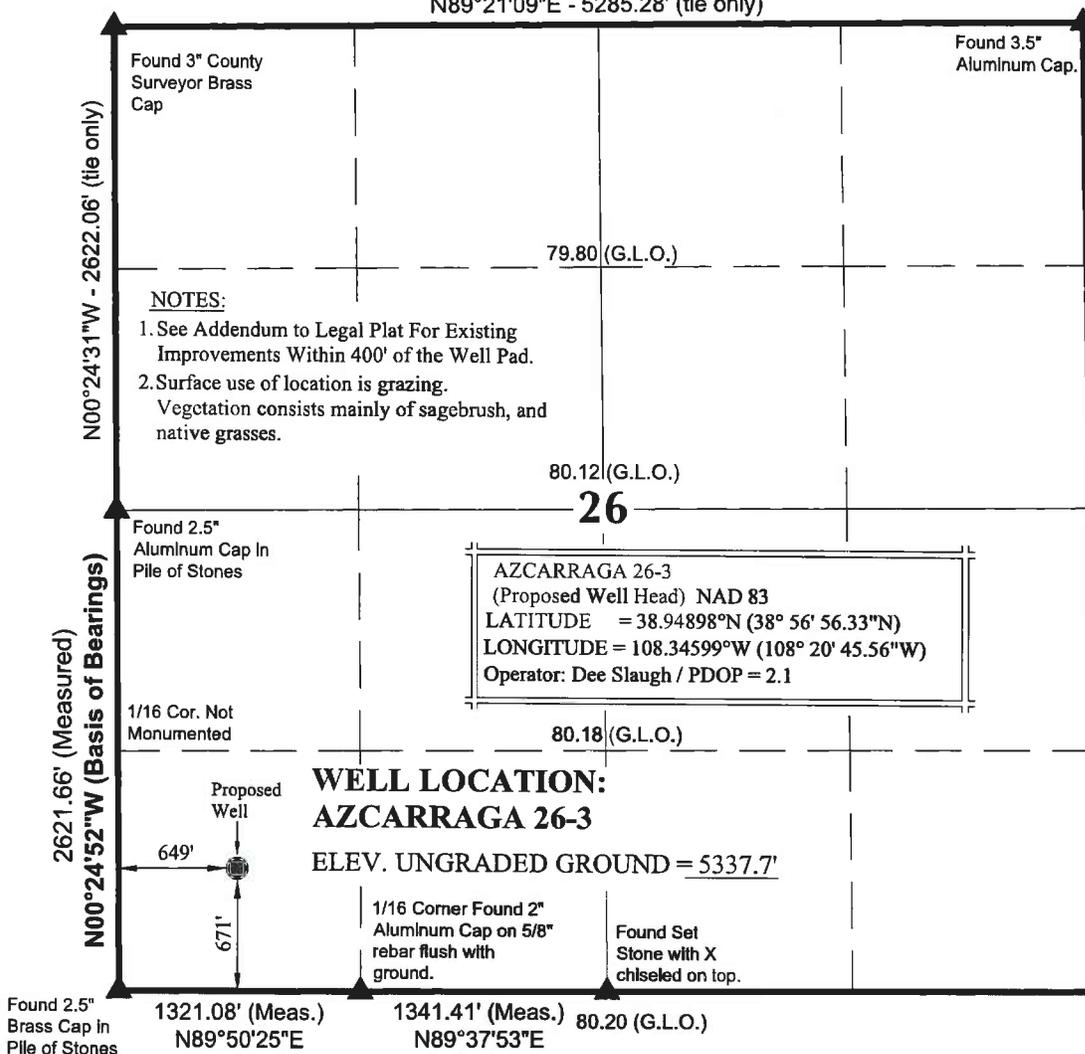
**AZCARRAGA 26-3**  
 (Proposed Well Head) NAD 83  
 LATITUDE = 38.94898°N (38° 56' 56.33"N)  
 LONGITUDE = 108.34599°W (108° 20' 45.56"W)  
 Operator: Dee Slauch / PDOP = 2.1

**WELL LOCATION:**  
**AZCARRAGA 26-3**  
 ELEV. UNGRADED GROUND = 5337.7'

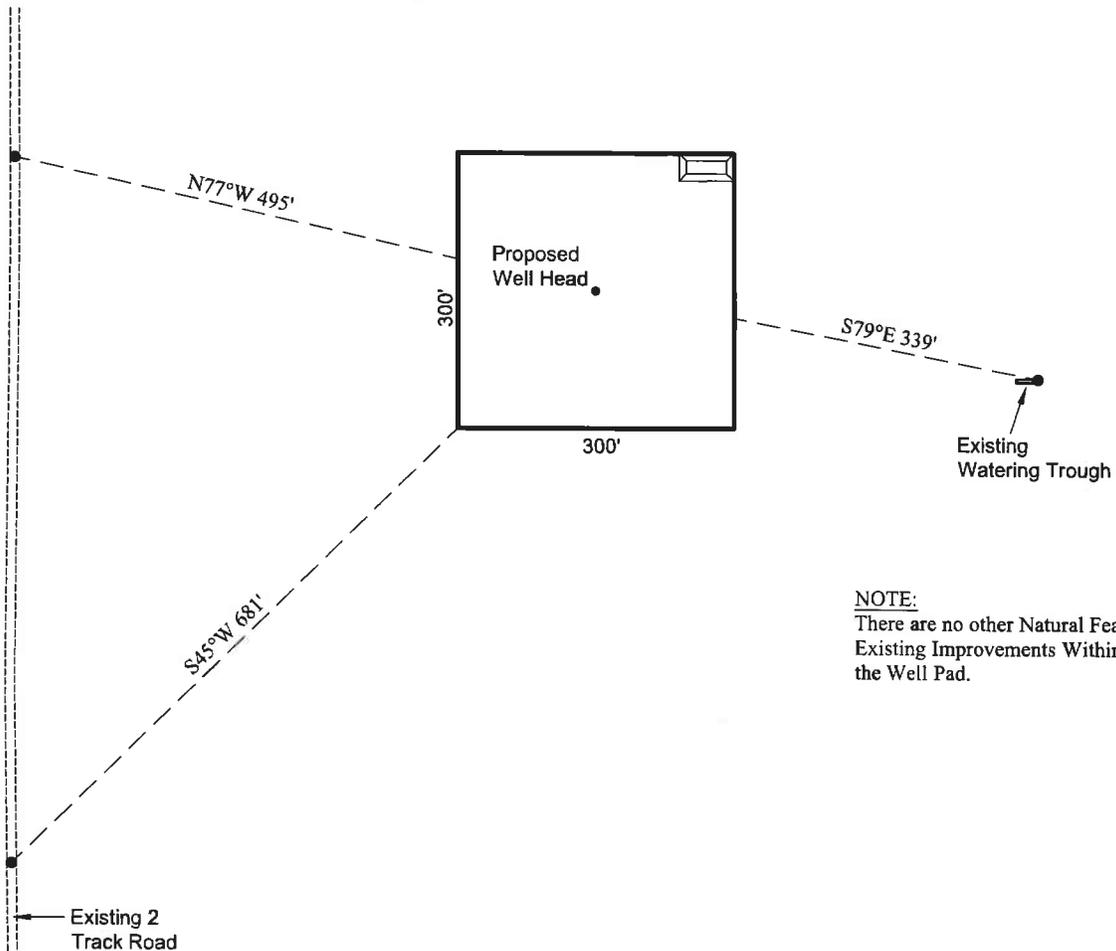
**ADDENDUM TO LEGAL PLAT**

**NOTE:**  
There are no other Natural Features or Existing Improvements Within 400' of the Well Pad.

**AZCARRAGA 26-3**  
**671' FSL, 649' FWL**  
**SW 1/4 SW 1/4 OF SECTION 26, T2S, R2E,**  
**UTE P.M., MESA COUNTY, COLORADO.**

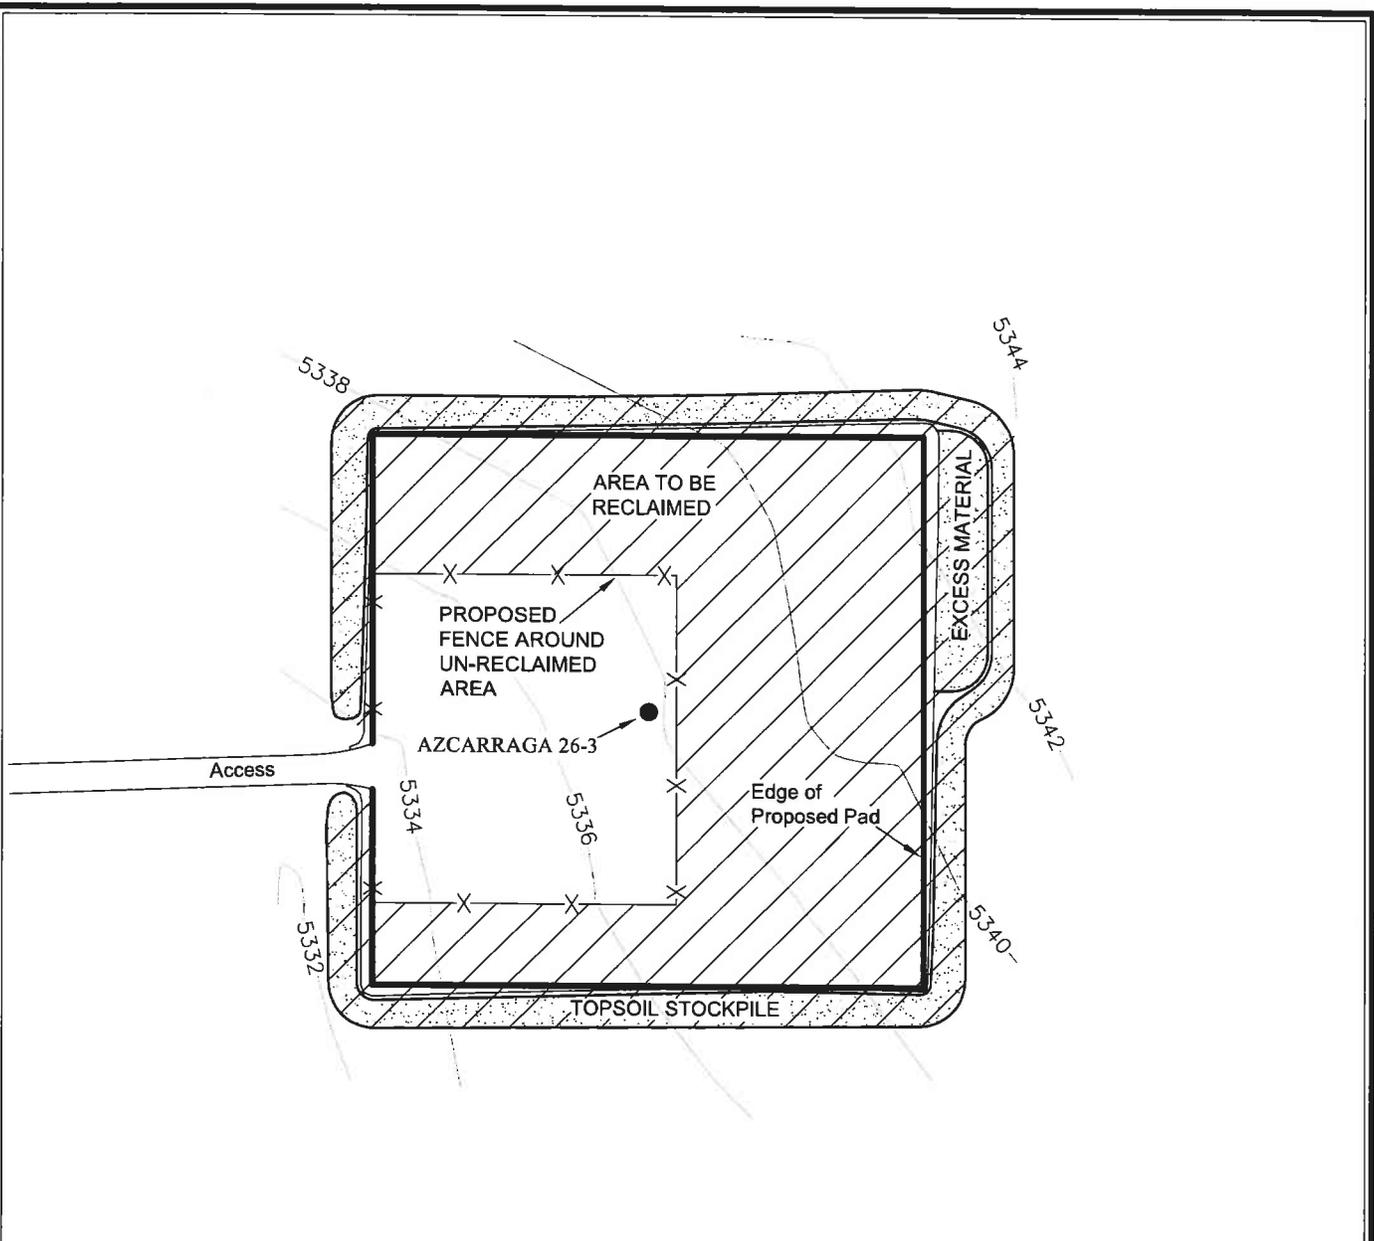
**WELL PAD RECLAMATION DIAGRAM**

1. PRODUCTION EQUIPMENT LOCATION  
COULD VARY DUE TO SITE AND OPERATION  
EFFECTIVENESS.
2. TOTAL DISTURBED AREA: ±2.81 ACRES  
RECLAIMED AREA: ±2.12 ACRES  
UN-RECLAIMED AREA: ±0.69 ACRES

**AZCARRAGA 26-3**  
**671' FSL, 649' FWL**  
**SECTION 26, T2S, R2E, UTE P.M.**
