# WELL LOCATION CERTIFICATE

SECTION 27  
TOWNSHIP 3 NORTH  
RANGE 64 WEST

# SITE SKETCH - RHINO D27-19D

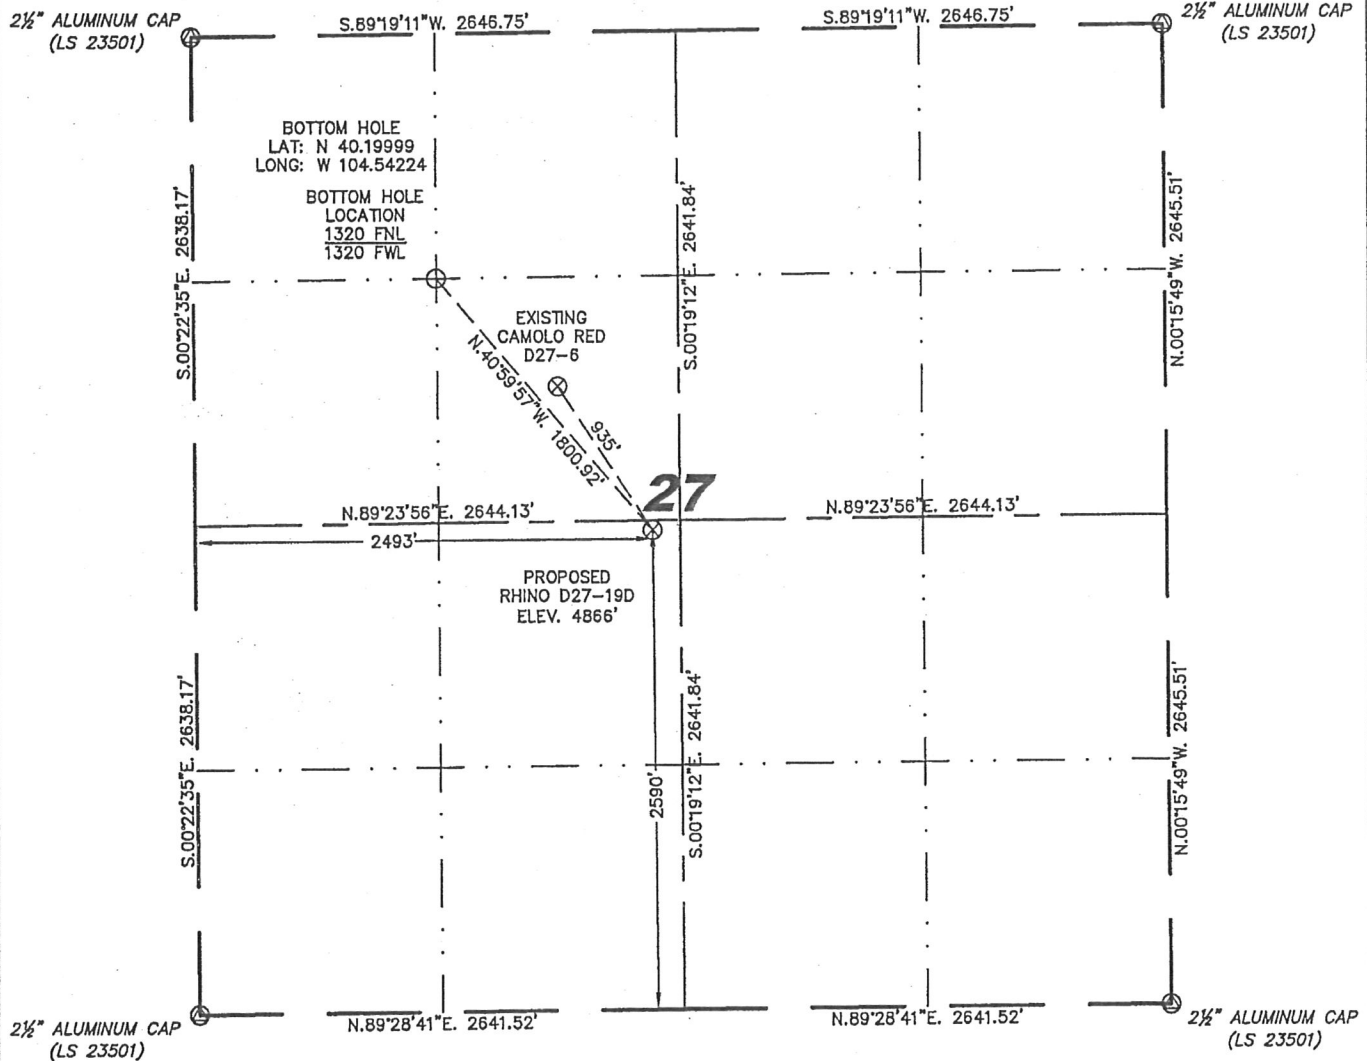
IN ACCORDANCE WITH A REQUEST FROM BRIAN DeROSE - NOBLE ENERGY INC, STEIL SURVEYING SERVICES, LLC HAS DETERMINED THE LOCATION OF THE RHINO D27-19D WELL TO BE 2590' FSL, 2493' FWL, AS MEASURED AT NINETY (90) DEGREES FROM THE SECTION LINES, SECTION 27, TOWNSHIP 3 NORTH, RANGE 64 WEST, 6TH PRINCIPLE MERIDIAN, WELD COUNTY, COLORADO.

LATITUDE: N 40.19623°  
LONGITUDE: W 104.53806°  
PDOP: 2.1  
QUARTER-QUARTER: NE/4SW/4  
NEAREST PROPERTY LINE: 2493' WEST

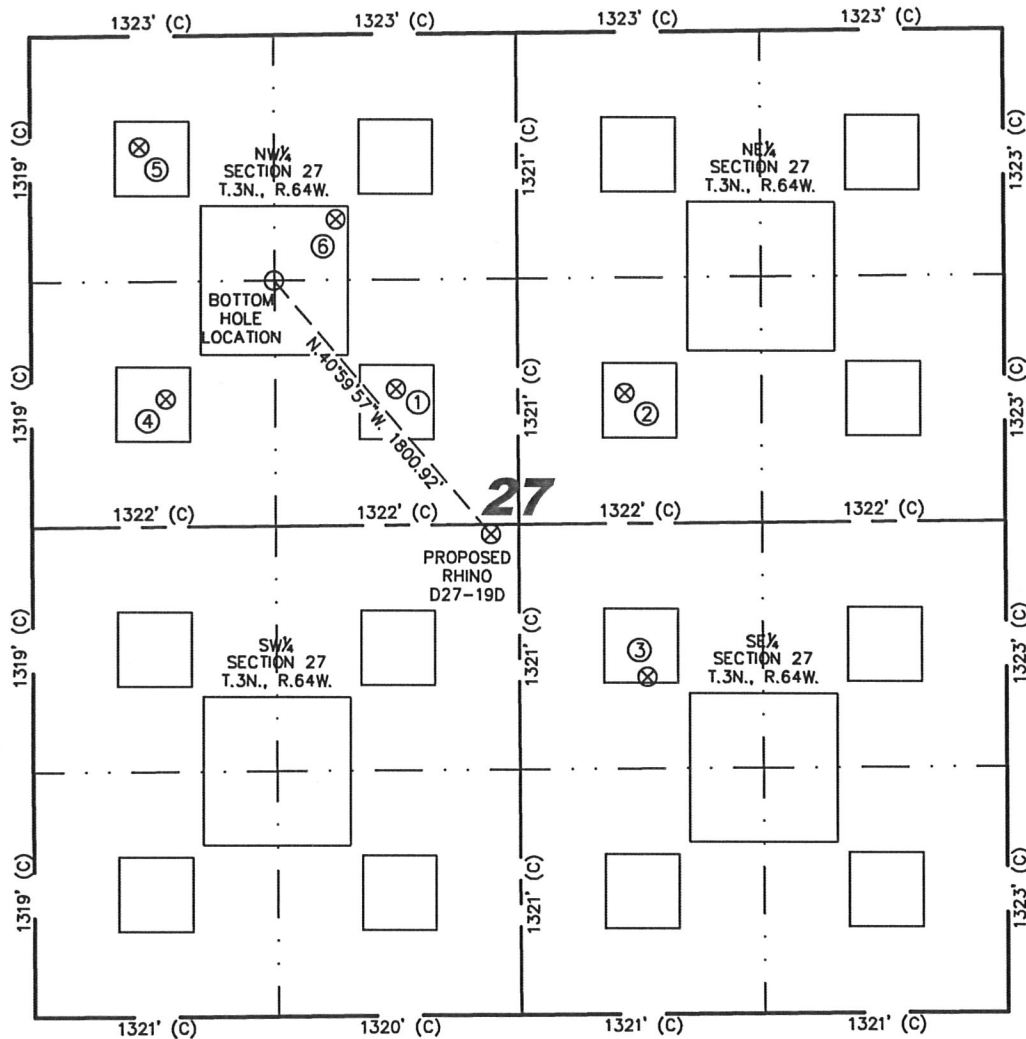
SECTION 27  
TOWNSHIP 3 NORTH  
RANGE 64 WEST

| ① | ② | ③ | ④ | ⑤ | ⑥ |
|---|---|--|--|---|---|
| CAMOLO RED<br>D27-6<br>SE/NW SEC. 27<br>1908' FNL<br>1981' FWL<br>EL 4855'<br>N 40.19838<br>W 104.53988<br>PDOP 1.9 | ESTES D27-7<br>SW/NE SEC. 27<br>1942' FNL<br>2065' FEL<br>EL 4853'<br>N 40.19829<br>W 104.53543<br>PDOP 2.0 | ESTES D27-10<br>NW/SE SEC. 27<br>1815' FSL<br>1950' FEL<br>EL 4874'<br>N 40.19410<br>W 104.53505<br>PDOP 2.0 | CAMOLO RED<br>D27-5<br>SW/NW SEC. 27<br>1952' FNL<br>729' FWL<br>EL 4854'<br>N 40.19826<br>W 104.54437<br>PDOP 1.7 | CAMOLO RED<br>D27-4<br>NW/NW SEC. 27<br>596' FNL<br>593' FWL<br>EL 4837'<br>N 40.20198<br>W 104.54483<br>PDOP 1.7 | CAMOLO RED<br>D27-2J<br>NE/NW SEC. 27<br>993' FNL<br>1659' FWL<br>EL 4847'<br>N 40.20089<br>W 104.54102<br>PDOP 1.9 |
