KING SURVEYORS, INC. 650 E. GARDEN DR. WINDSOR, CO 80550
WELL LOCATION CERTIFICATE

MEIS 32-8B

SECTION: 8
 TOWNSHIP: 1N
 RANGE: 46W

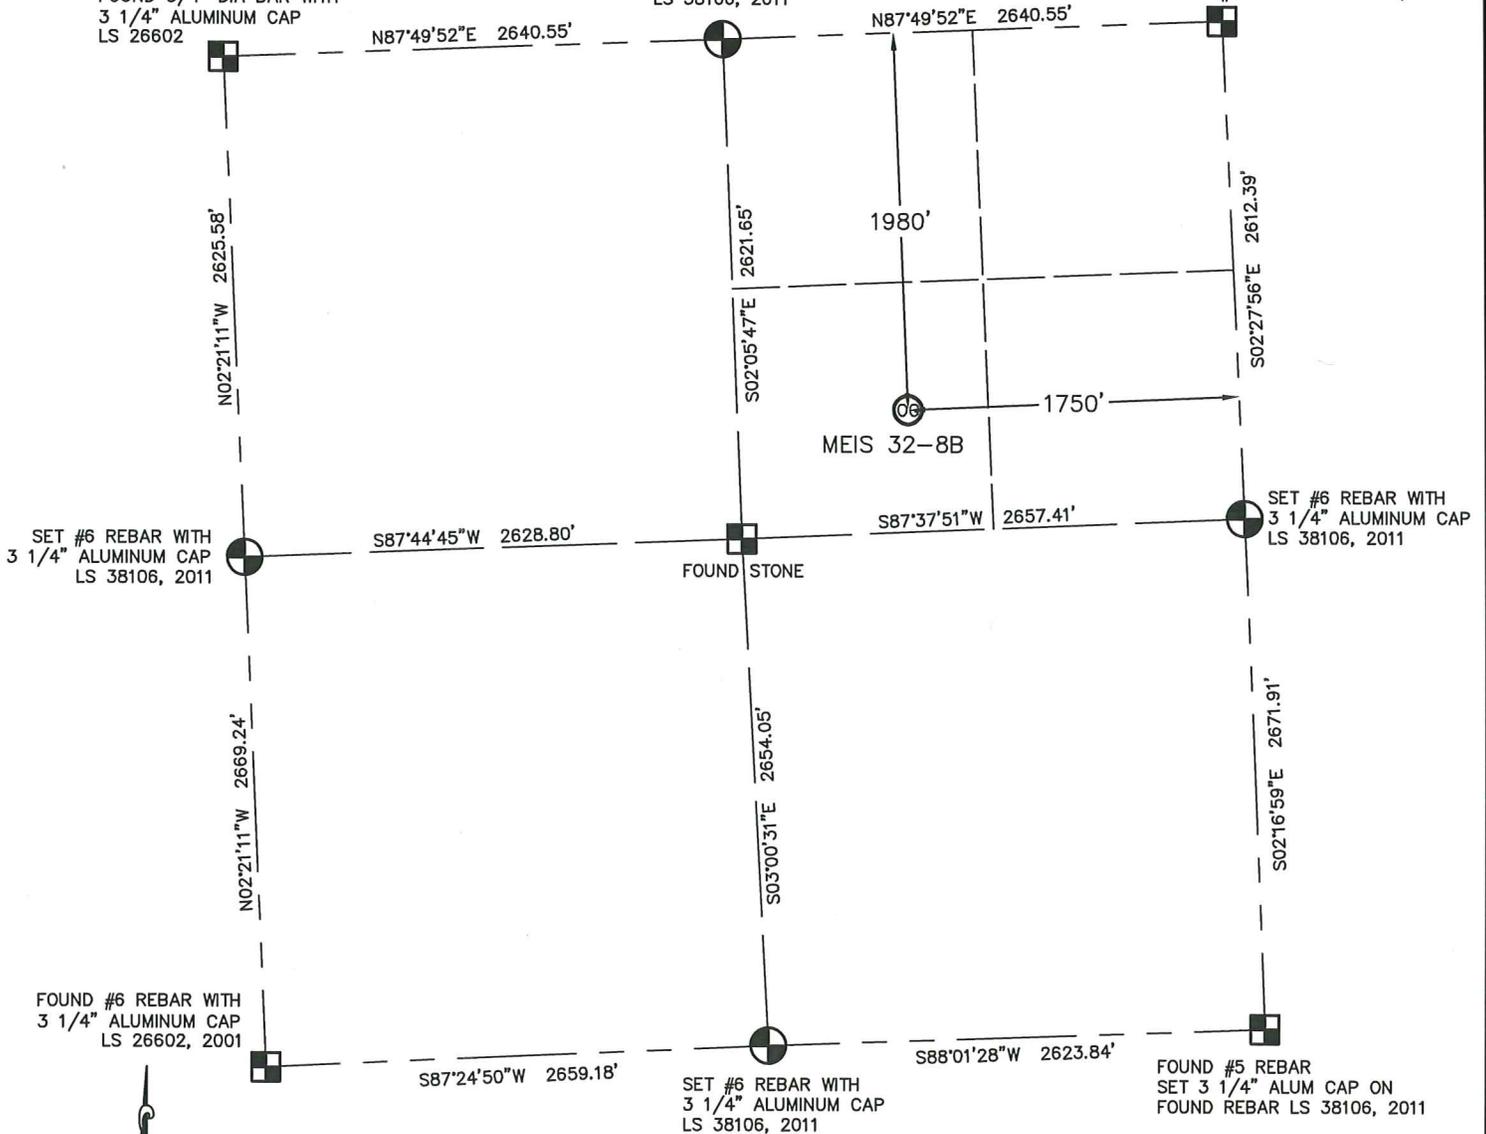
FOUND #5 REBAR WITH
 1 1/2" ILLEGIBLE ALUMINUM CAP
 SET 3 1/4" ALUM CAP ON
 FOUND #5 REBAR LS 38106, 2011

SET #6 REBAR WITH
 3 1/4" ALUMINUM CAP
 LS 38106, 2011

FOUND 3/4" DIA BAR WITH
 3 1/4" ALUMINUM CAP
 LS 26602

In accordance with a request from DAVID LEDEI with NOBLE ENERGY INC.
 King Surveyors Inc. has determined the surface location of MEIS 32-8B to be 1980' from the NORTH line and 1750' from the EAST line, as measured at right angles, from the section lines of Section 8, Township 1 North, Range 46 West of the Sixth Principal Meridian, County of Yuma, State of Colorado.

SURFACE LOCATION
 LATITUDE: 40.07017°N
 LONGITUDE: 102.53609°W
 PDOP: 1.5
 ELEV: 3966'
 1/4,1/4: SW1/4 NE1/4
 NEAREST PROPERTY LINE: 671' NORTH
