# WELL LOCATION CERTIFICATE

UNGER 14-11

SECTION: 11  
TOWNSHIP: 1N  
RANGE: 46W

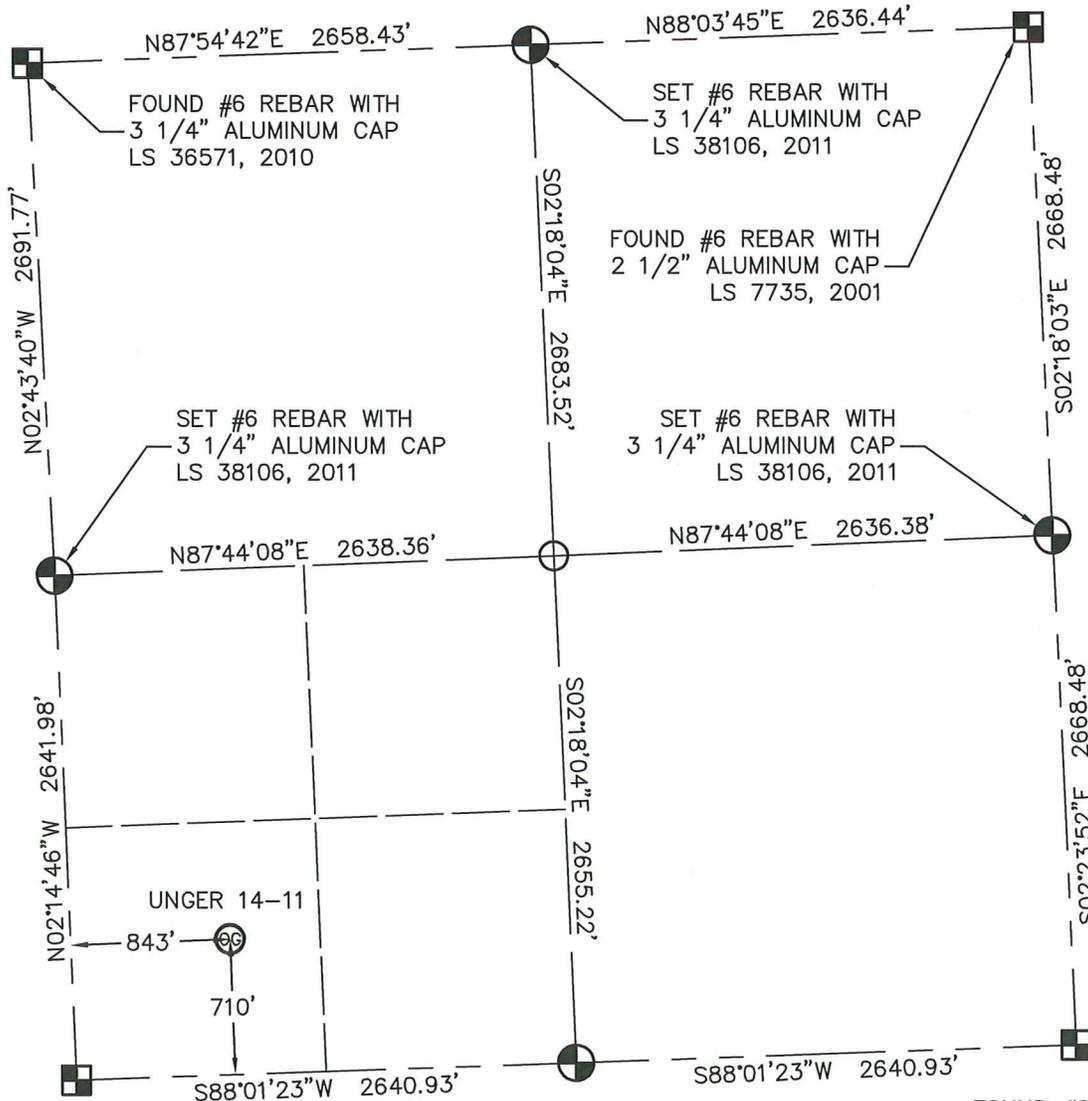
King Surveyors Inc. has determined the surface location of UNGER 14-11 to be 710' from the SOUTH line and 843' from the WEST line, as measured at right angles, from the section lines of Section 11, Township 1 North, Range 46 West of the Sixth Principal Meridian, County of Yuma, State of Colorado.

**SURFACE LOCATION**  
LATITUDE: 40.06323N  
LONGITUDE: 102.48902W  
PDOP: 2.6  
ELEV: 3940'  
1/4,1/4: SW1/4 SW1/4  
NEAREST PROPERTY LINE: 710' SOUTH
