KING SURVEYORS, INC. 650 E. GARDEN DR. WINDSOR, CO 80550  
**WELL LOCATION CERTIFICATE**

EASTIN 42-23

SECTION: 23  
 TOWNSHIP: 1S  
 RANGE: 46W

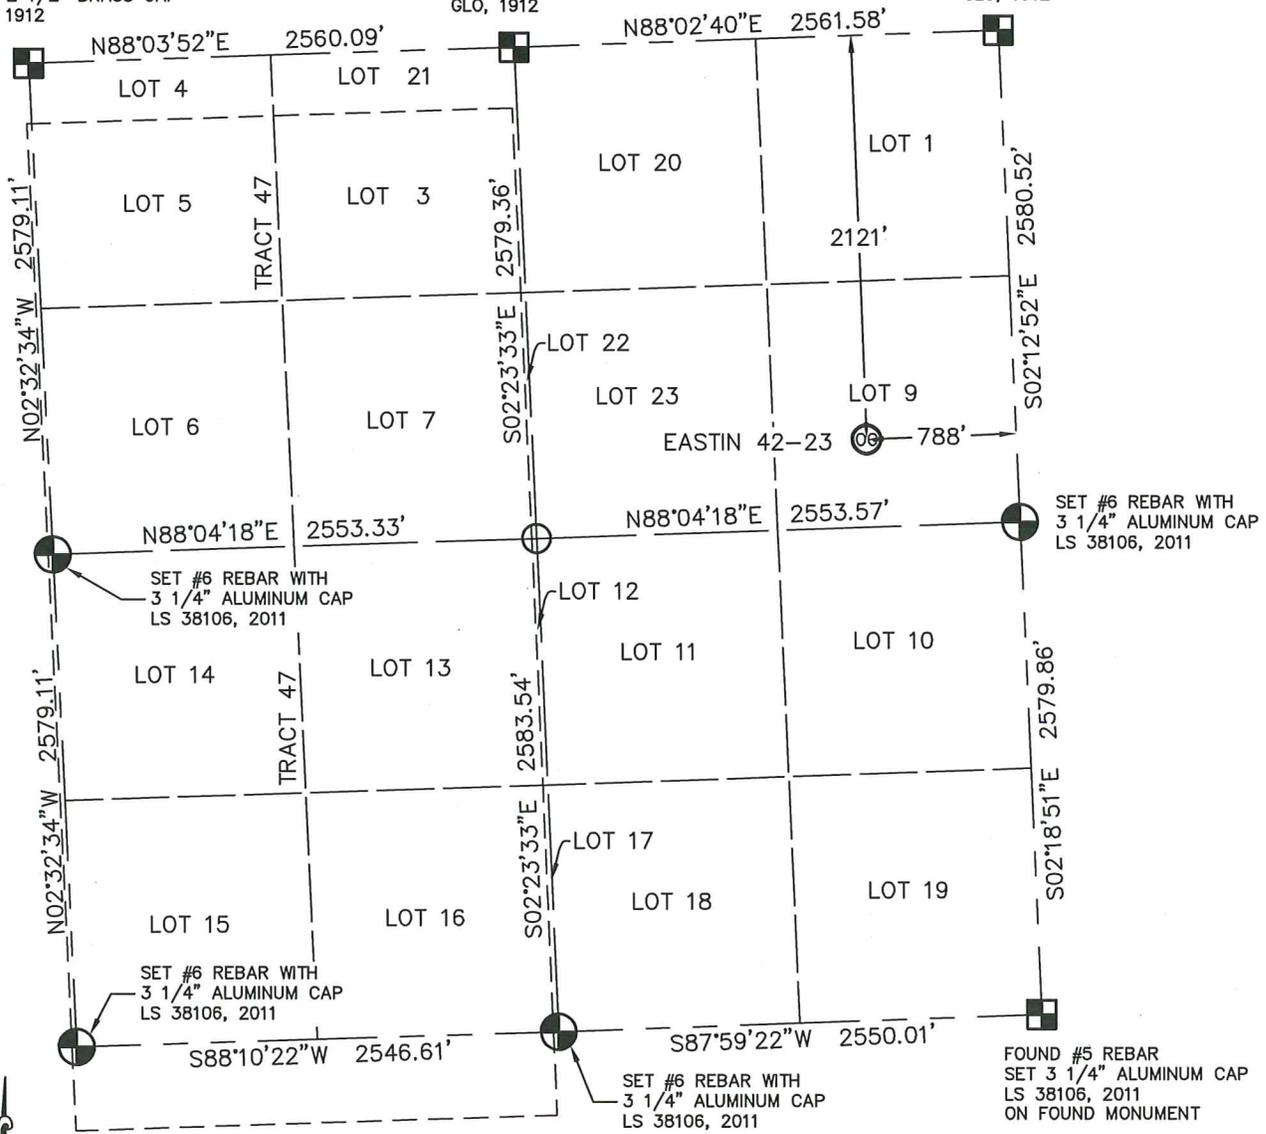
FOUND 2" DIA PIPE  
 WITH 2 1/2" BRASS CAP  
 GLO, 1912

FOUND 1" DIA PIPE  
 WITH 2 1/2" BRASS CAP  
 GLO, 1912

In accordance with a request from DAVID LEDET with NOBLE ENERGY INC. King Surveyors Inc. has determined the surface location of EASTIN 42-23 to be 2121' from the NORTH line and 788' from the EAST line, as measured at right angles, from the section lines of Section 23, Township 1 South, Range 46 West of the Sixth Principal Meridian, County of Yuma, State of Colorado.

**SURFACE LOCATION**  
 LATITUDE: 39.95560°N  
 LONGITUDE: 102.48873°W  
 PDOP: 1.3  
 ELEV: 3985'  
 1/4,1/4: LOT 9  
 NEAREST PROPERTY LINE: 459' SOUTH
