WELL LOCATION CERTIFICATE

EASTIN 32-23

SECTION: 23
TOWNSHIP: 1S
RANGE: 46WFOUND 2" DIA PIPE
WITH 2 1/2" BRASS CAP
GLO, 1912FOUND 1" DIA PIPE
WITH 2 1/2" BRASS CAP
GLO, 1912FOUND 2" DIA PIPE
WITH 2 1/2" BRASS CAP
GLO, 1912

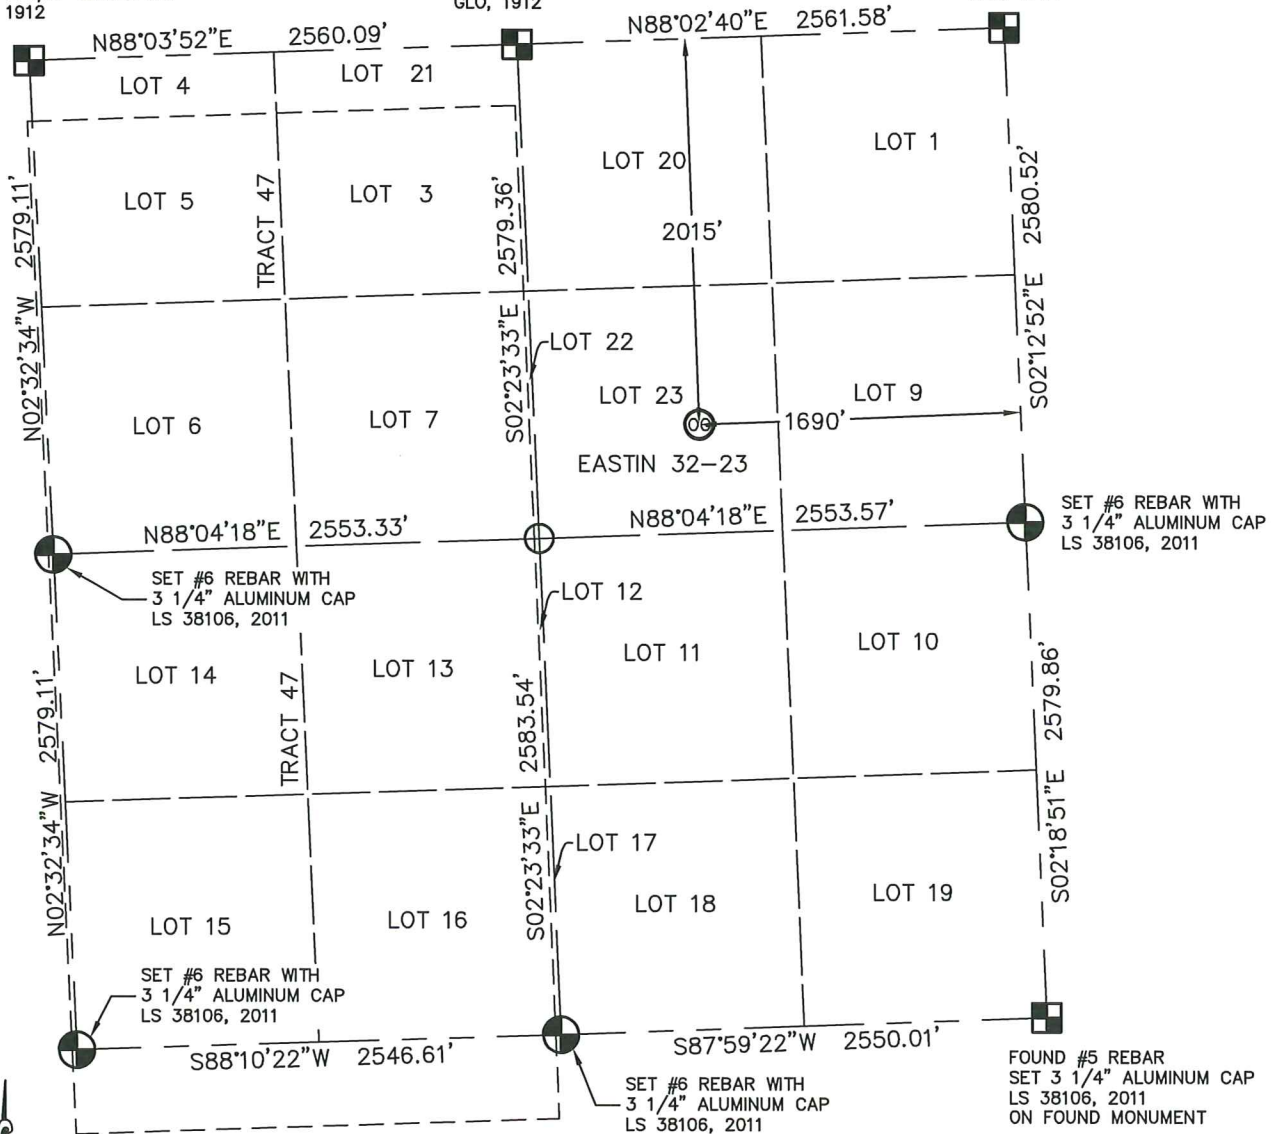
King Surveyors Inc. has determined the surface location of EASTIN 32-23 to be 2015' from the NORTH line and 1690' from the EAST line, as measured at right angles, from the section lines of Section 23, Township 1 South, Range 46 West of the Sixth Principal Meridian, County of Yuma, State of Colorado.

SURFACE LOCATION
LATITUDE: 39.95590°N
LONGITUDE: 102.49194°W
PDOP: 1.9
ELEV: 3973'
1/4, 1/4: LOT 23
NEAREST PROPERTY LINE: 412' EAST
