STATE OF
COLORADO

Closure on remediation project 3797?

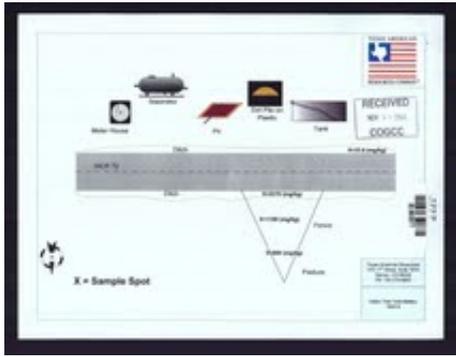
Sample Location Diagram-3797.jpg
609K

I looked through the files for Remediation Project 3797. We need a confirmation sample from the surface soil across CR72 from the tank battery where a previous sample contained a TPH concentration of 5370 mg/kg. Please see the attached figure. A soil sample should be collected and analyzed for TPH to demonstrate current conditions. I stopped by this location yesterday, and based on that inspection and the remediation file, we should be able to close the project if a confirmation sample shows that TPH concentrations have been reduced.
