**WELL: Padilla #1 to be located 885.42' FEL and 1153.33' FNL in Section 9, Township 22 South, Range 58 West of the 6th P.M.**  
**Location falls in : Irrigated crop land Ground Elevation = 4284.66' Improvements: No visible improvements within 500 ft radius of the location.**

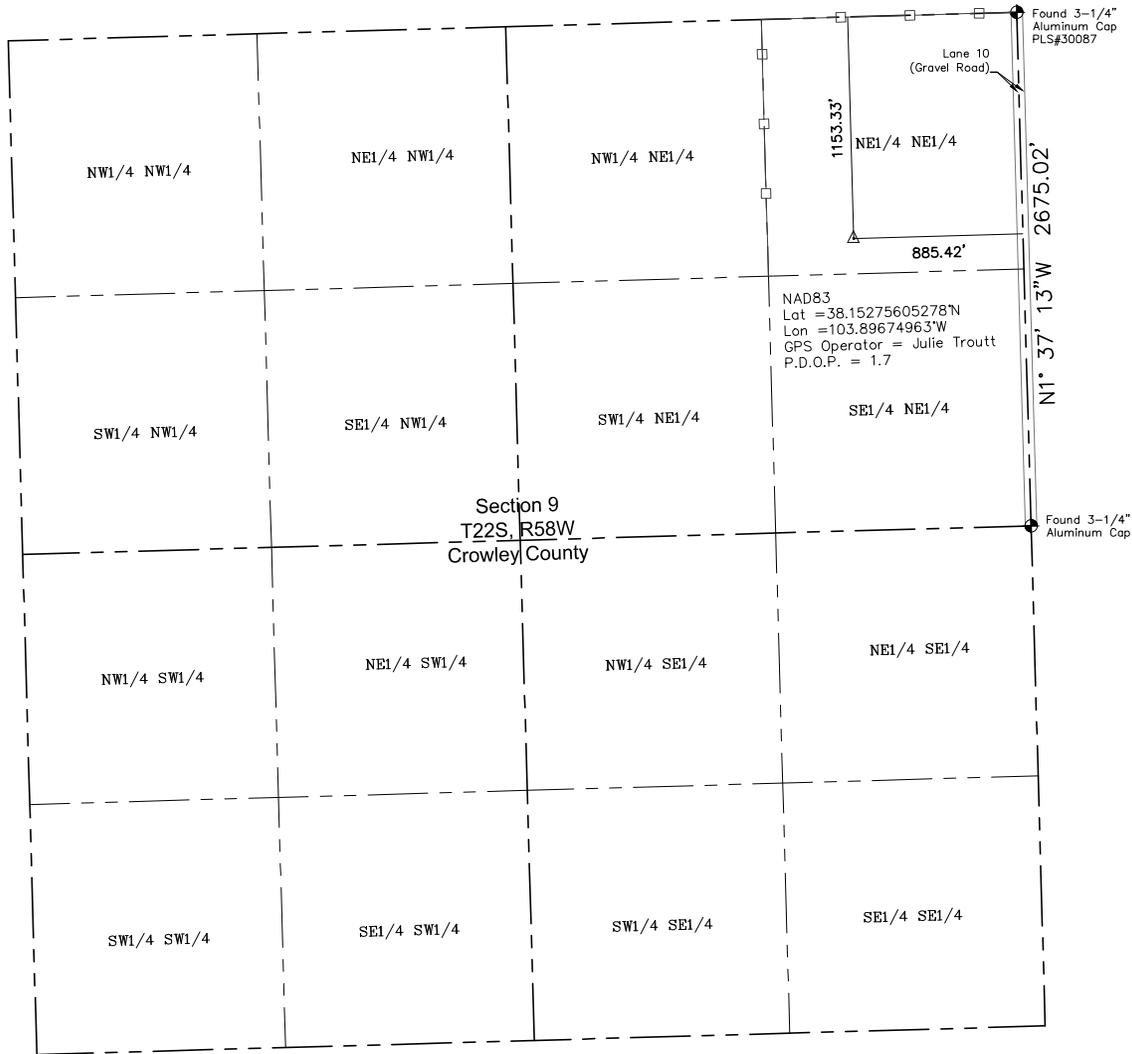
1. This survey was done by GPS methods and conforms to the minimum standards as set by the C.O.G.C.C. Rule No. 215.
2. The Bearings as shown hereon are based on GPS observation between the monuments shown hereon as found in the field date below.
3. Distance shown hereon are at ground level, as measured in the field, with ties to wells measured at a perpendicular to section lines.  
 Vertical = NAVD88 Horizontal = NAD83
