WELL LOCATION CERTIFICATE

NB Farms 22-01

DATE OF FIELD WORK 3/10/2014	DATE OF DRAWING 3/19/2014	PROJECT NO. 1083.007
Augustus Energy Resources, LLC NB Farms 22-01 1N46W		
SE1/4 NW1/4 SEC. 1, T1N, R46W, 6PM, Yuma County, Colo.

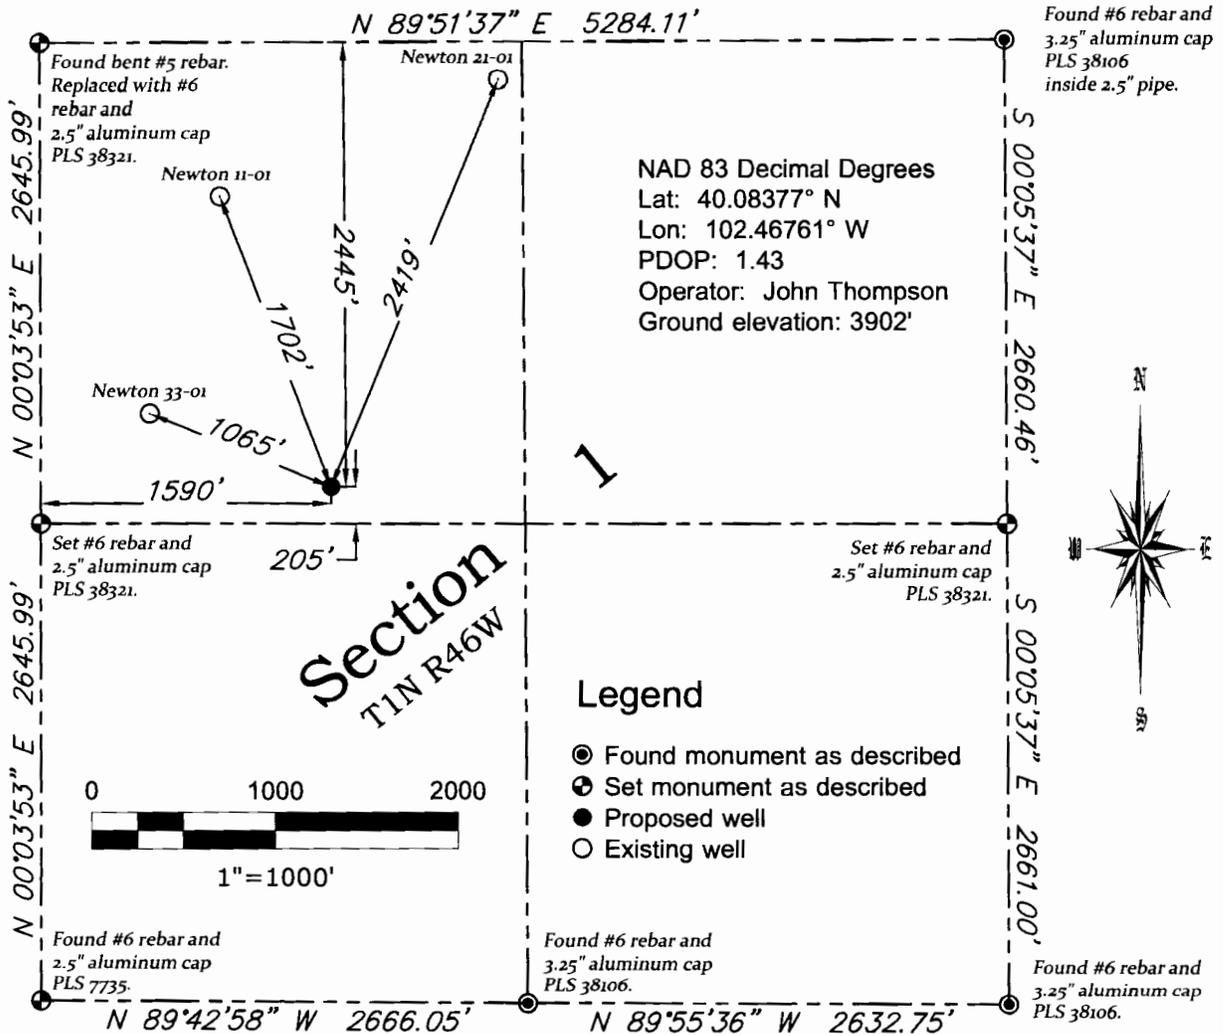
NAD 83 Decimal Degrees
 Lat: 40.08377° N
 Lon: 102.46761° W
 PDOP: 1.43
 Operator: John Thompson
 Ground elevation: 3902'

Found #6 rebar and
 3.25" aluminum cap
 PLS 38106
 inside 2.5" pipe.

Found bent #5 rebar.
 Replaced with #6
 rebar and
 2.5" aluminum cap
 PLS 38321.

Set #6 rebar and
 2.5" aluminum cap
 PLS 38321.

Found #6 rebar and
 2.5" aluminum cap
 PLS 7735.

Found #6 rebar and
 3.25" aluminum cap
 PLS 38106.

NB Farms 22-01 is to be located at a point 2445' from the NORTH line and 1590' (measured at right angles) from the WEST line of the NW Quarter of Section 1, Township 1 North, Range 46 West of the Sixth Principal Meridian, Yuma County, Colorado.

Bearings of this survey are based on the assumption that the north line of the Section 1, Township 1 North, Range 46 West of the 6th Principal Meridian, between monuments described hereon bears N 89°51'37" E as shown hereon.
