**Ursa** | OPERATING COMPANY

Piceance Basin

B&V Pad

Multi Well Diagram

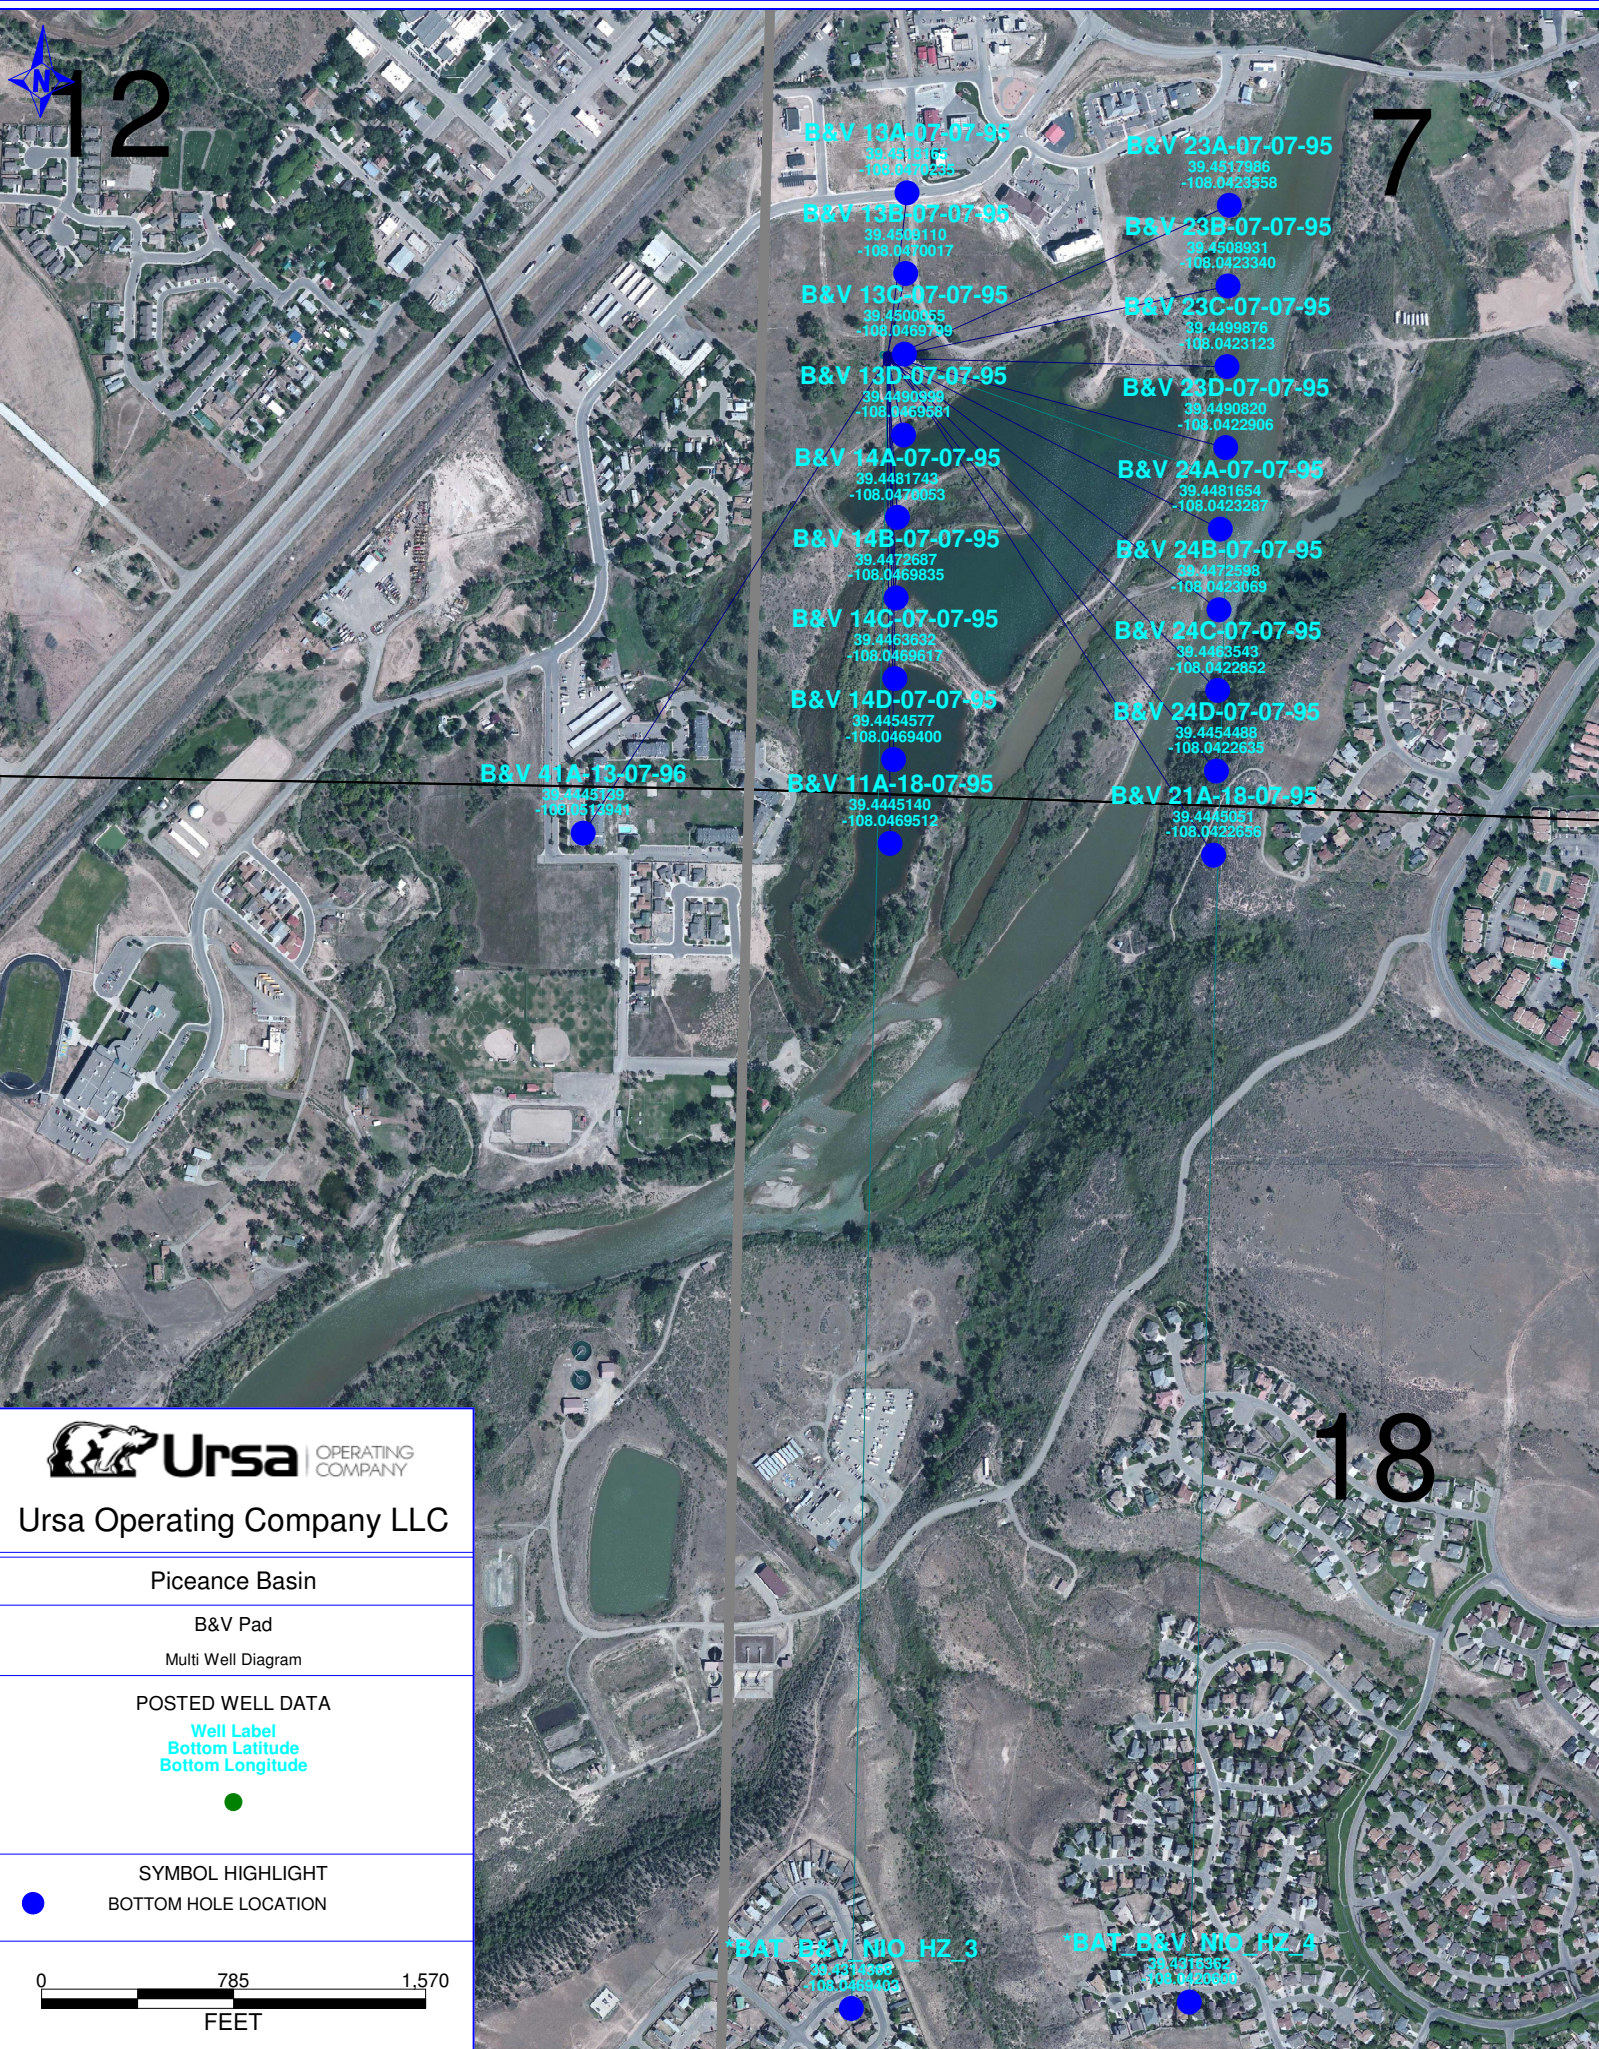
POSTED WELL DATA

Well Label  
Bottom Latitude  
Bottom Longitude

SYMBOL HIGHLIGHT  
BOTTOM HOLE LOCATION
