CURRENT WELLBORE DIAGRAM

ALLAN # 1

API # 05-123-05775

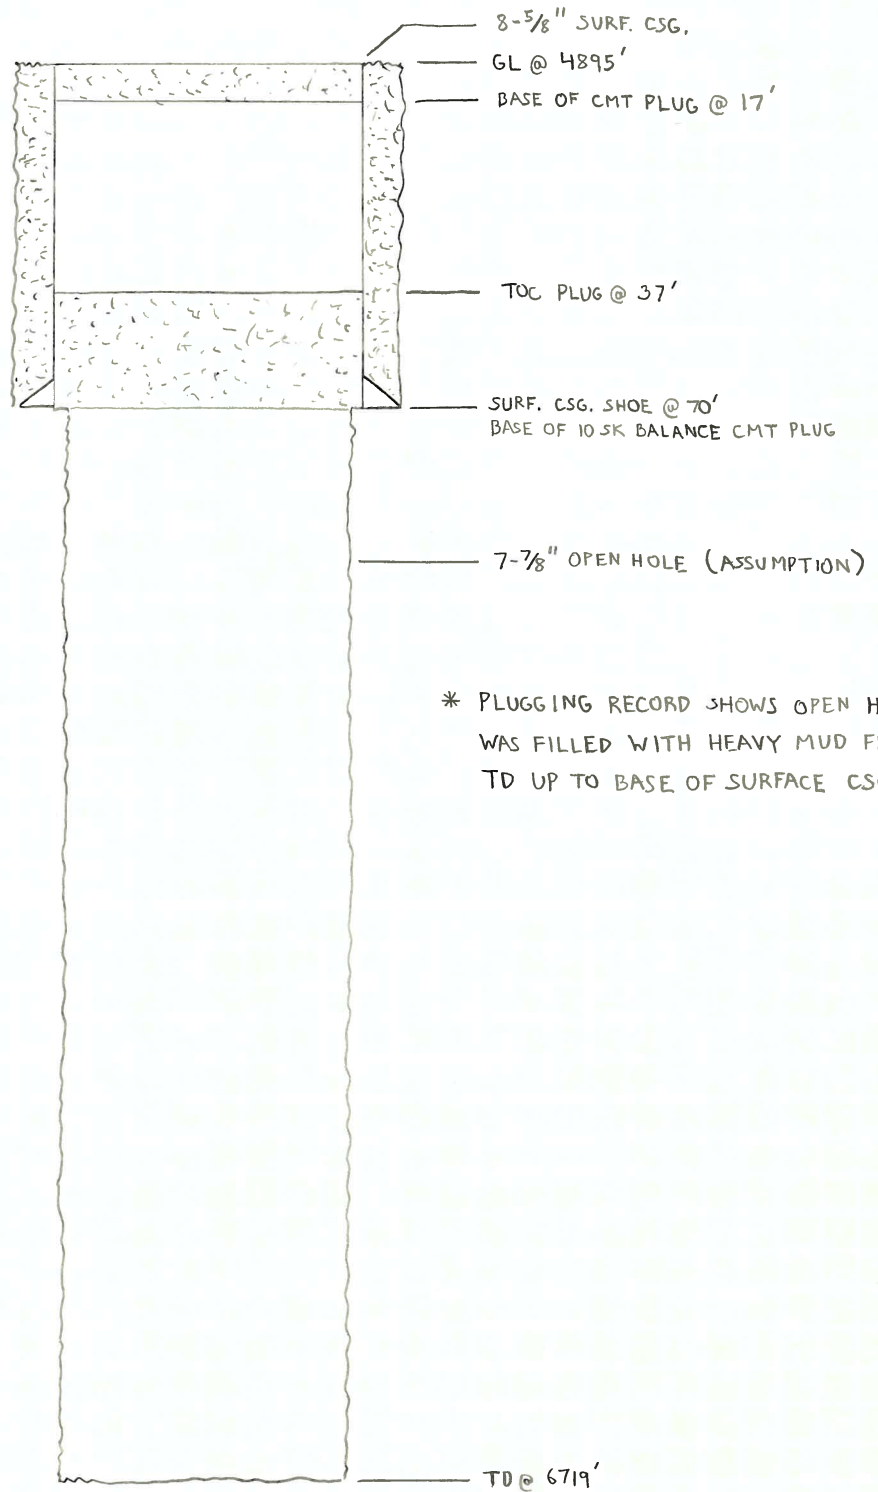
- EXISTING CMT

\* PLUGGING RECORD SHOWS OPEN HOLE  
WAS FILLED WITH HEAVY MUD FROM  
TD UP TO BASE OF SURFACE CSG,
