Assessment of P&A Wells Within 1/4 Mile of Proposed CBM Well

Operator: BP America Production Company

Proposed Well(s): Ford H 1, 2, & 3 (API Pending)

Well Name: Ford Gas Unit 1 (API 05-067-05490)

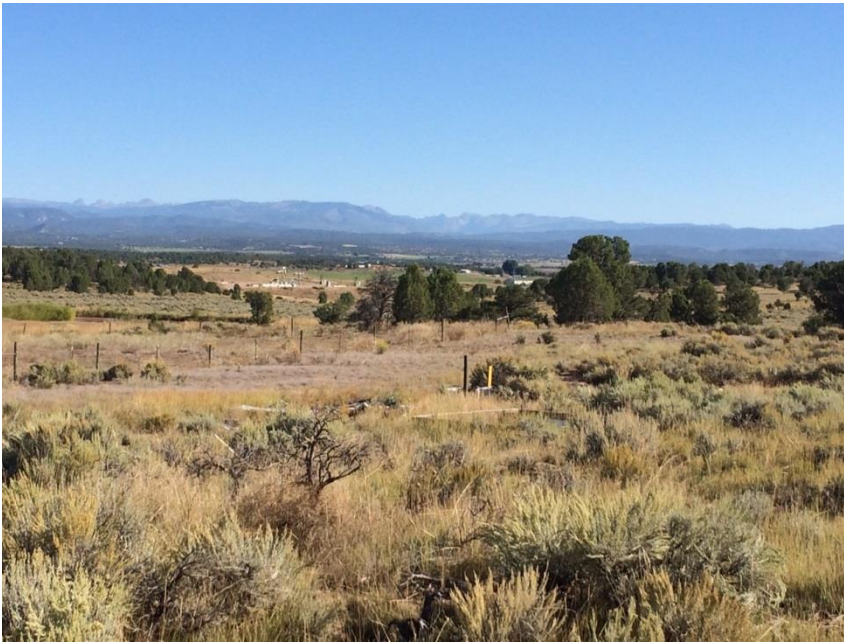
Figure 1 – Ford Gas Unit 1 Location

A visual inspection of the Pan American Petroleum Corp. 1 Ford GU PA location was conducted by BP personnel on September 11, 2015. The location was properly marked with a steel pipe (Photo 1). The PA Is located in a reclaimed well pad with abundant native vegetation. There is significant residential debris in the vicinity of the PA marker

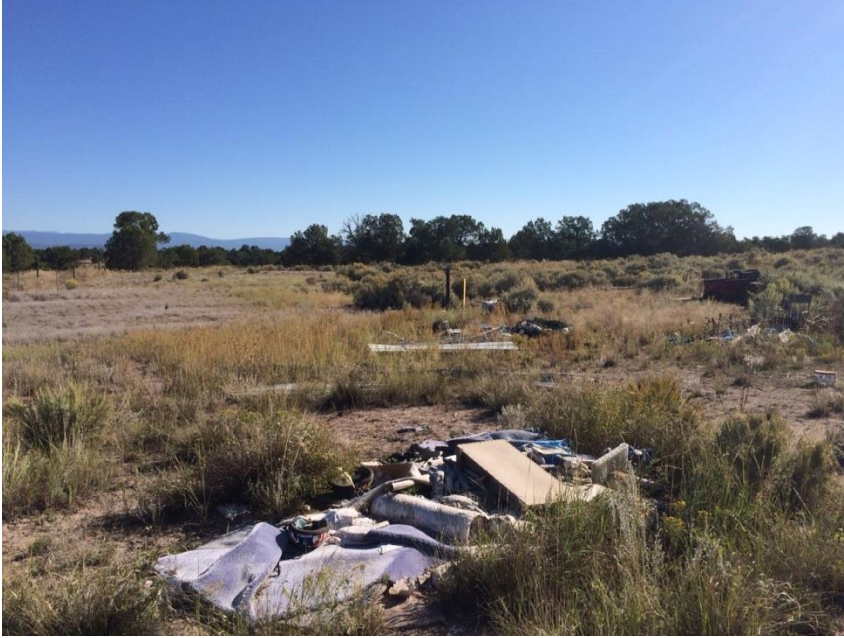
Figure 2 – Ford Gas Unit 1 Location

(Photo 2). There were no bare spots or signs of stressed vegetation anywhere near the PA marker (Photo 3). There is what appears to be older soil vapor tubes near the PA marker from some prior testing. The area around the pipe was saturated with water to test for bubbles, but no bubbles were observed.
