**Re: Sump Replacement Summary Letter Report
UPRC-63N65W33NWNW (UPRC 33-4J5)
API: 05-123-17697
Facility ID: 329672
Legal: NWNW Sec 33-T3N-R65W
Remediation Project #8961**

Sample Location
Map

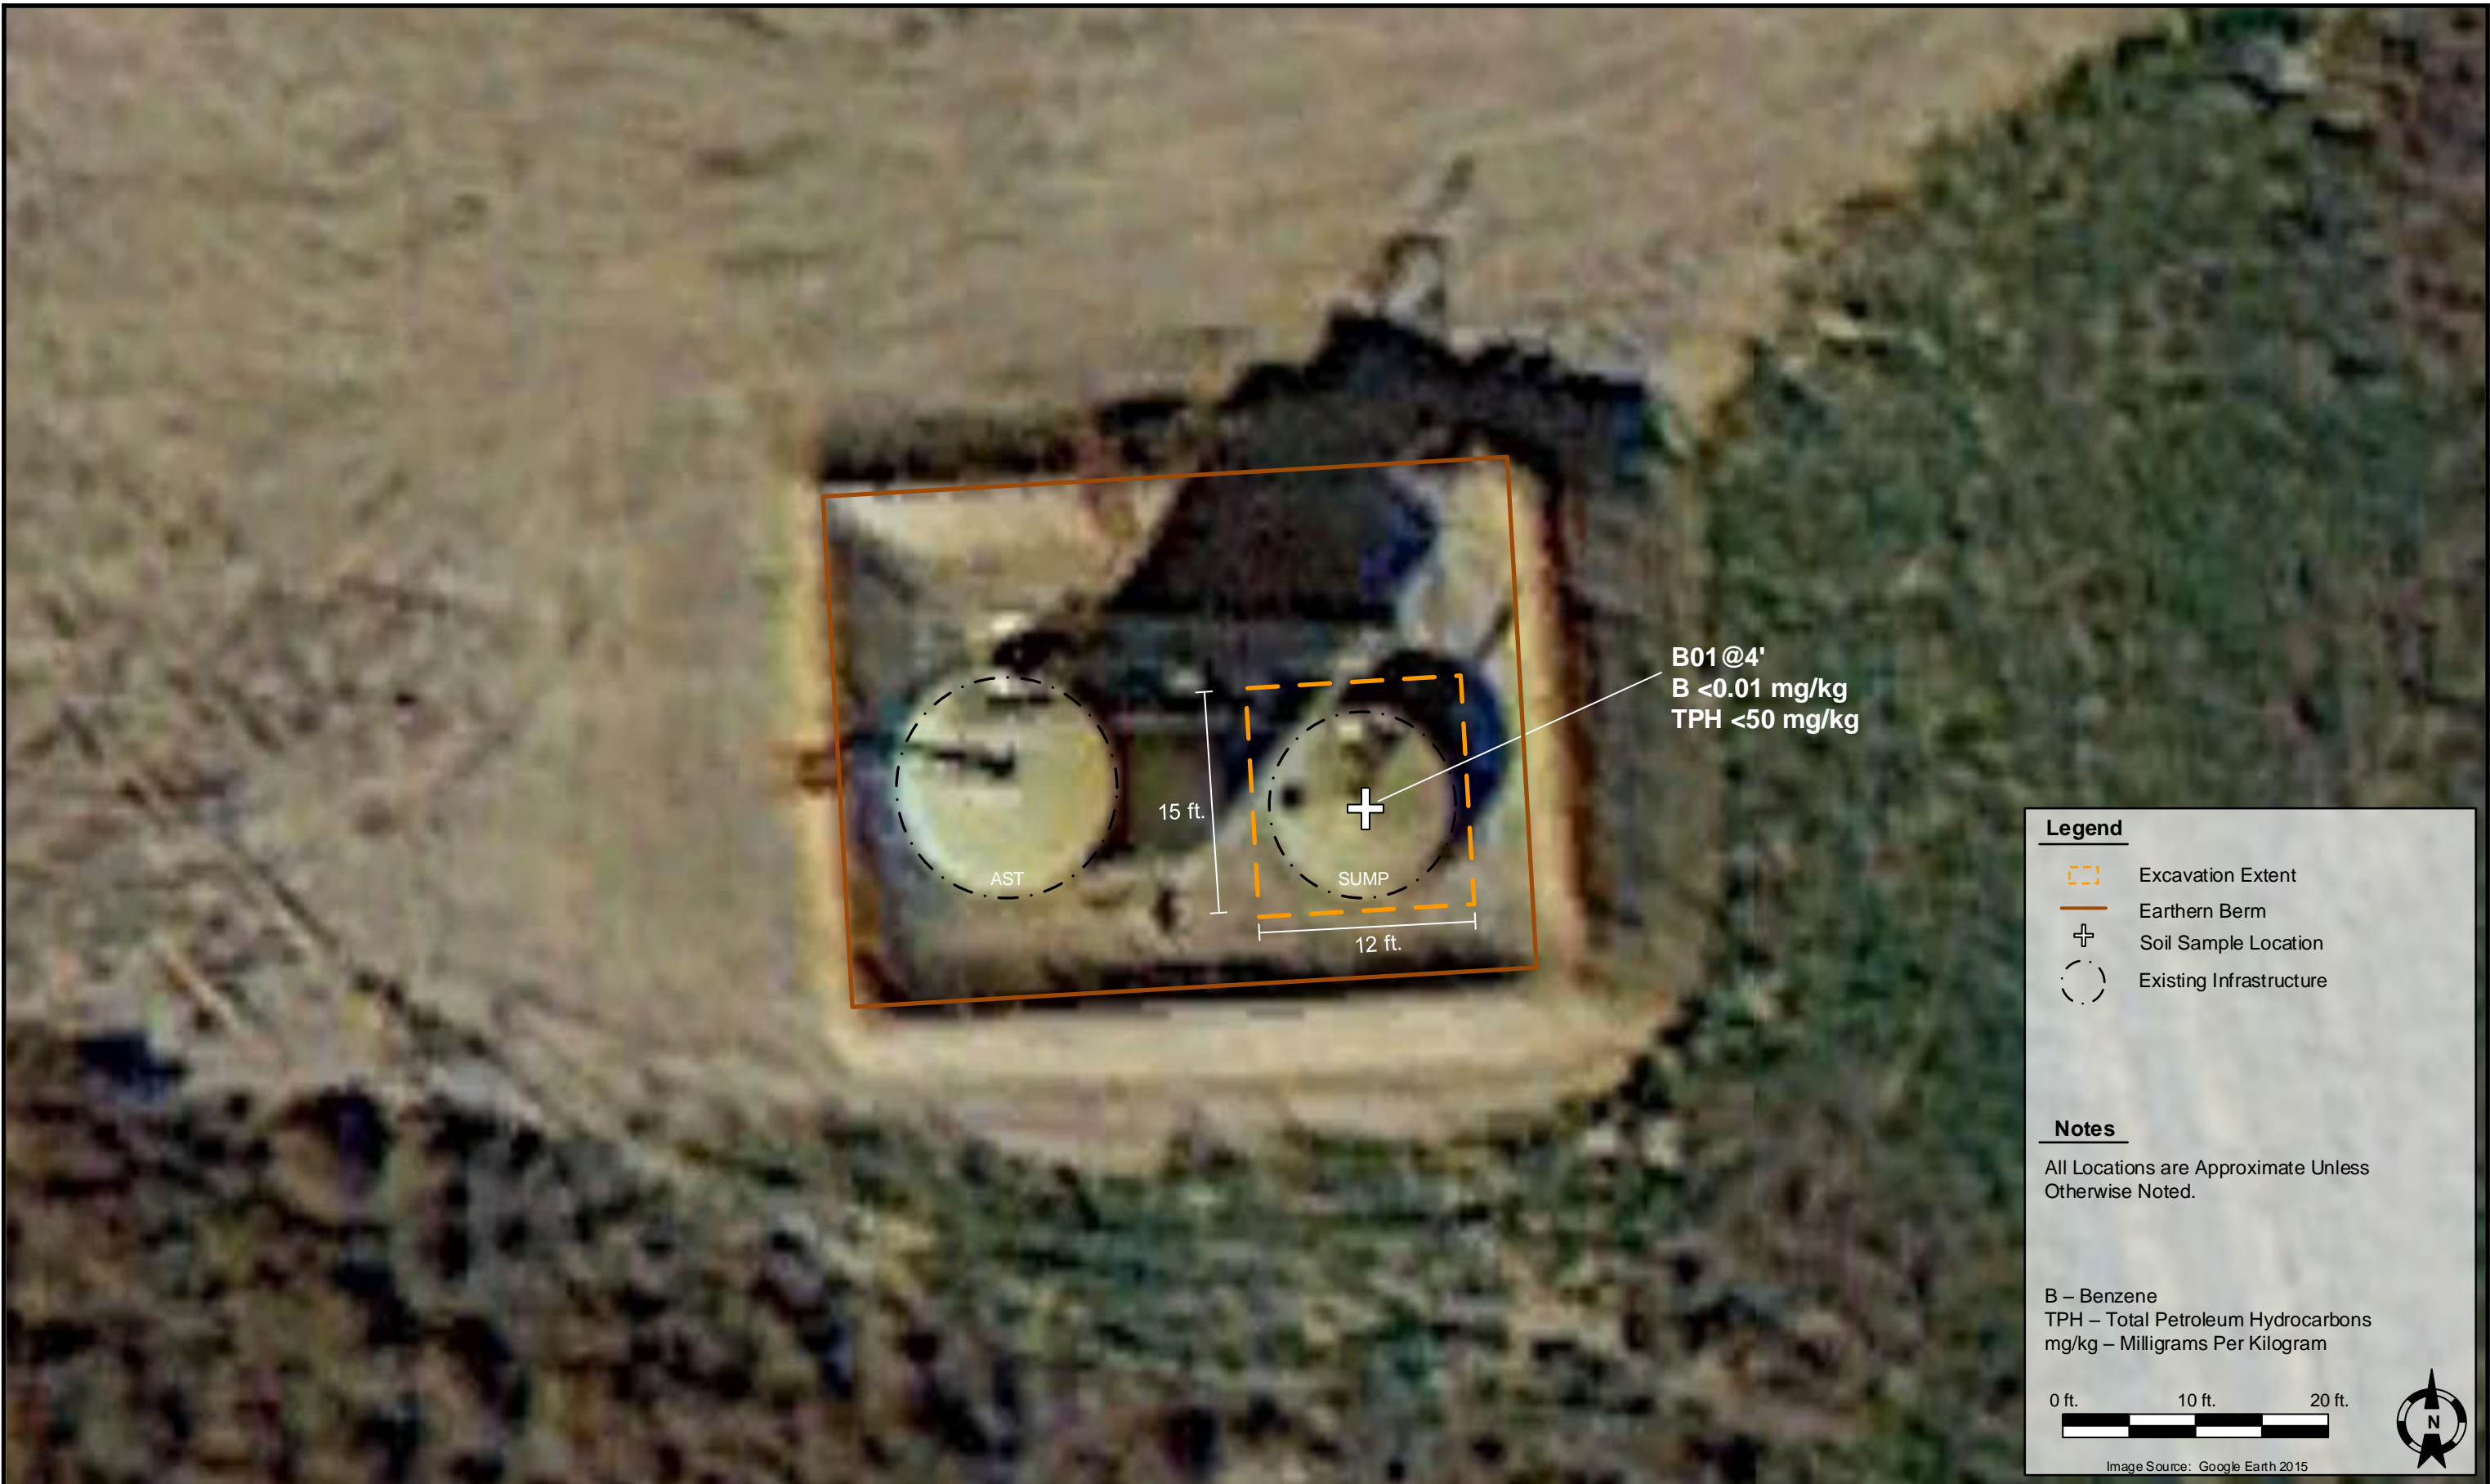
FIGURE
1

The field activities described herein were performed with the purpose of assessing potential hydrocarbon impacts at the site related to the replacement of the produced water sump on August 15, 2014. Soil sampling activities, laboratory analytical results, and conclusions are presented below. The general site layout and sample locations are provided in the attached site map (Attachment A).
