RE: Airport - Drilling Mud Beneficial Re-Use Application Site, Sampling, June 2013,
MEC # 2013.INT/Bays2

Attached please find the results of the June 2013 sampling at the Great Western, Drilling Mud Beneficial Re-Use Airport site, Weld County, Co. The sampling was performed on June 16, 2013.

DELINEATION OF POD SAMPLE AREAS - JUNE 2013

COMPOSITE SURFACE SOIL SAMPLE LOCATIONS - JUNE 2013

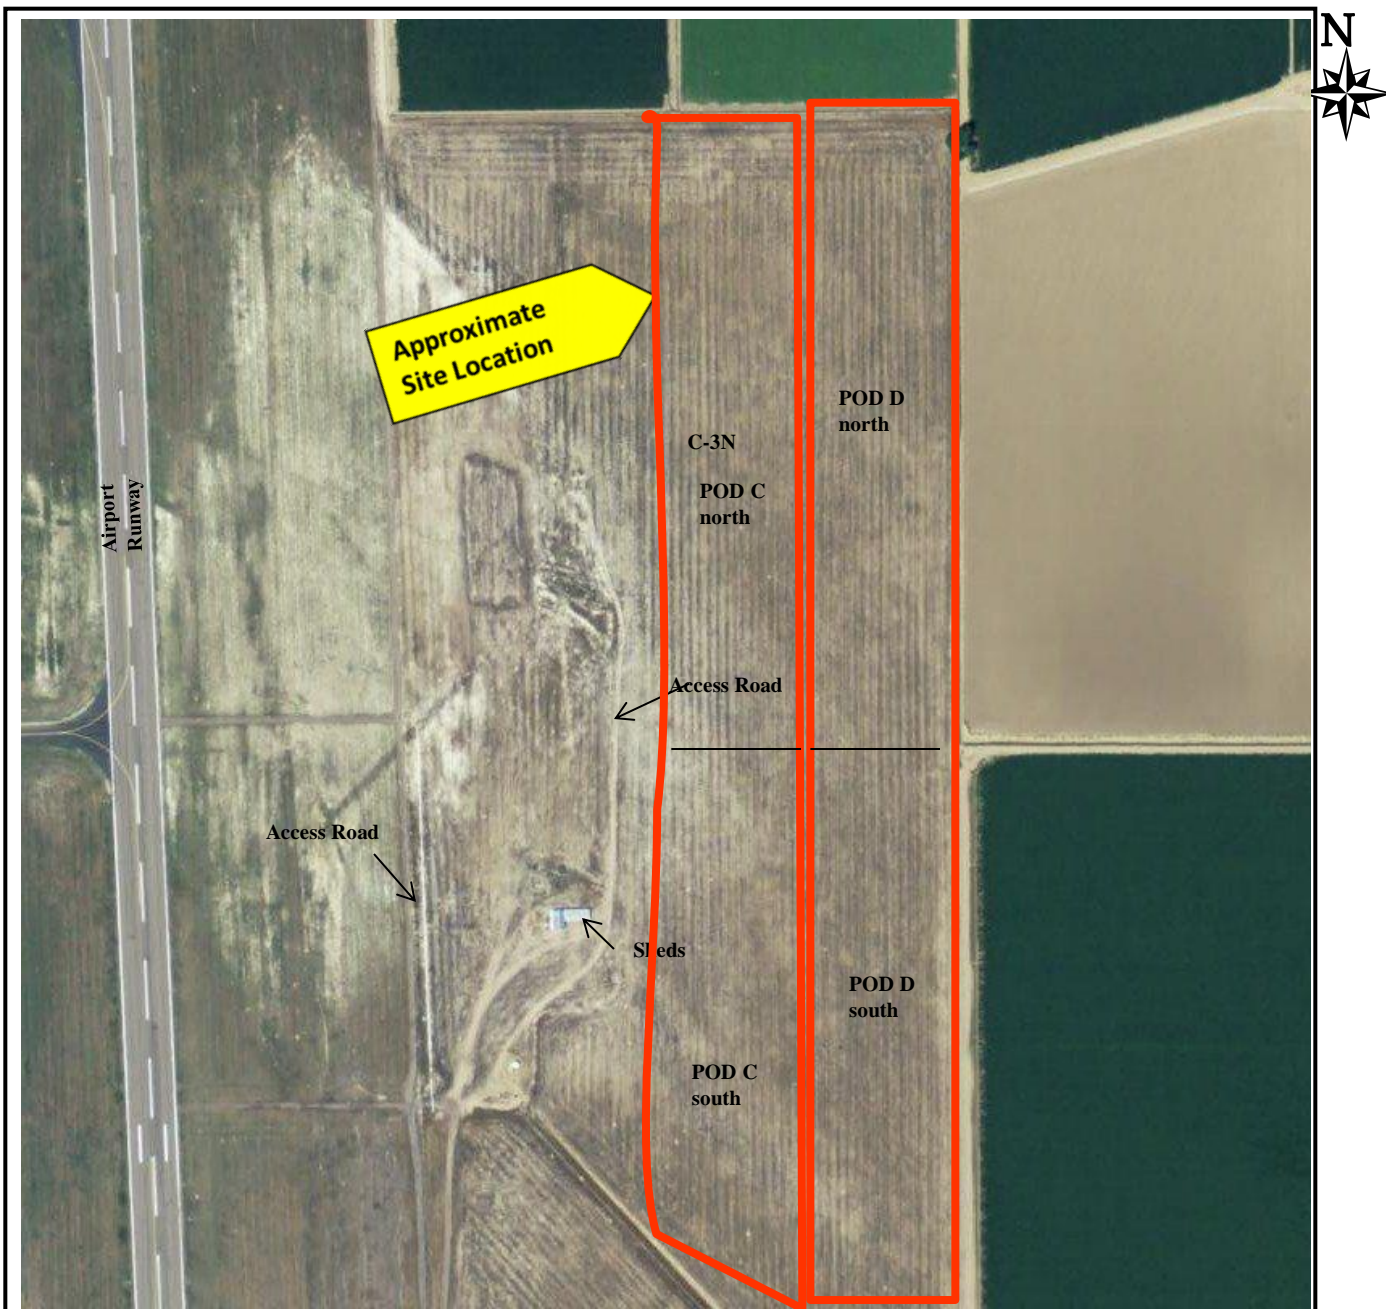
For the purpose of the site sampling, MEC Inc. divided the site into PODs based on application history. Based on site observations, the status of the delineated PODs appear to be at various stages of use: no mud application at this time, mud placement in progress, and mud application completed (such areas may be at various stages of ripping/tilling).

PODs C / D / E: Located in NE corner of site. Application of drilling muds has been completed and tilled in, additional tilling and ripping may be necessary. Background sample for this area was collected in June 2013, sample # POD-C/D Bkg.

Boundaries are approximate,
Scale 1:12,500

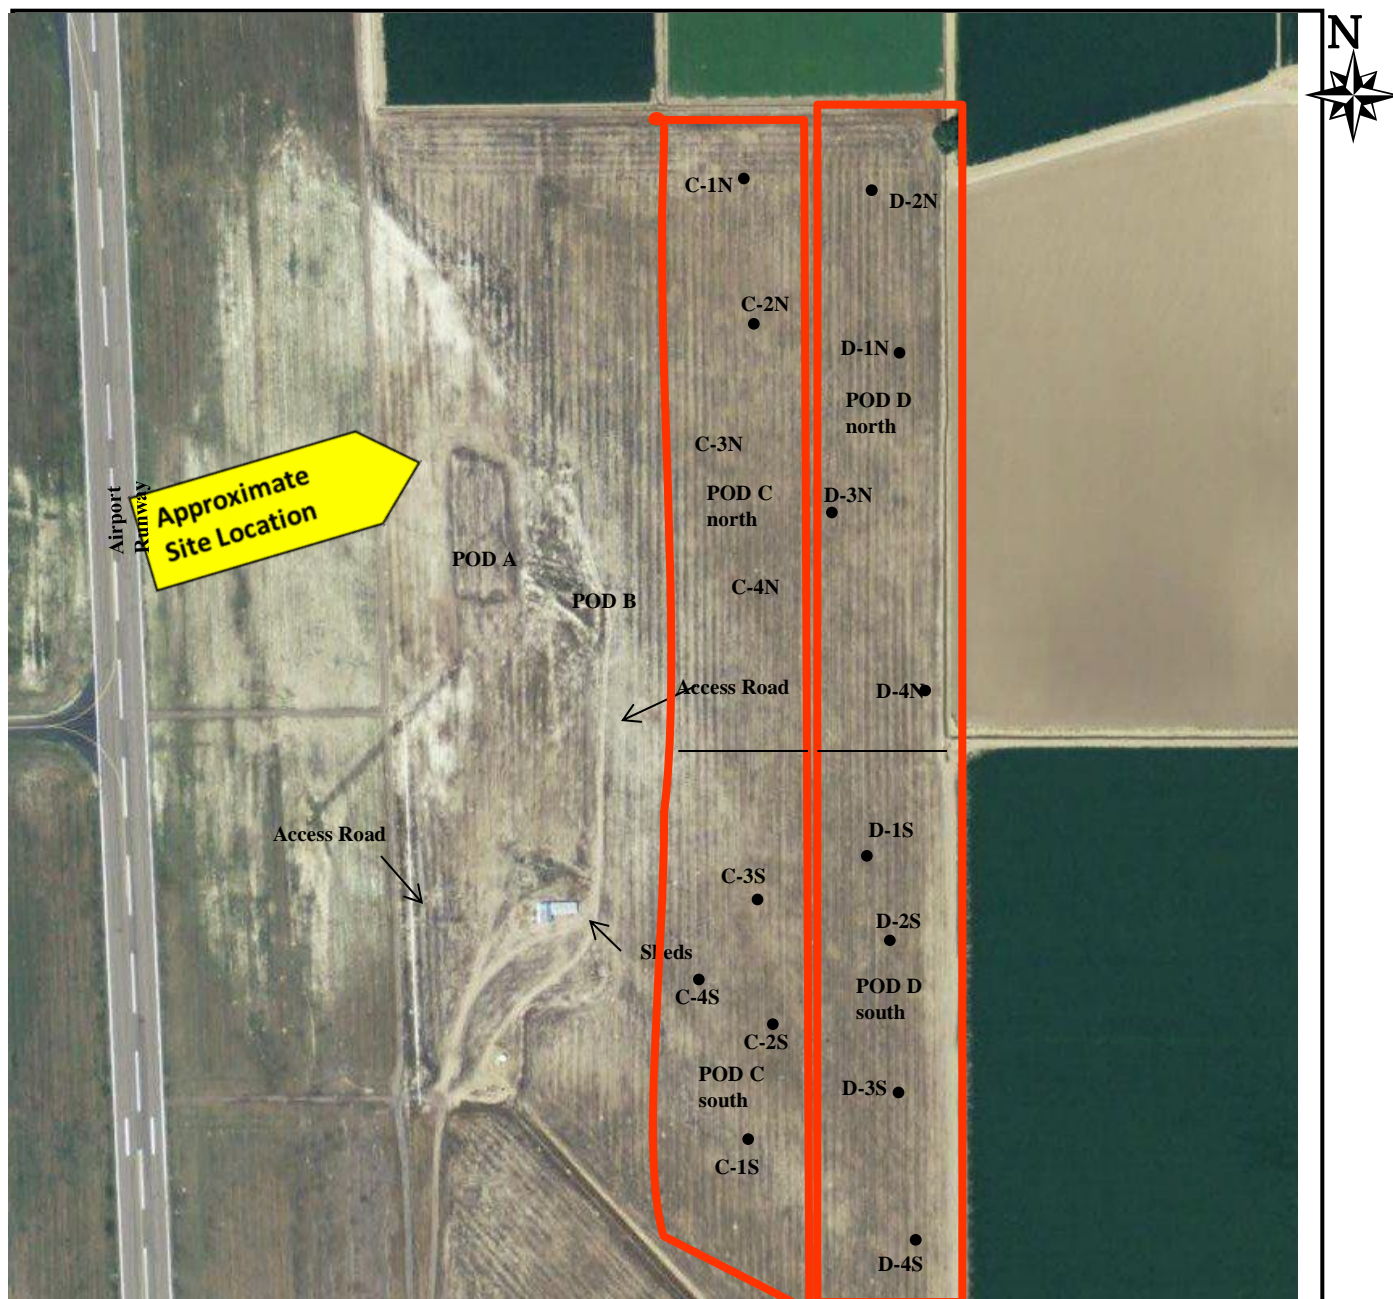
See figure 2 for the approximate location of the 4 aliquot sample locations for each pod that were mixed to form the composite sample from each pod.

Note lab samples consisted of upto 4 composite aliquot samples. The approximate location of the respective aliquot samples are illustrated for each POD.

Composite Sample #,	Aliquots ID for each POD	Composite Sample #,	Aliquots ID for each POD
POD -D north	D: -1N, 2N, 3N, 4N	POD-D South	D: 1S, 2S, 3S, 4S
POD-C/D BKG	BKG: 1, 2, 3, 4
