KERR-McGEE OIL & GAS ONSHORE, LP
 2014 ANNUAL PROJECT SUMMARY TABLE
 Tasman Geosciences, LLC

TABLE 1
UPRC 15-6K, 15-3K
2014 GROUNDWATER SAMPLE RESULTS SUMMARY TABLE
KERR-McGEE OIL AND GAS ONSHORE LP

DRAWN BY: KF	Facility Diagram Kerr-McGee Oil and Gas Onshore, LP UPRC 15-6K & 15-3K NENW S15 T3N R66W Weld County, CO

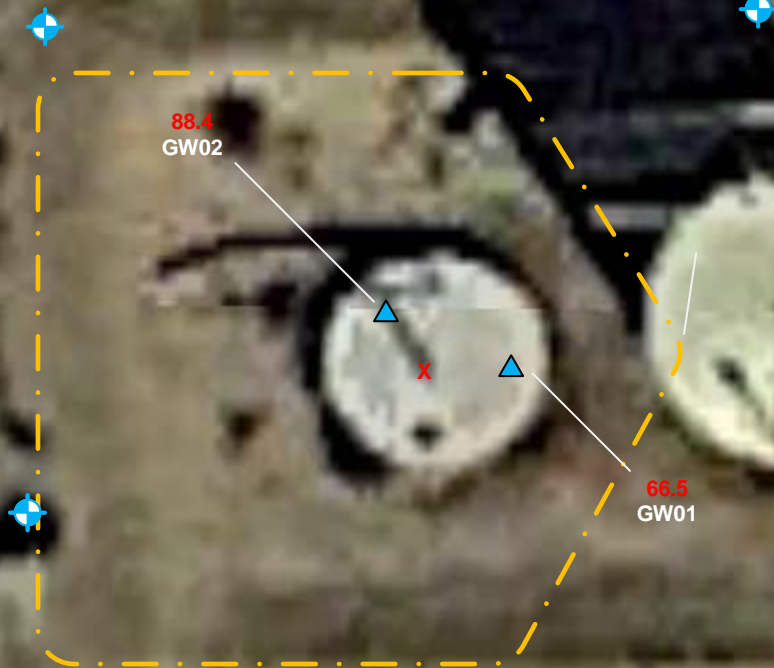
Proposed Temporary Monitoring Well Location	Figure 1
DATE: 4/16/2015

Benzene Concentrations Listed Above Sample ID.
Groundwater concentrations in µg/L.
