Construction and Stormwater Inspection

August 8, 2017

Operator: PDC ENERGY INC - #69175

Location ID: 305317

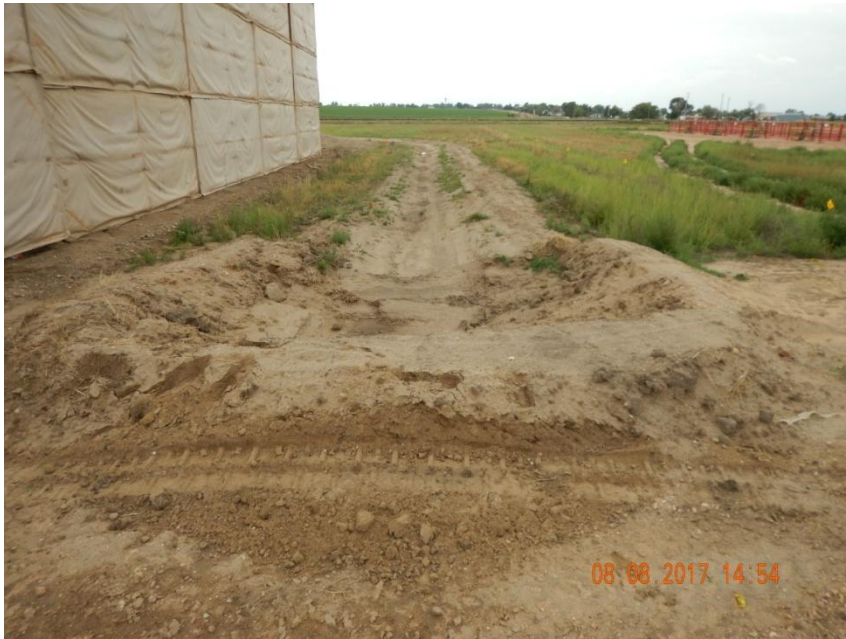
Photo 1. Photo taken from the western location, facing South. Appears to be a sediment trap but no stabilized outfall protection has been installed. Embankment berms do not appear to be properly compacted. Ditch and berm BMP installed around the perimeter of the location.

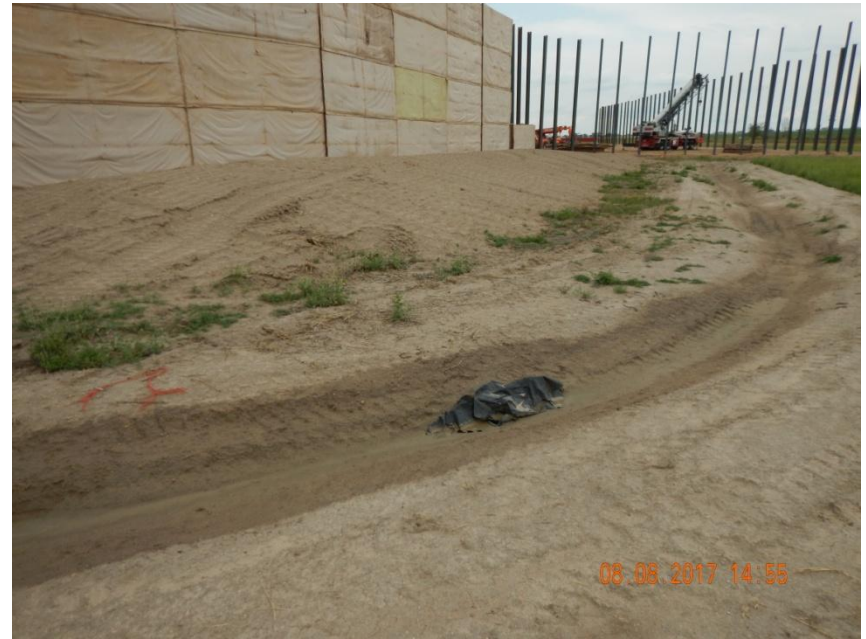
Photo 2. Photo taken from the southwest location, facing East. Topsoil stockpile temporarily stabilized with equipment tracking.

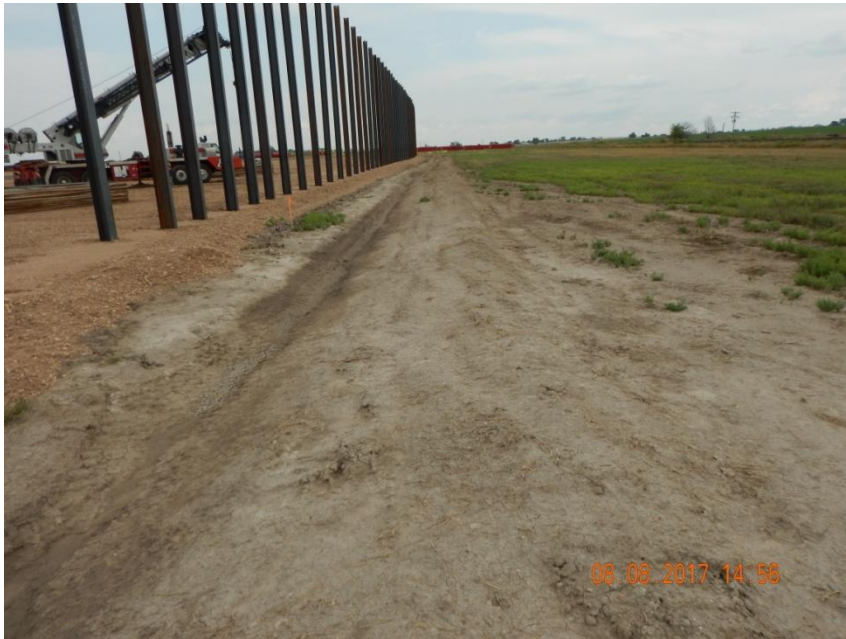
Photo 3. Photo taken from the southern location, facing East. Ditch and berm BMP installed around the perimeter of the location.

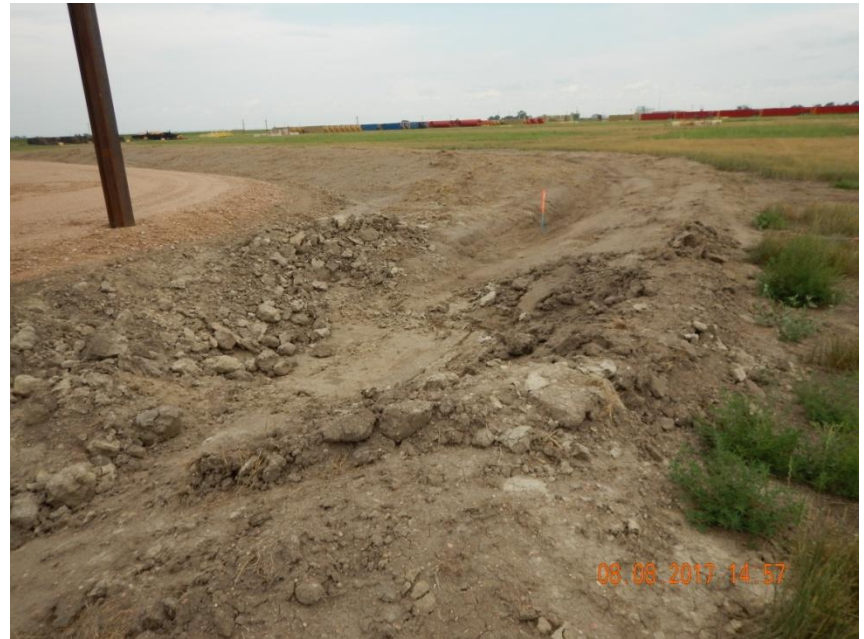
Photo 4. Photo taken from the southeast location, facing Northeast. Appears to be a sediment trap but no stabilized outfall protection has been installed. Embankment berms do not appear to be properly compacted.

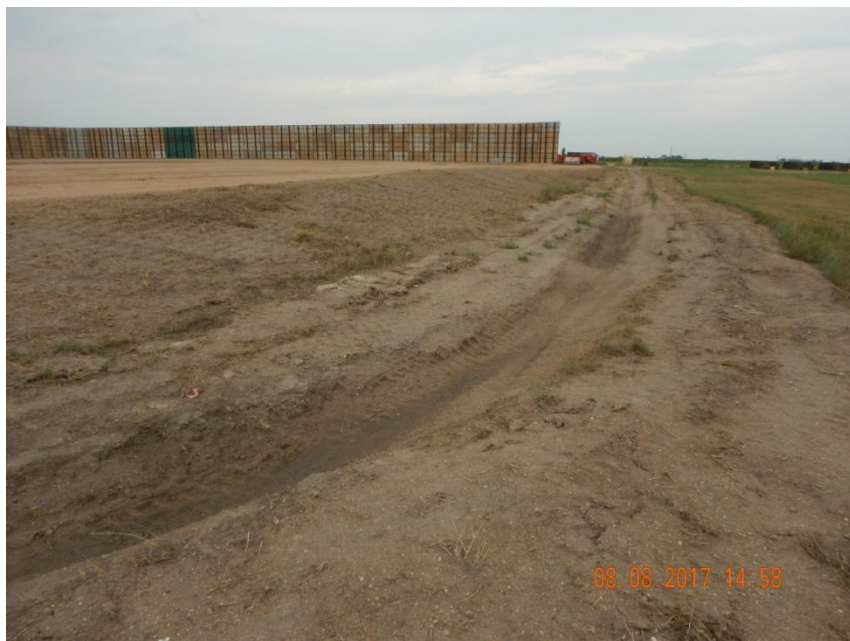
Photo 5. Photo taken from the southeast location, facing North. Ditch and berm BMP installed around the perimeter of the location. A second topsoil stockpile has been stored and temporarily stabilized with equipment tracking.

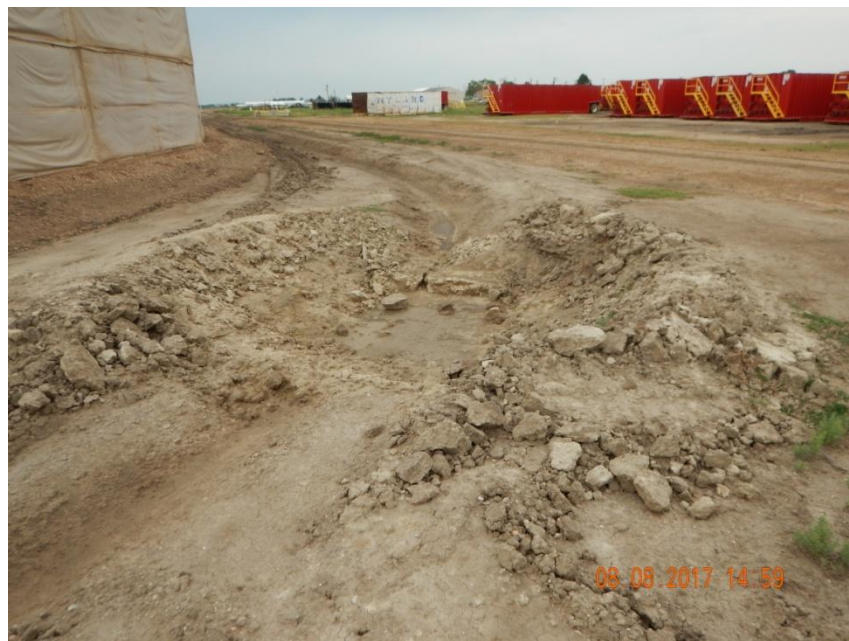
Photo 6. Photo taken from the northeast location, facing Northwest. Appears to be a sediment trap but no stabilized outfall protection has been installed. Embankment berms do not appear to be properly compacted.

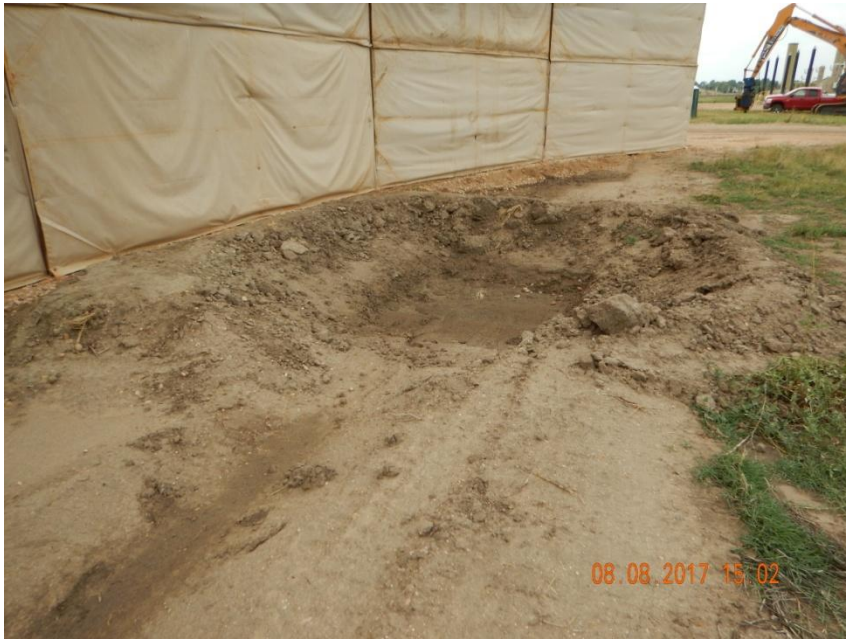
Photo 7. Photo taken from the western location, facing South. Appears to be a sediment trap but no stabilized outfall protection has been installed. Embankment berms do not appear to be properly compacted.

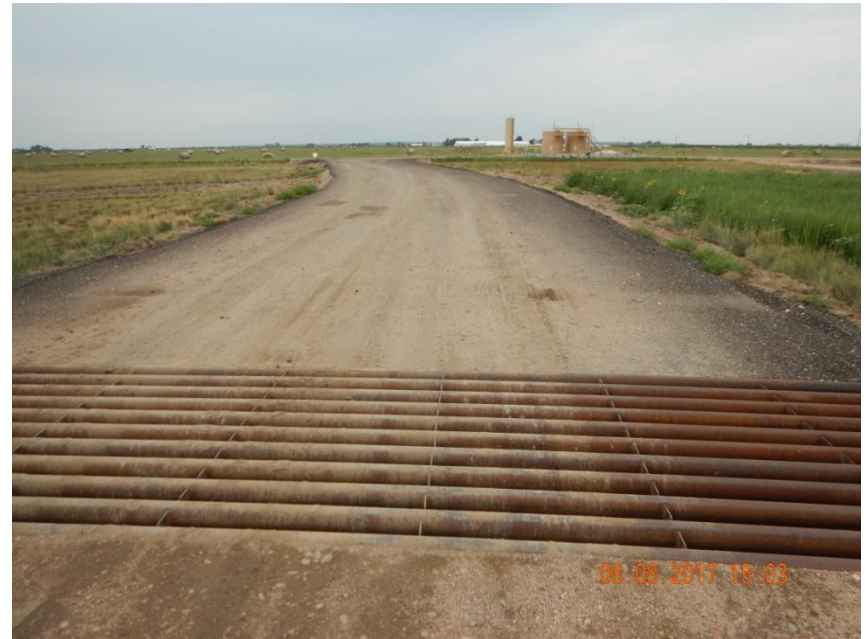
Photo 8. Photo taken from the entrance of the location, facing West. Vehicle tracking pad installed with a cattle guard.
