Inspection Photos

Operator: ADKINS OIL CO - 650

Location ID: 393754

Inspection Doc. Number: 675103806

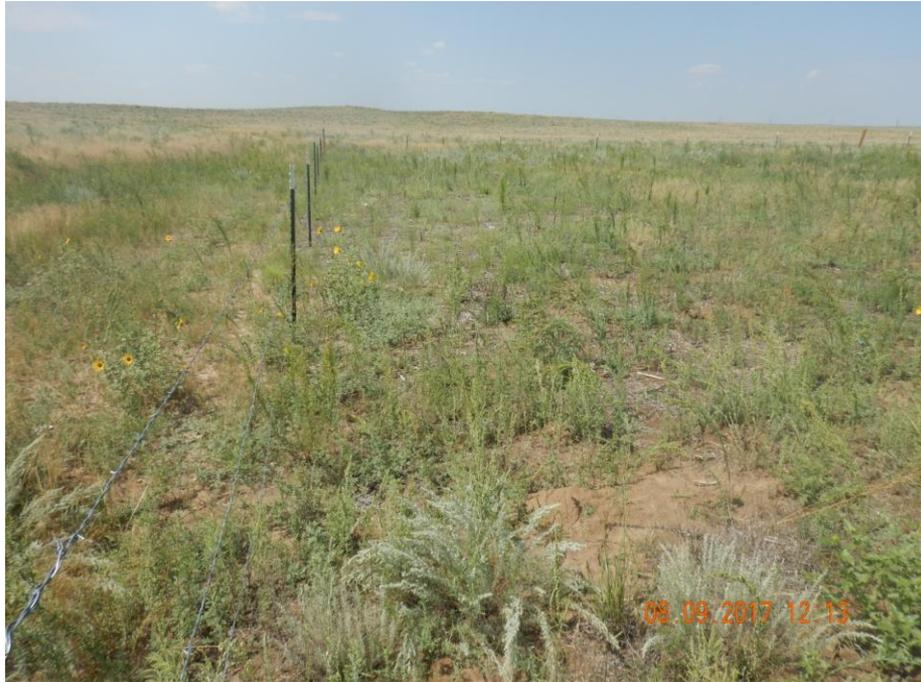
Photo 1: Photo taken from the south east end of the location, facing west. Photo shows vegetation over the reclamation area.

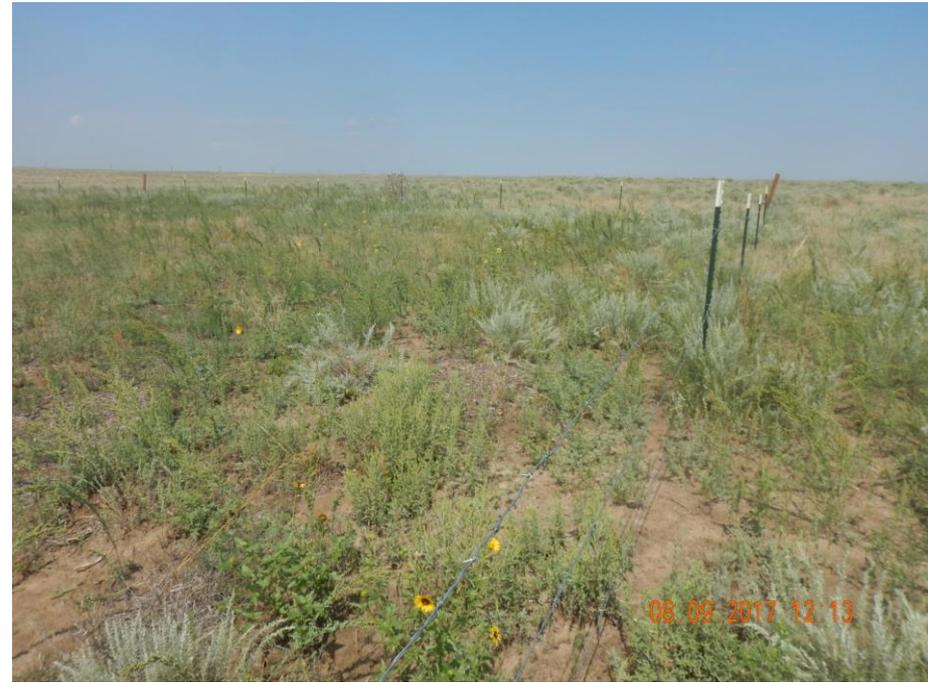
Photo 2: Photo taken from the south east end of the location, facing north. Photo shows vegetation over the reclamation area.

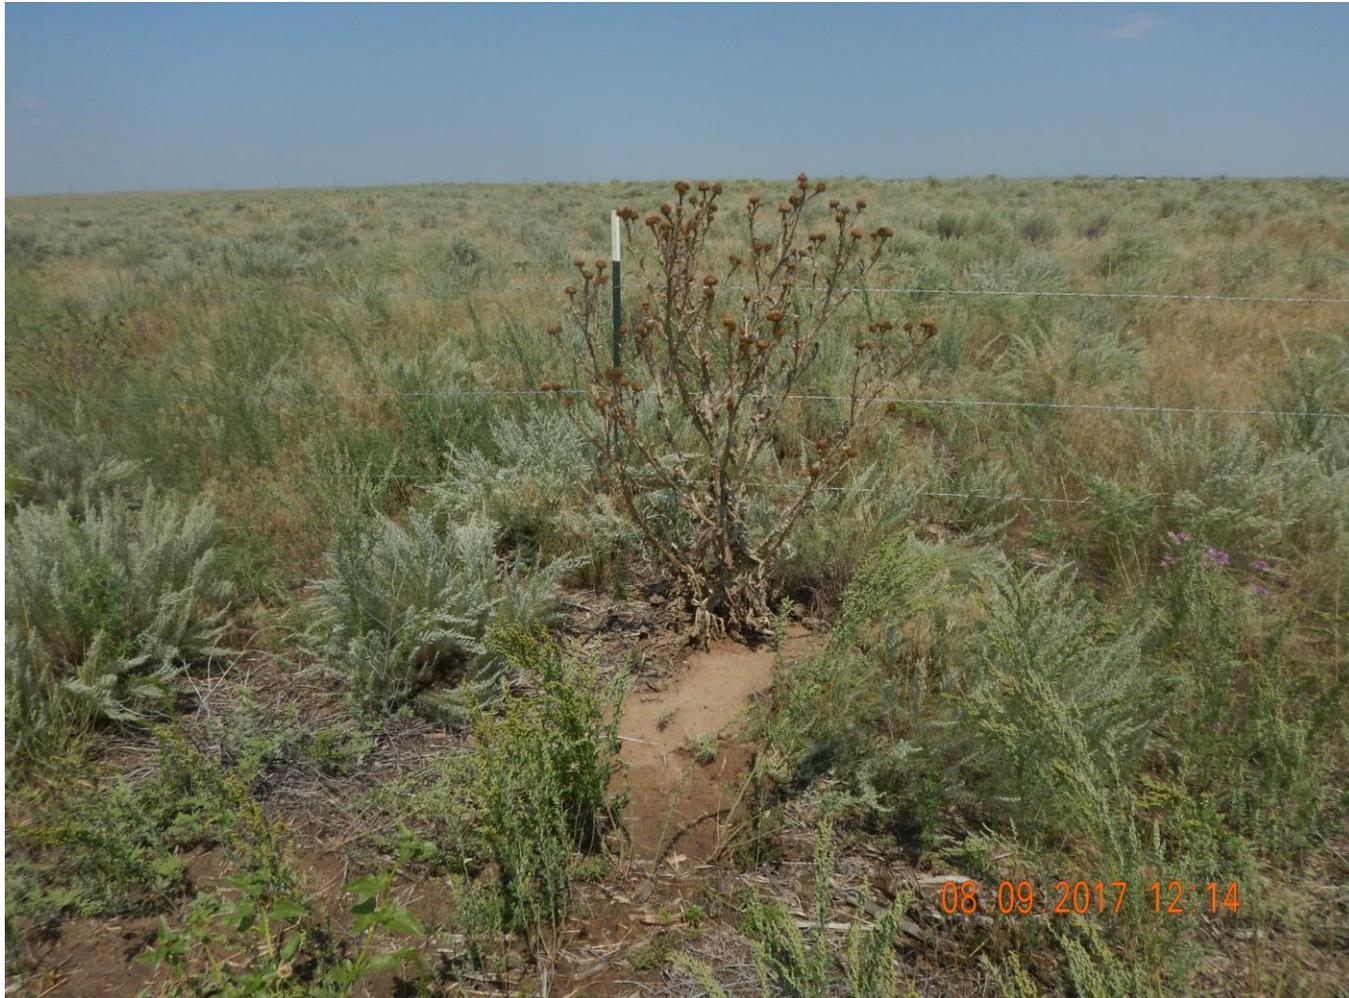
Photo 3: Photo taken from the north end of the location. Photo shows Scotch thistle stalk on location. During previous inspection, all weeds found on location were sprayed with herbicide. The application appears to have been successful as all weeds found were dead.
