Inspection Photos

Operator: EDDY OIL COMPANY - 26420

Location ID: 322675

Inspection Doc. Number: 675103868

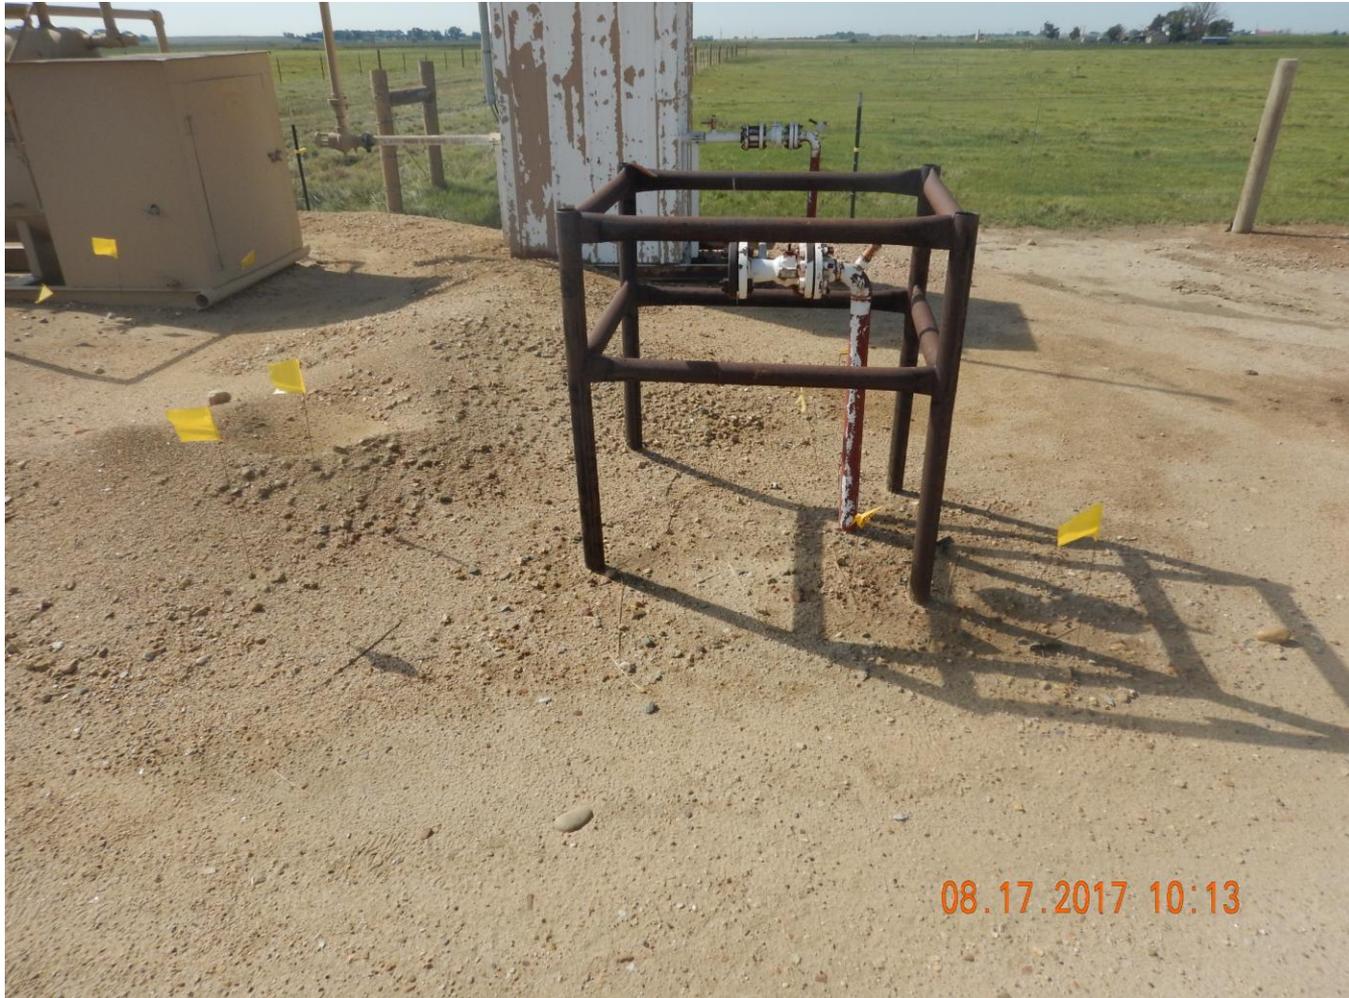
Photo 1: Photo taken from the battery location, facing south. Inspection doc. # 682502199 required operator to remove riser at the battery facility in accordance to the 2017 Flowline and Pipeline NTO, and per reclamation ruled. Photo shows riser remains on location.
