Inspection Photos

Operator: KERR MCGEE OIL & GAS ONSHORE LP
- 47120

Location ID: 327317

Inspection Doc. Number: 682502605
Weld County, CO

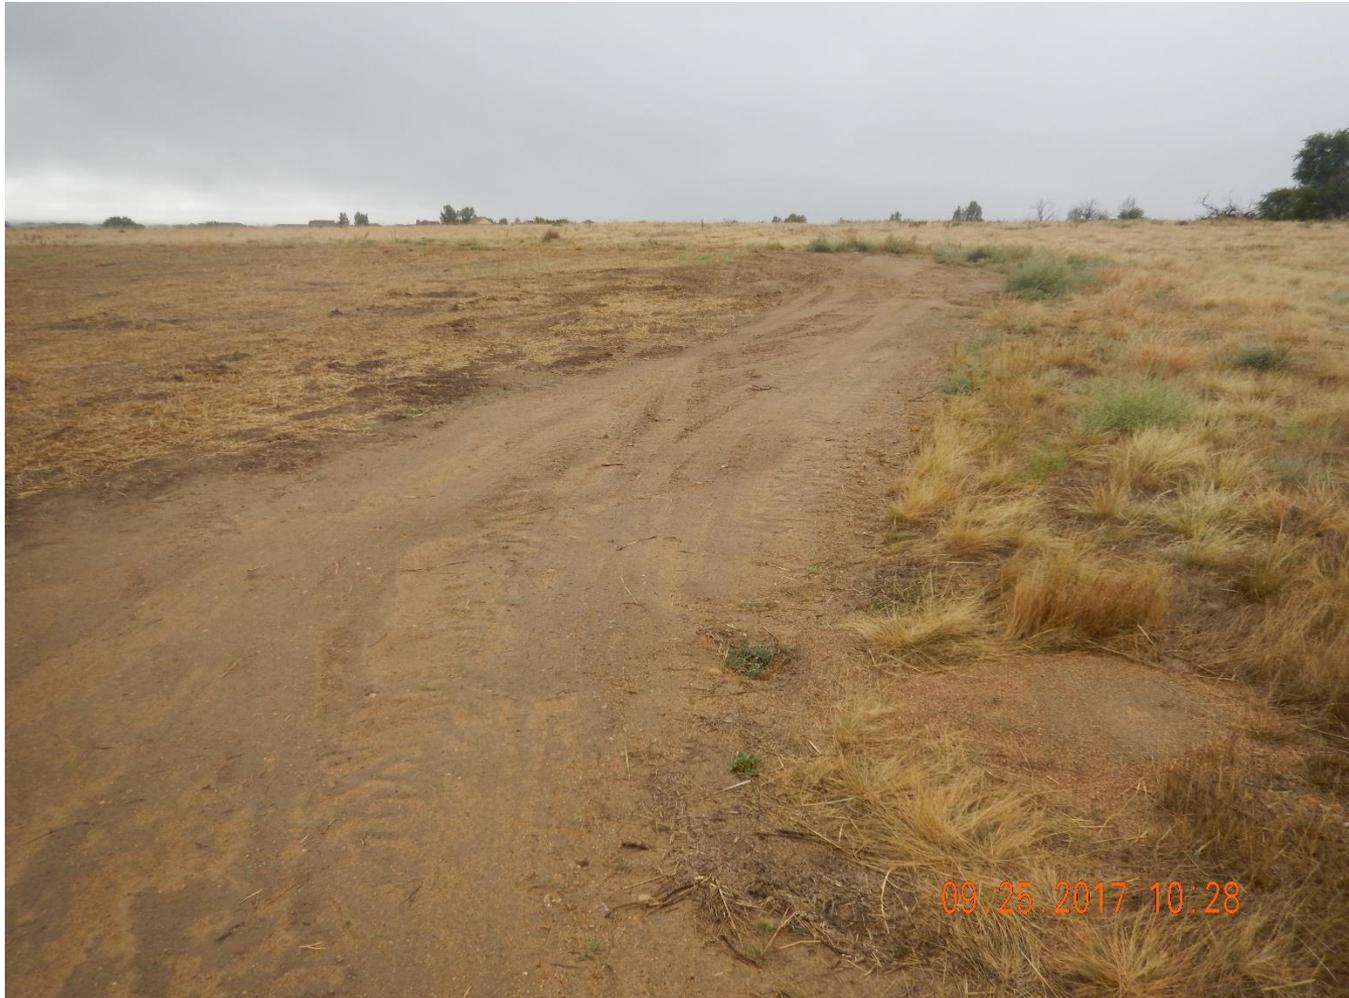
Photo 1: Photo taken from the west end of the location, facing south. Photo shows pipe riser equipment has been removed per CA's

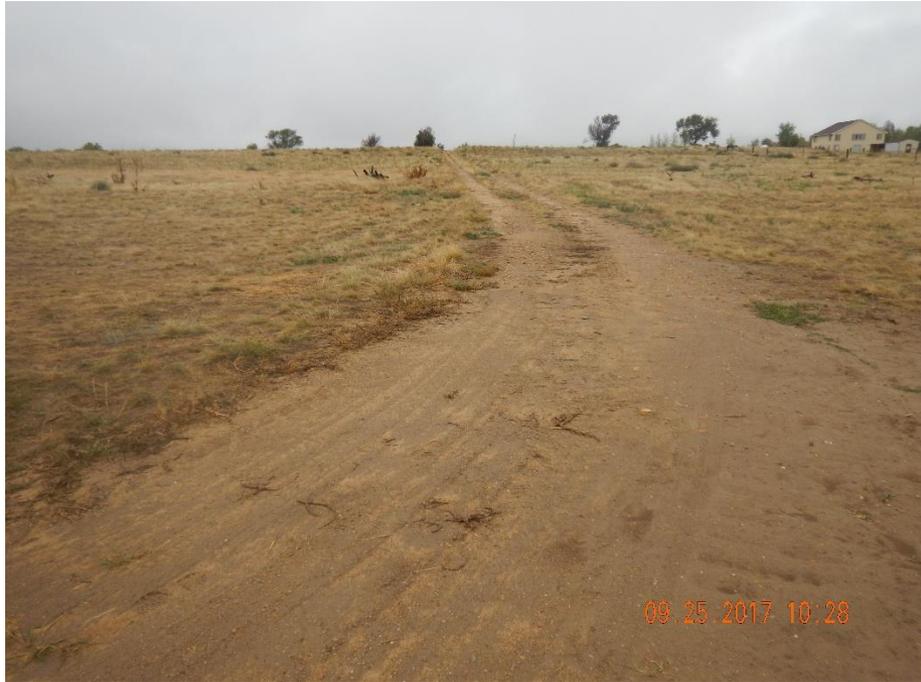
Photo 2: Photo taken from the northwest end of the location, facing west. Photo shows access road has not been reclaimed per COGCC 1000 series reclamation rules and requirements. Corrective actions have not been addressed.

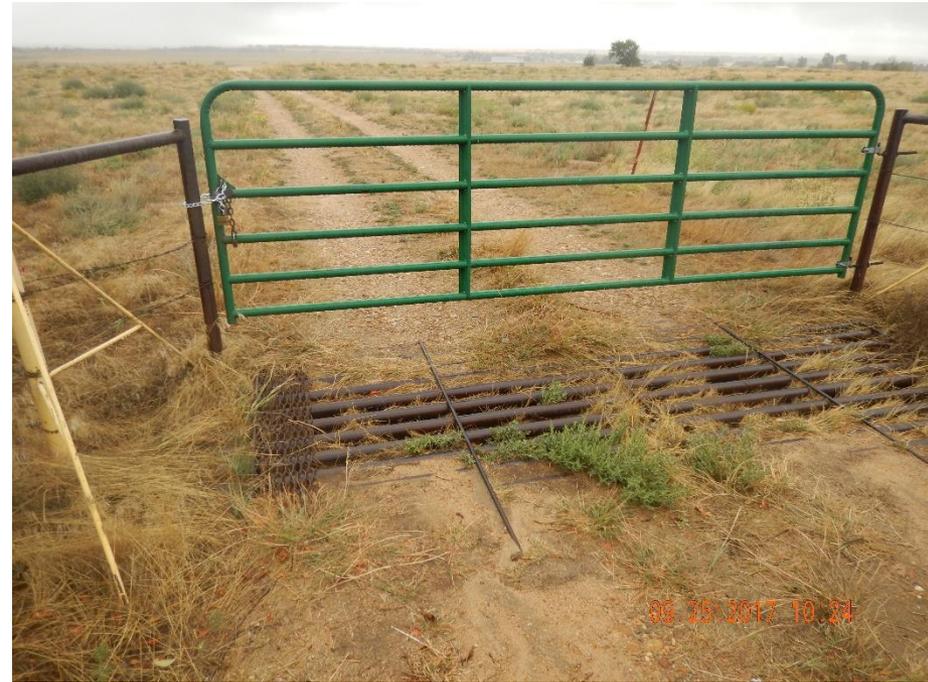
Photo 3: Photo taken from the access road entrance, west of the location. Photo cattle guard and gate remains; access road has not been reclaimed per COGCC 1000 series reclamation rules and requirements. Corrective actions have not been addressed.
