# Inspection Photos

Operator: NOBLE ENERGY INC - 100322

Location ID: 327240

Inspection Doc. Number: 682502621

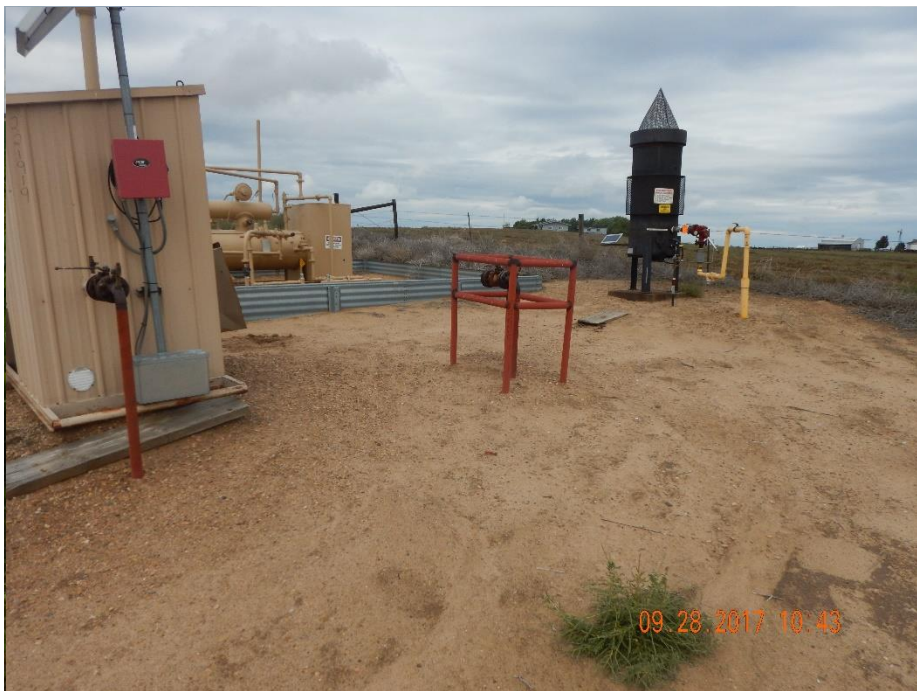
**Photo 1:** Photo taken from the west end of the battery location, facing northwest. Inspection doc. #682502147 and #675103862 required operator to remove riser at the battery in accordance to 1004.a reclamation requirements. Photo shows riser has not been removed.

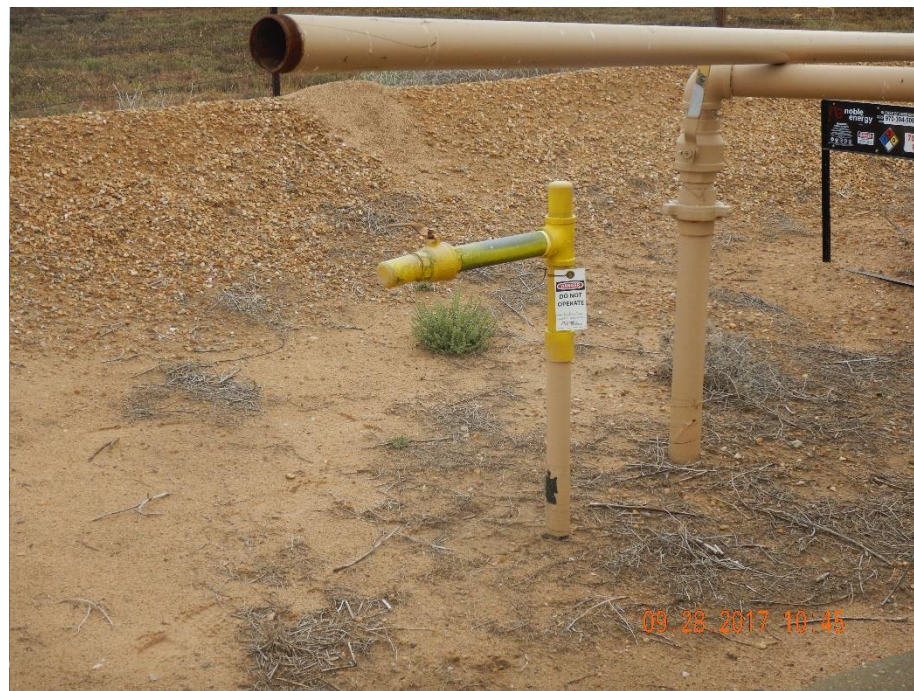
**Photo 2:** Photo taken from the east end of the battery location within the tank berm. Photo shows pipe riser that has been tagged and painted per the 2017 Flowline NTO, but has not been removed per the NTO required dates. This riser will need to be removed per the NTO and per 1004.a reclamation rules.
