Final Reclamation Inspection

Operator: WELLINGTON OPERATING COMPANY - 95233

API: 05-069-05284

Location Name: WELLINGTON MUDDY UNIT #25-1

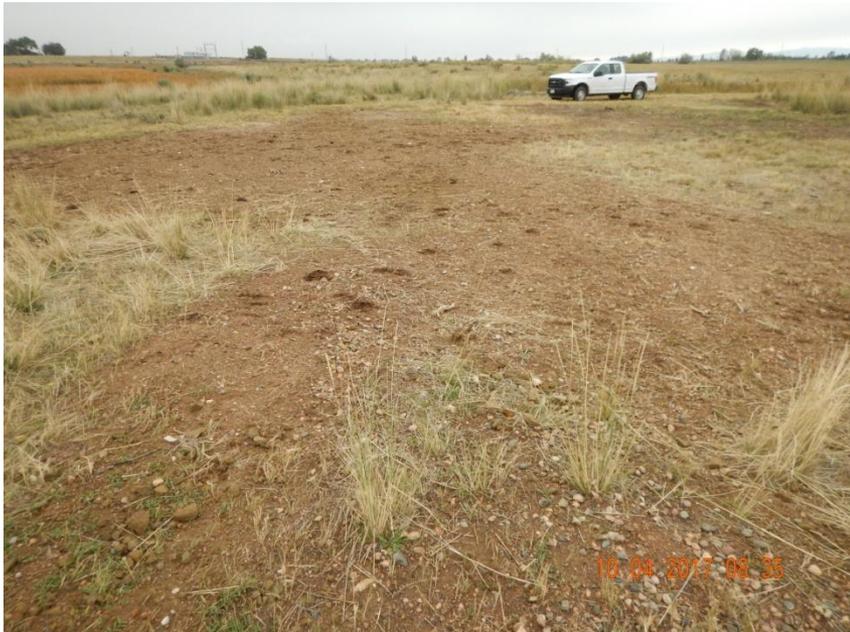
Photo 1. Photo taken from the northern well location, facing South. Gravel pile has been removed but gravel remains at the well location, and appears location was mowed, including noxious weeds. Appears the well marker and pipe riser have been removed.

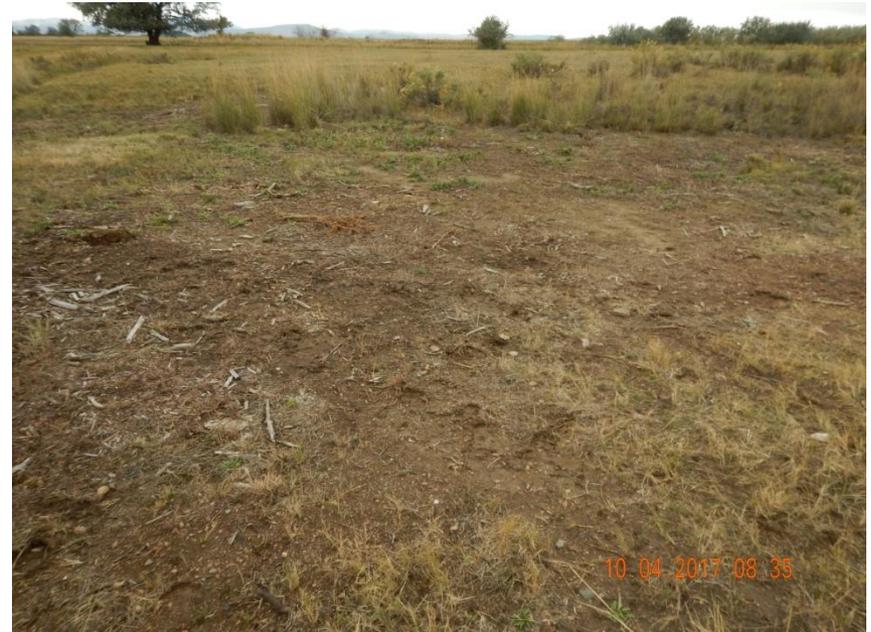
Photo 2. Photo taken from the approximate center of the location, facing West. Refer to Photo 1 for description of observations.
