Final Reclamation Inspection

Operator: CHESAPEAKE OPERATING LLC- 16660

API: 05-123-33550

Inspection Photos
Location Name: Sidwell #32-10-66 1H
API: 05-123-33550

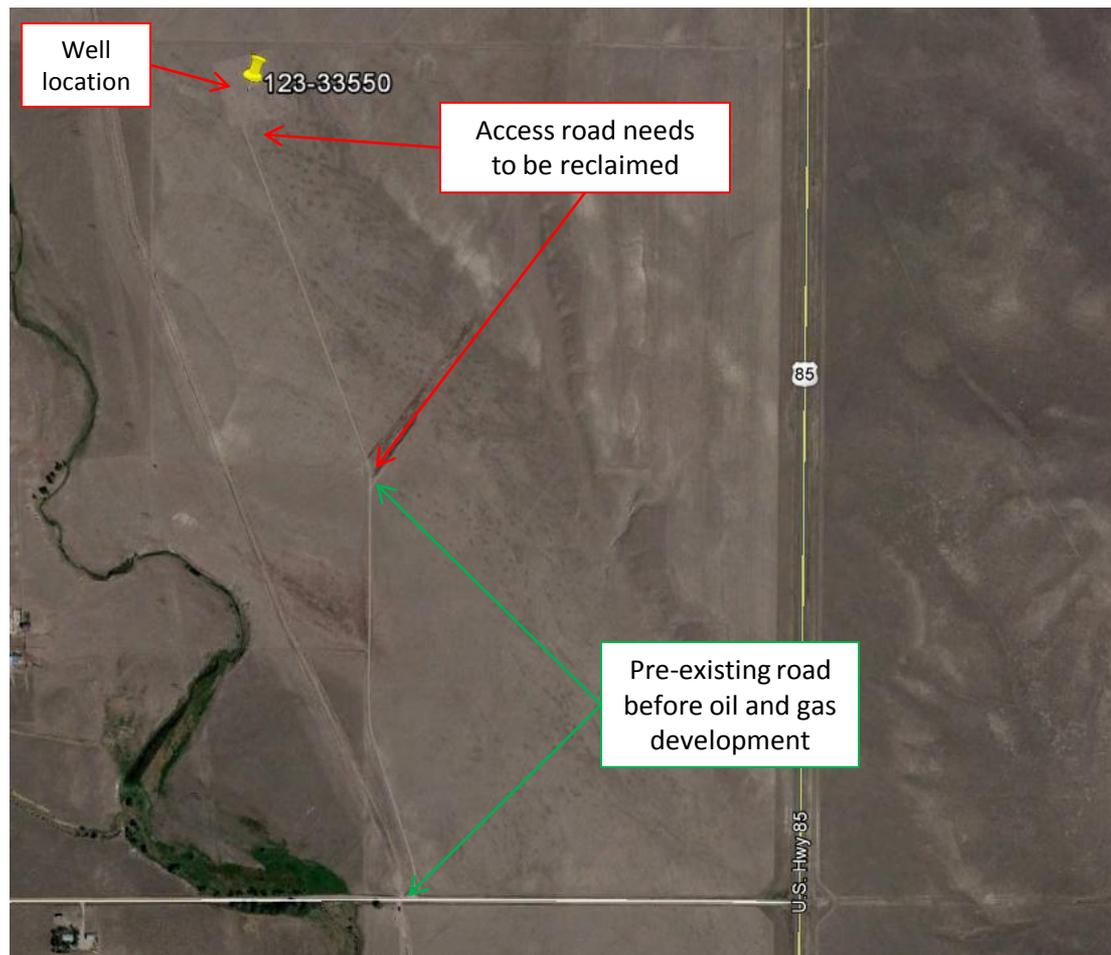
Google Earth imagery taken September 7, 2016 illustrating the well location and access road. Appears a portion of the access road was pre-existing before oil and gas but a portion (~0.41 miles) needs to be reclaimed- see map above.

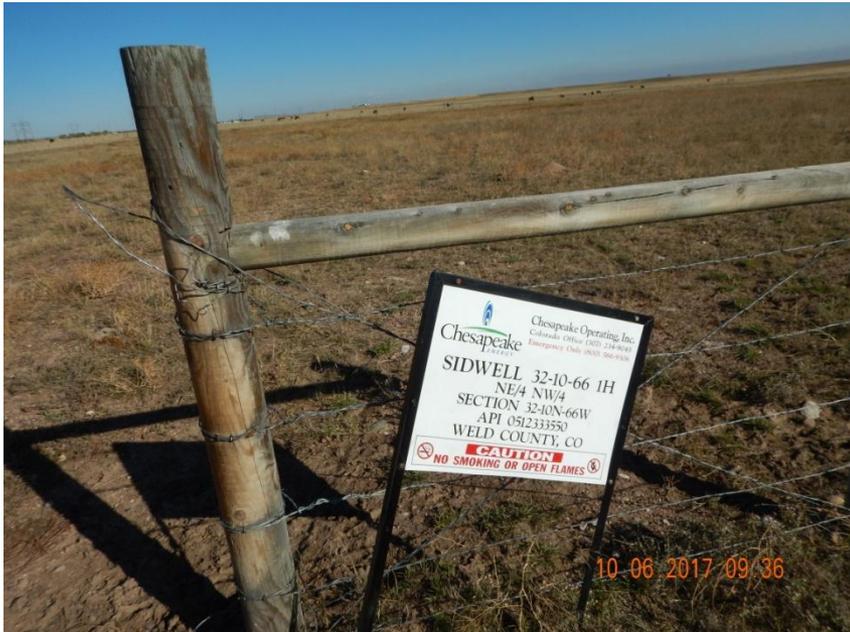
Photo 1. Photo taken from the entrance of the well location, facing North. Operator sign at well entrance confirms location.

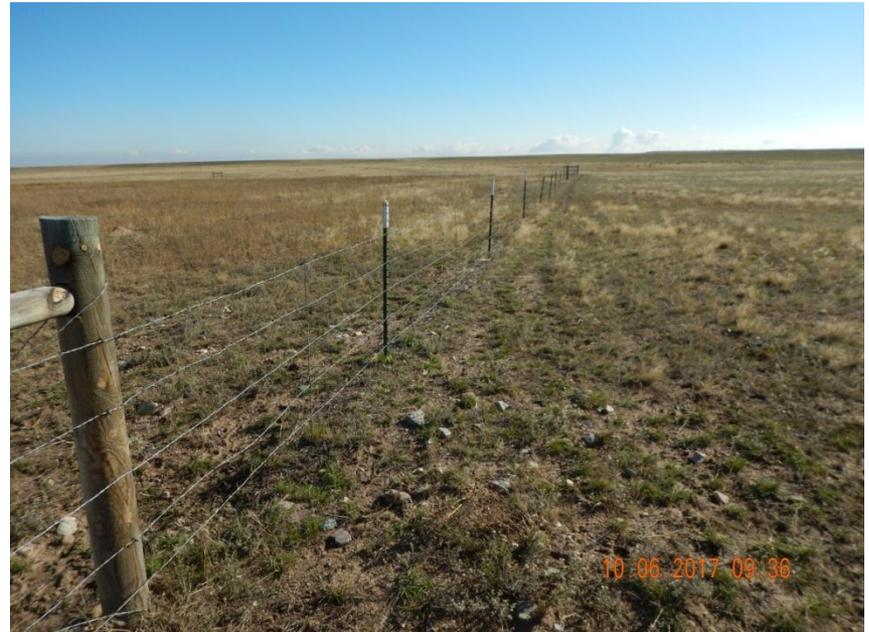
Photo 2. Photo taken from the entrance of the well location, facing East. Photo illustrates the perimeter fence around the entire location remains.

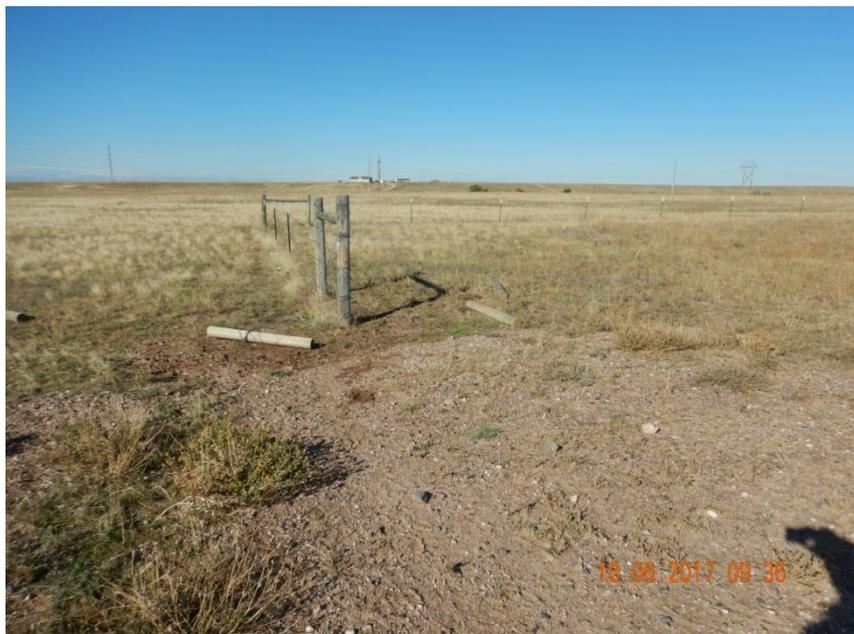
Photo 3. Photo taken from the entrance of the well location, facing West. See comments under Photo 2.

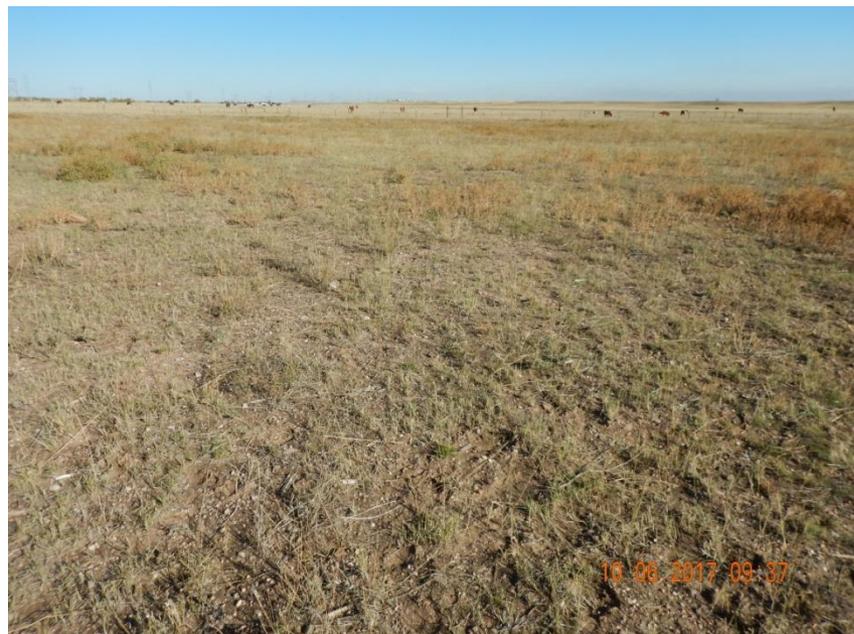
Photo 4. Photo taken from the approximate center of the location, facing North. Well location appears reflective of reference area levels.

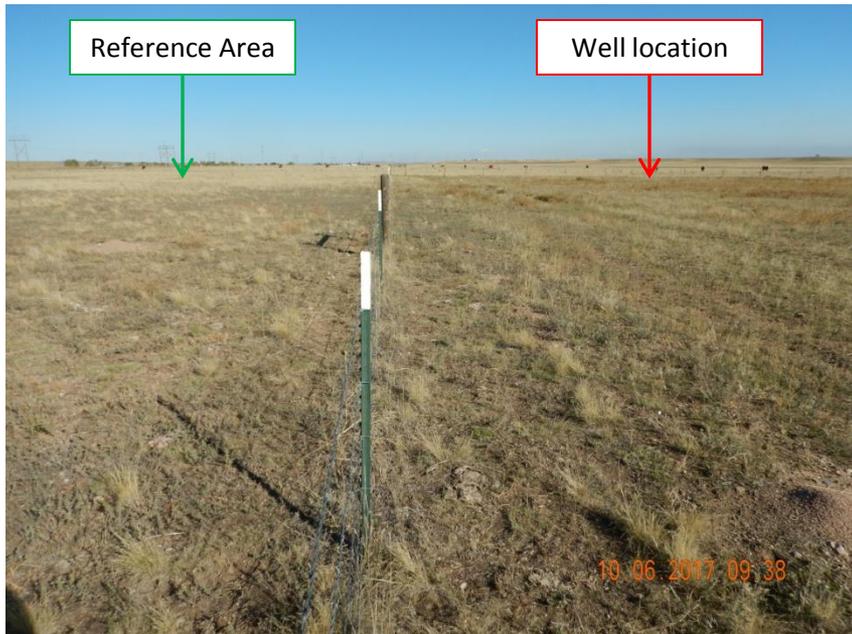
Photo 5. Photo taken from the western well location, facing North. See comments under Photo 4.

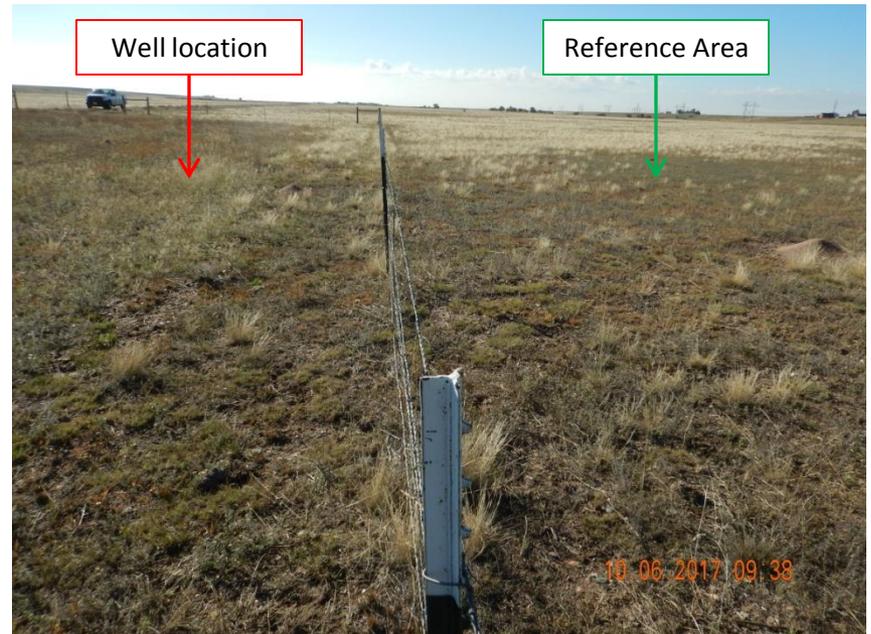
Photo 6. Photo taken from the western well location, facing South. See comments under Photo 4.

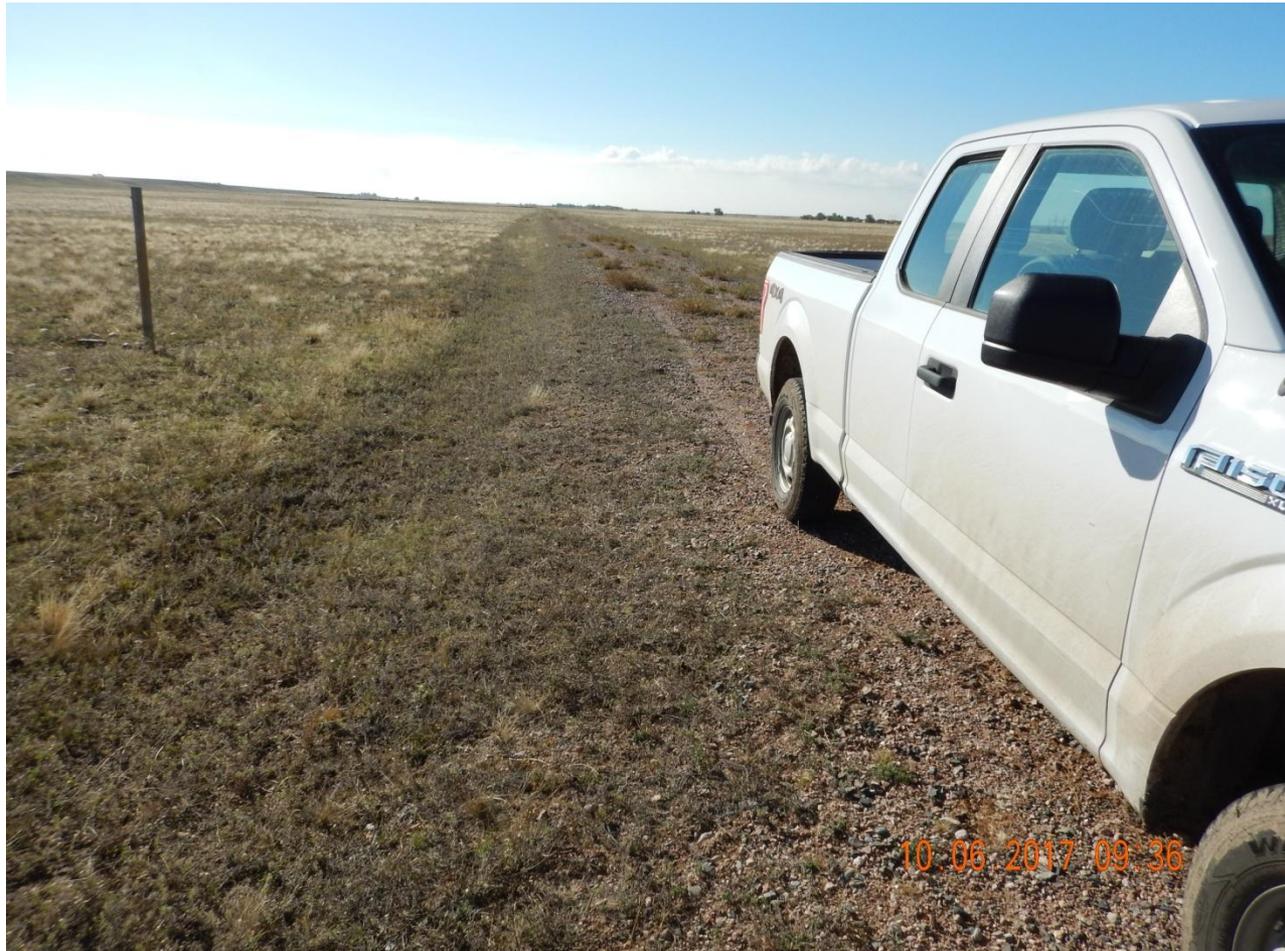
Photo 7. Photo taken from the entrance of the well location, facing South. Photo illustrates the access road used for oil and gas development that needs to be reclaimed. An approximate 0.41 mile portion of access road needs to be reclaimed per Rule 1004.a.
