Inspection Photos

Operator: NOBLE ENERGY INC - 100322

Location ID: 447546

Inspection Doc. Number: 682502655

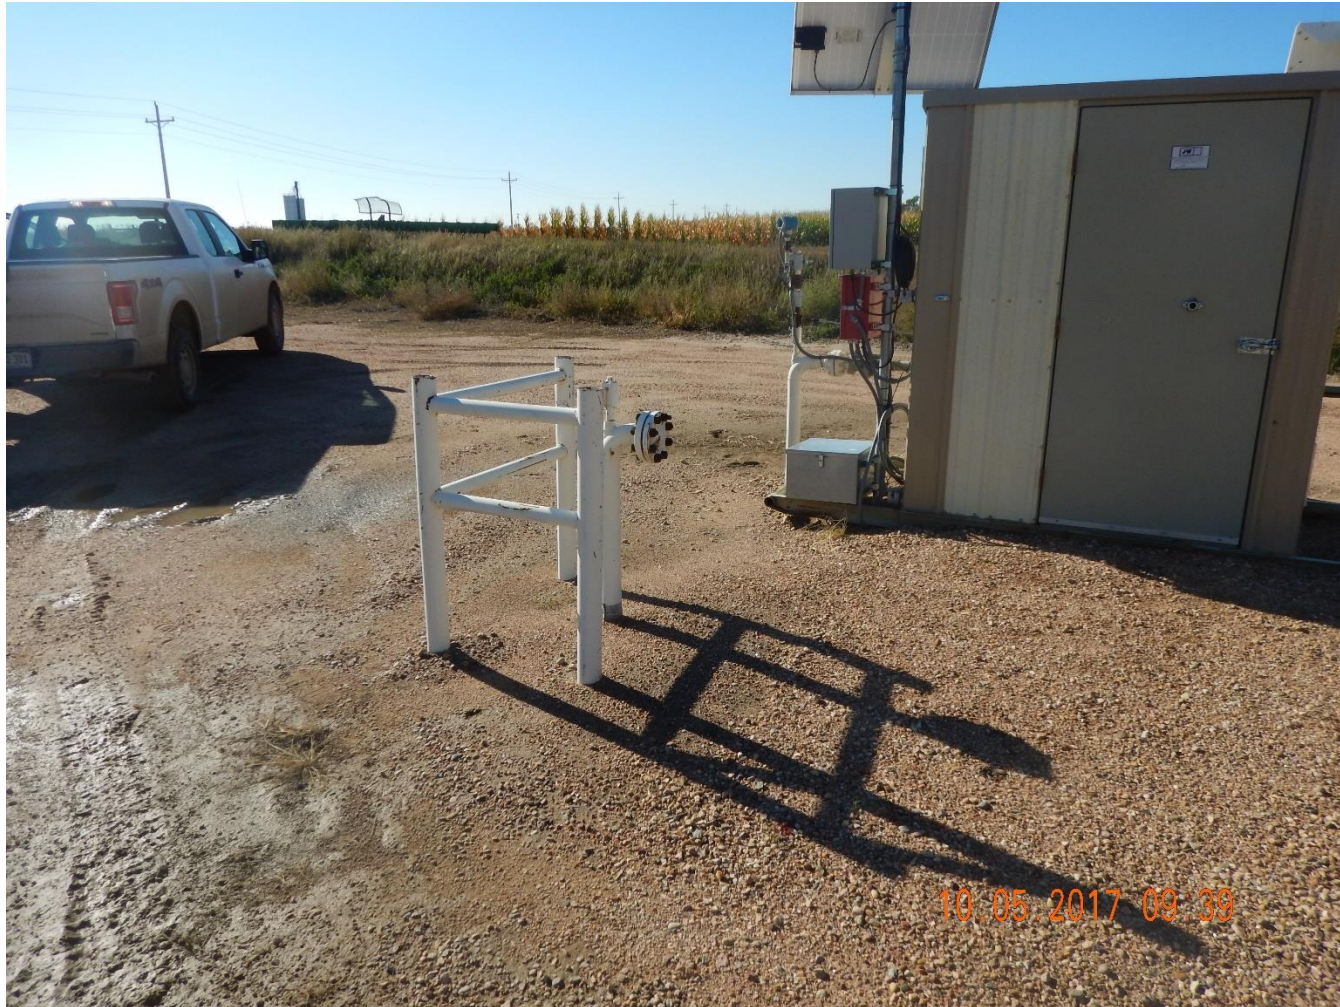
Photo 1: Photo taken from the western portion of the battery facility, facing south. Photo shows pipe riser equipment that appears to be abandoned. Riser needs to be removed in accordance to COGCC rule 1004.a
