Location Name: Keely B11-63-1HN

Location: 429244, Spill ID: 454197

Inspection Date: 3/6/2018

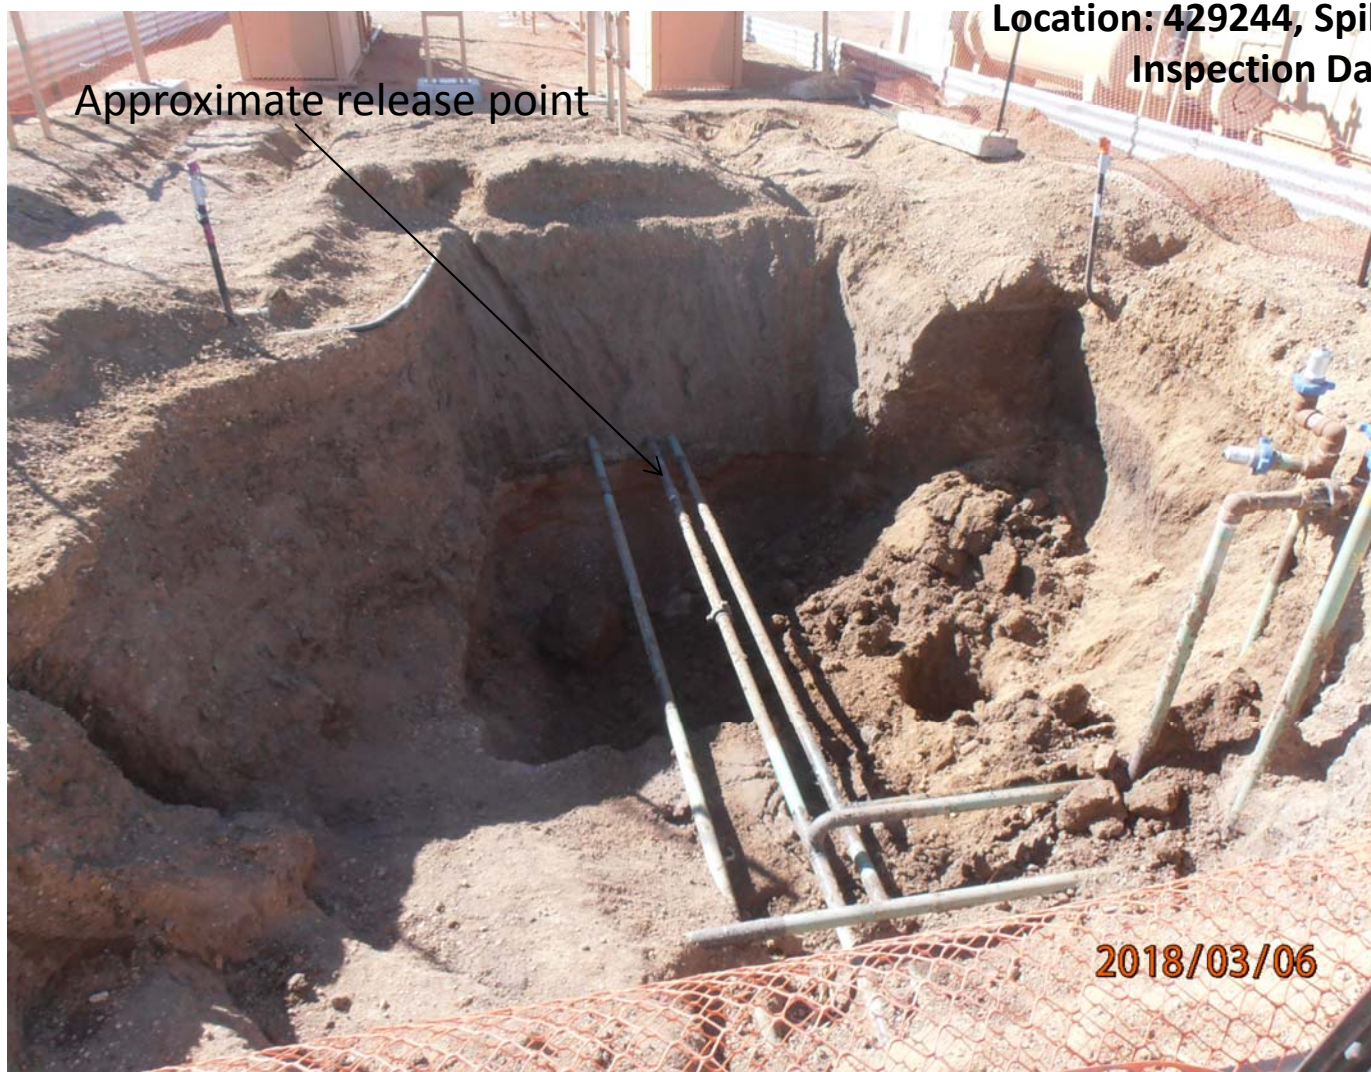
Photo of active excavation area. Middle steel line is subject produced water liner for the Keely B11-63-1HN. Release occurred at collar on far end of line in photo.
