Stormwater Inspection

Operator: PETROSHARE CORPORATION- 10454

API: 05-039-06558

Inspection Photos
Location Name: RUNNING CREEK #11-21
API: 05-039-06558

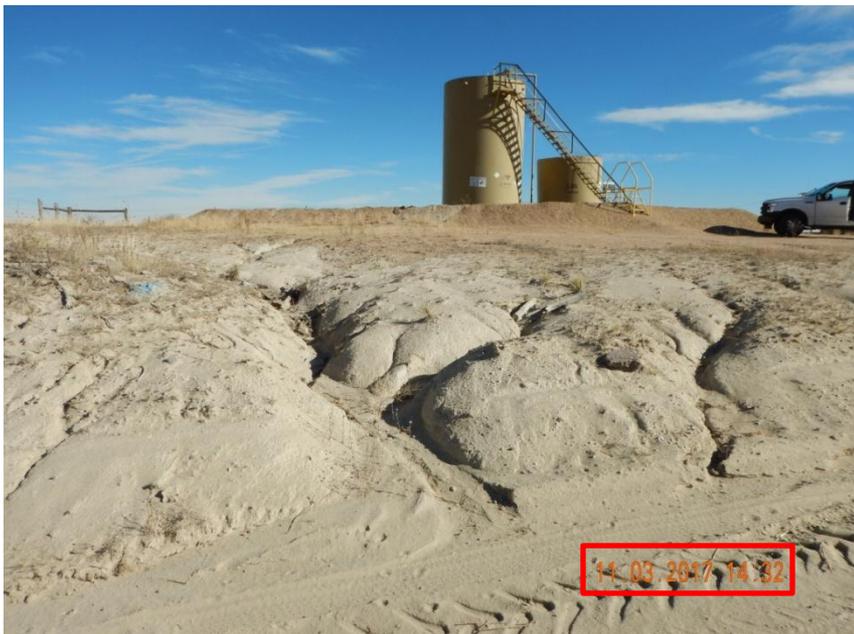
Photo 1. Photo taken from the northwest battery location on November 3, 2017, facing East. Gully erosion evident and no observed BMPs have been implemented to control and manage stormwater erosion along any portion of the location.

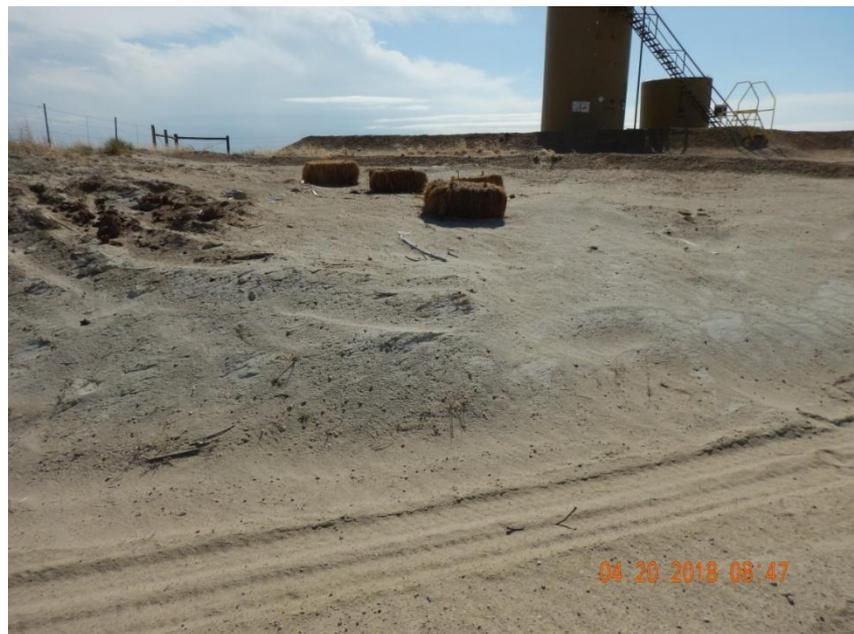
Photo 2. Photo taken from the northwest battery location on April 20, 2018, facing East. Operator made repairs to the gully erosion and installed BMPs (i.e straw bales and berm). Berm BMP has been damaged due to vehicle traffic and is not in proper functioning condition.

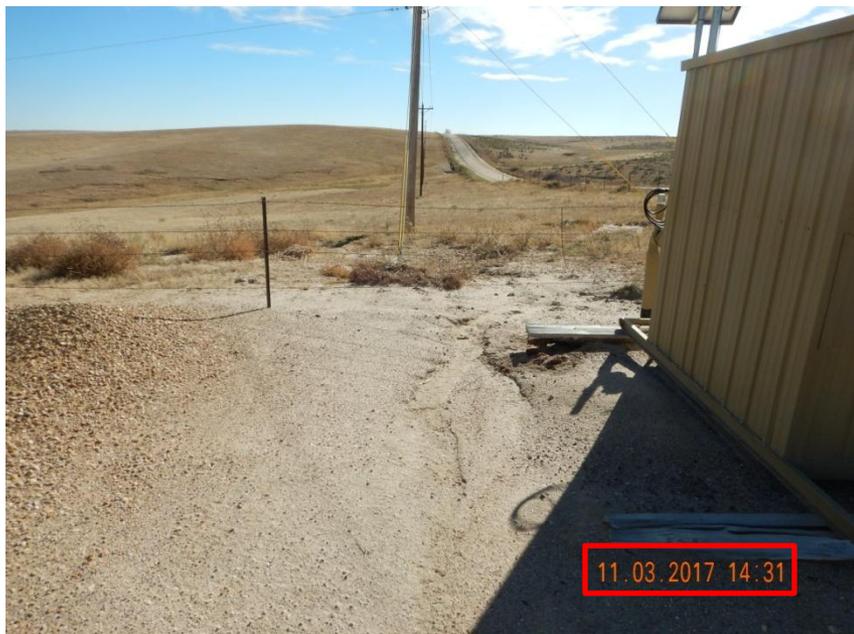
Photo 3. Photo taken from the southern battery location on November 3, 2017, facing South. Photo illustrates the area at which stormwater runoff is leaving the southern location.

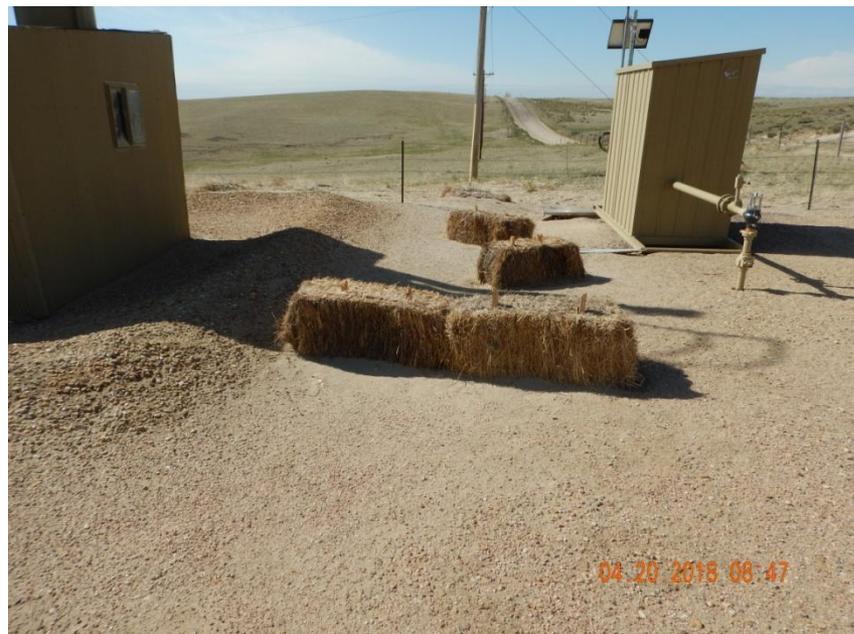
Photo 4. Photo taken from the southern battery location on April 20, 2018, facing South. Operator has installed BMPs (i.e straw bales).

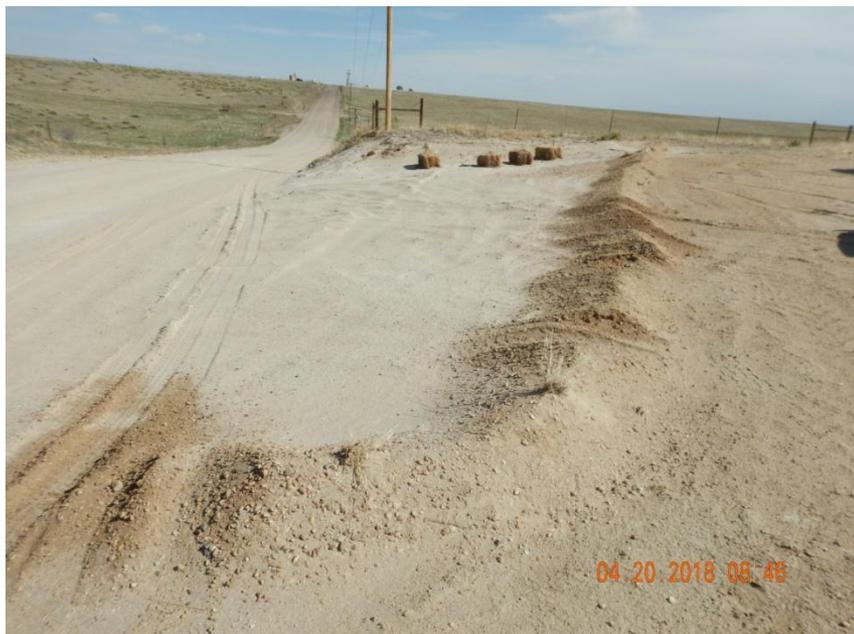
Photo 5. Photo taken from the southern battery location on April 20, 2018, facing North. Photo illustrates berm BMP has been damaged due to vehicle traffic and is not in proper functioning condition.

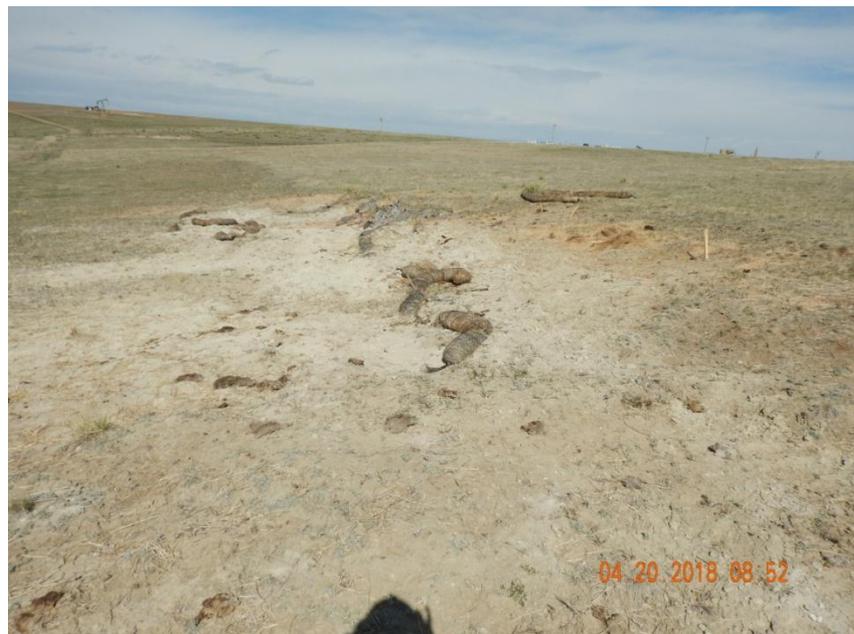
Photo 6. Photo taken from the northern well location on April 20, 2018, facing West. Appears the Operator has installed BMPs to control erosion but all the BMPs have been damaged due to cattle. Operator may need to coordinate with the surface owner to exclude cattle around the oil and gas location.

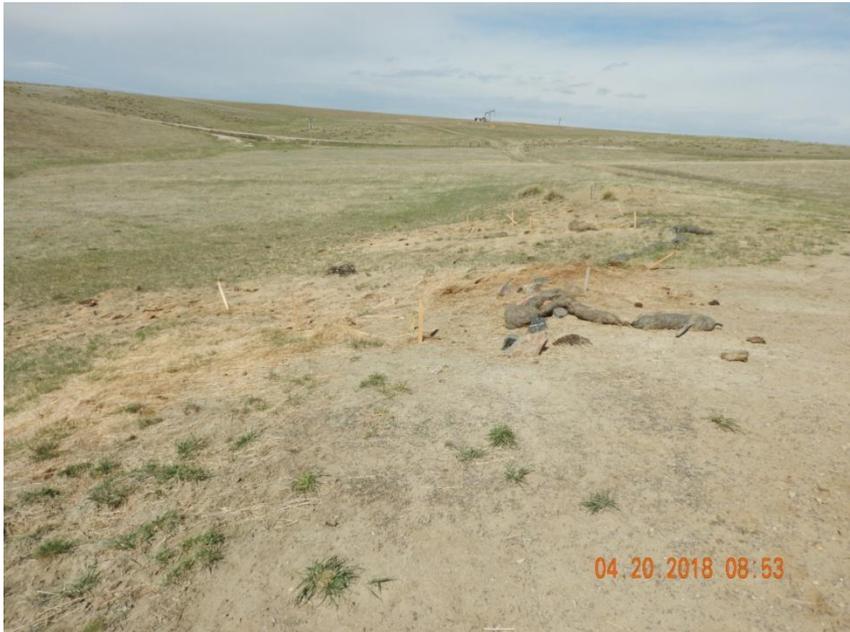
Photo 7. Photo taken from the southern well location on April 20, 2018, facing West. See comments under Photo 6.
