LOPEZ CANYON SWD 1 API# 05-071-09733 – TIMBER CREEK
OGCC OPERATOR NUMBER 10672 – INSPECTION DATE: MAY 07, 2018
CORRECTIVE ACTIONS COMPLETED REGARDING COGCC FIR DOCUMENT # 680102780

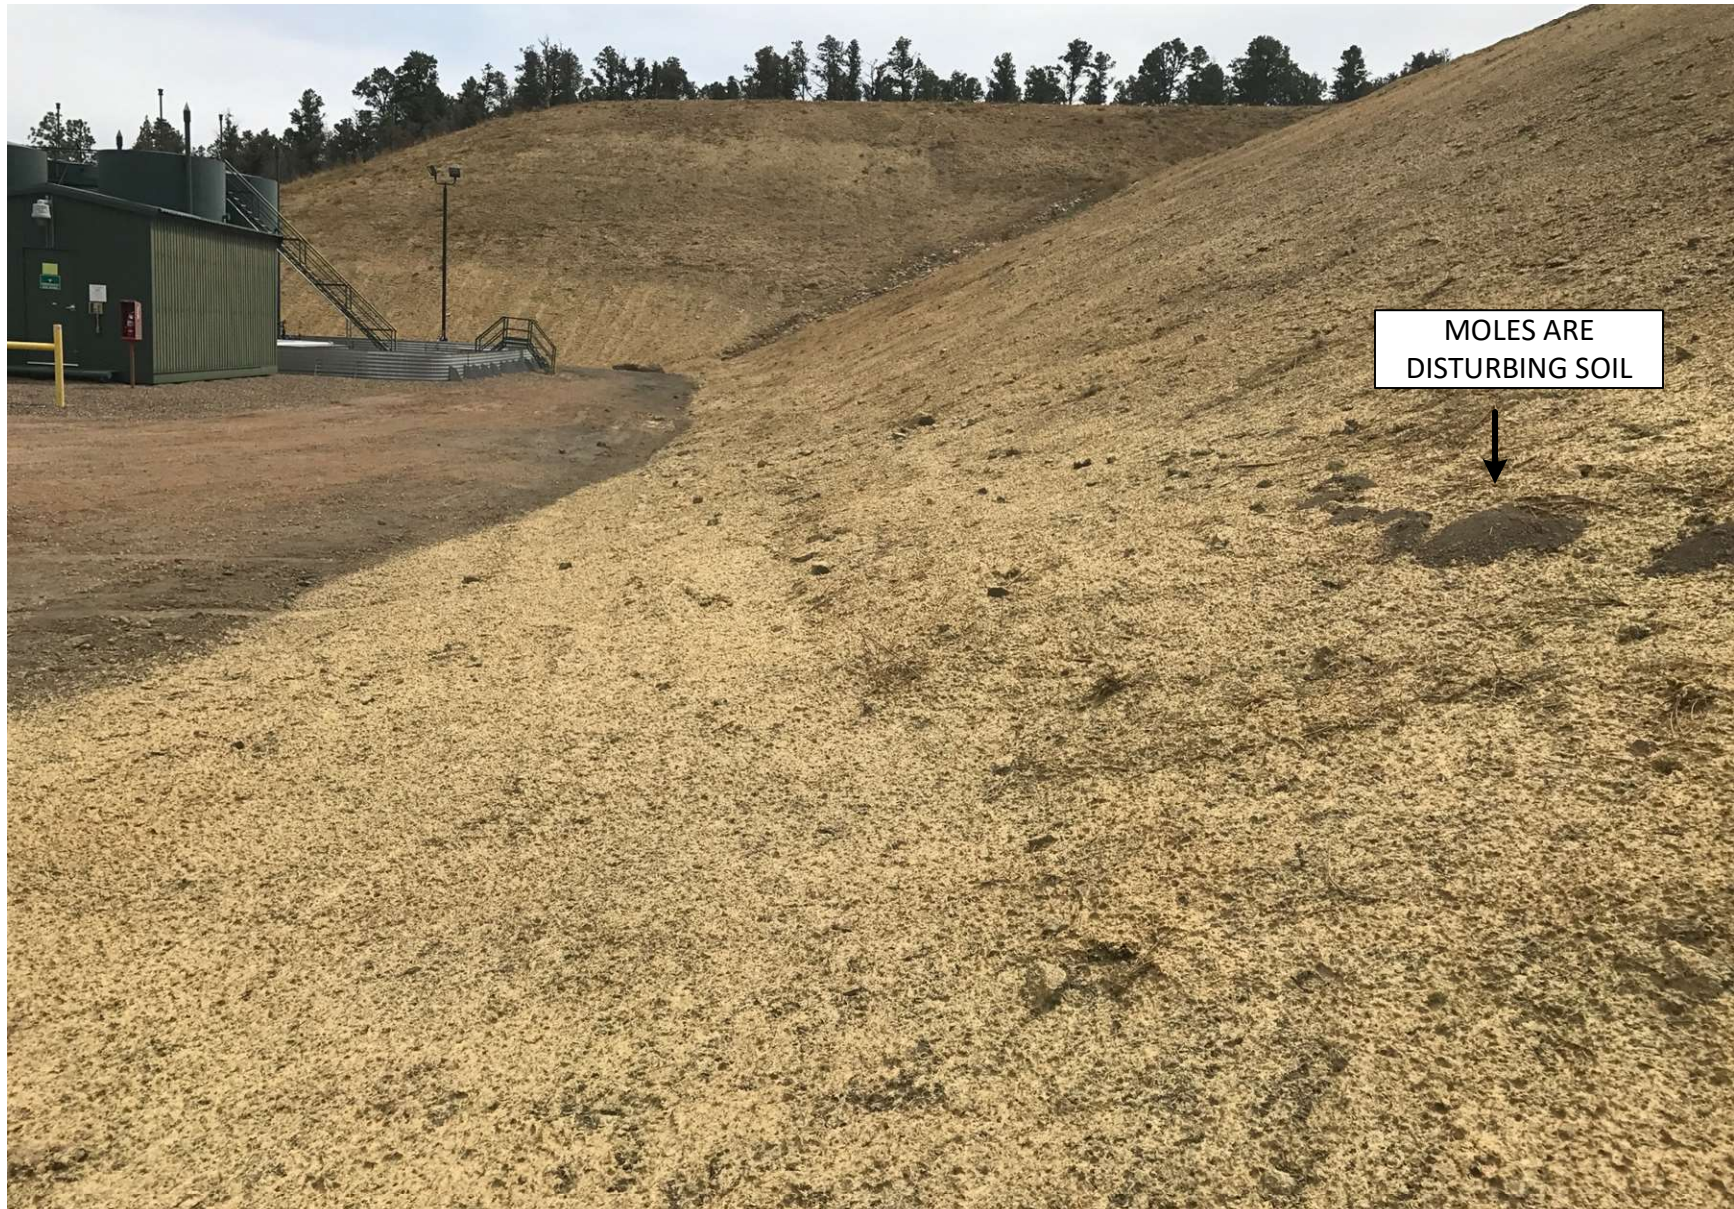
PHOTO 1: OVERVIEW OF LOCATION TO SOUTH. GRADING TECHNIQUES WERE INSTALLED ON THE CONTOUR TO ELIMINATE THE RILL FORMATION ON THE CUT SLOPE. THE EARTH DISTURBANCE WAS STABILIZED BY HYDRO-SEEDING USING AN APPROVED HILL RANCH SEED MIX TO PROMOTE THE ESTABLISHMENT OF VEGETATION.

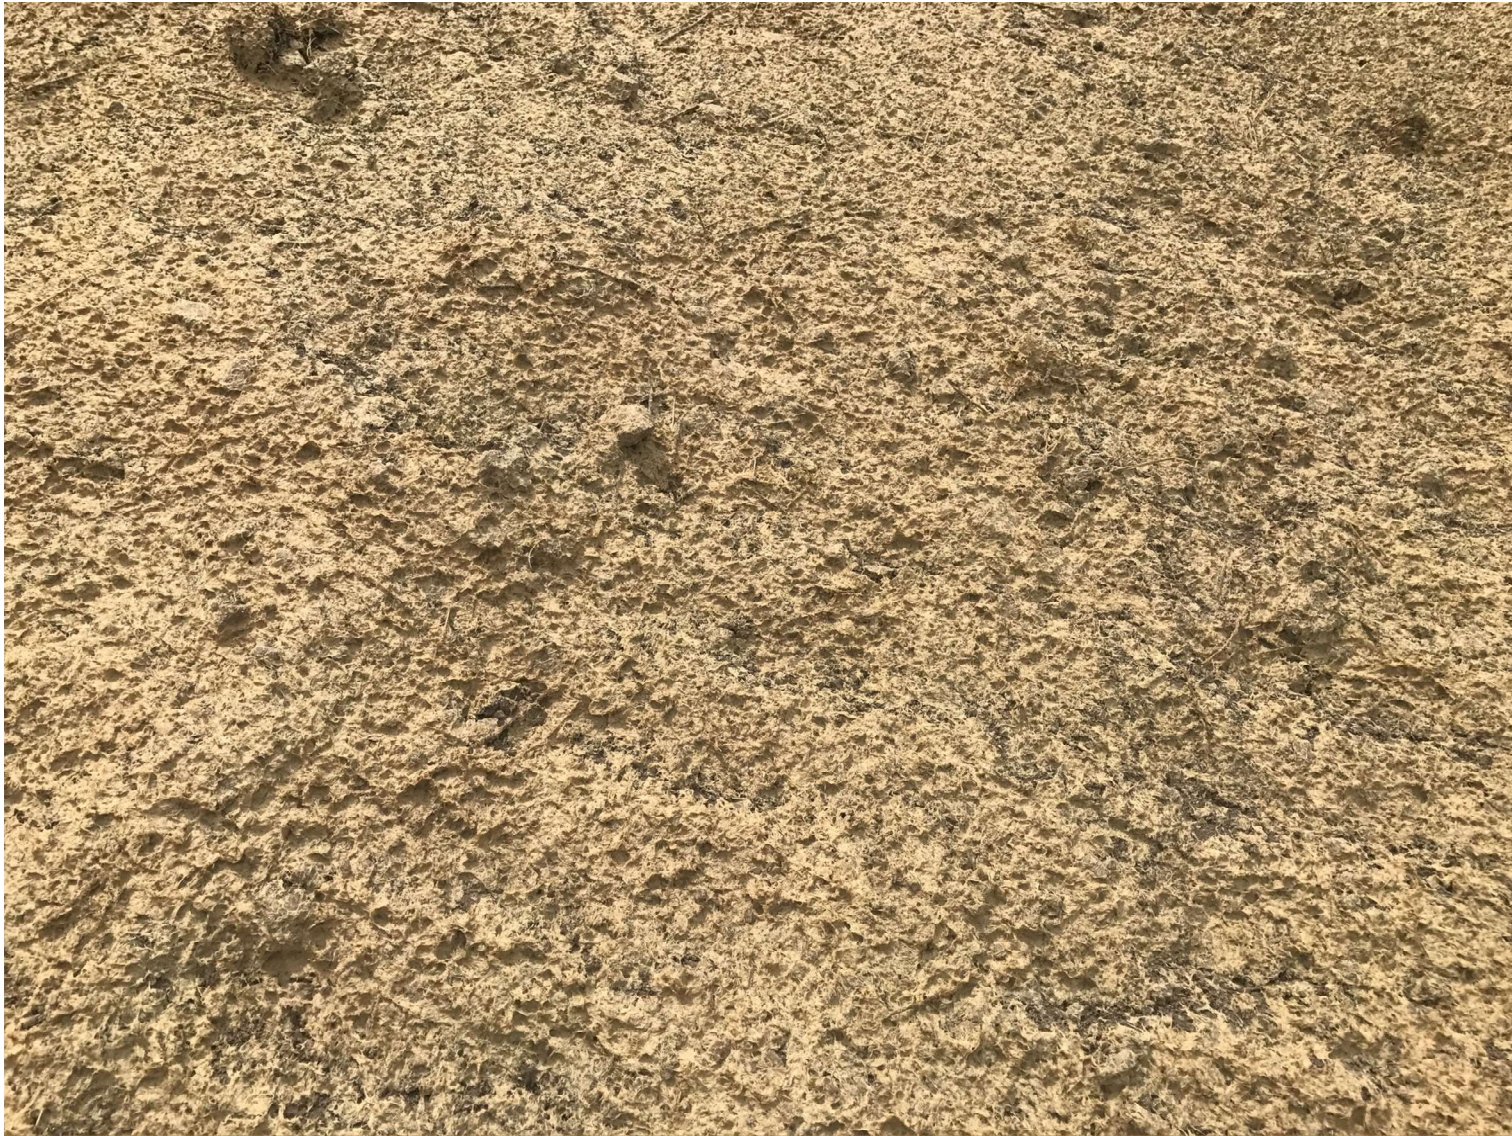
PHOTO 2: CLOSE UP PHOTO OF CUT SLOPE SOIL CONDITIONS.

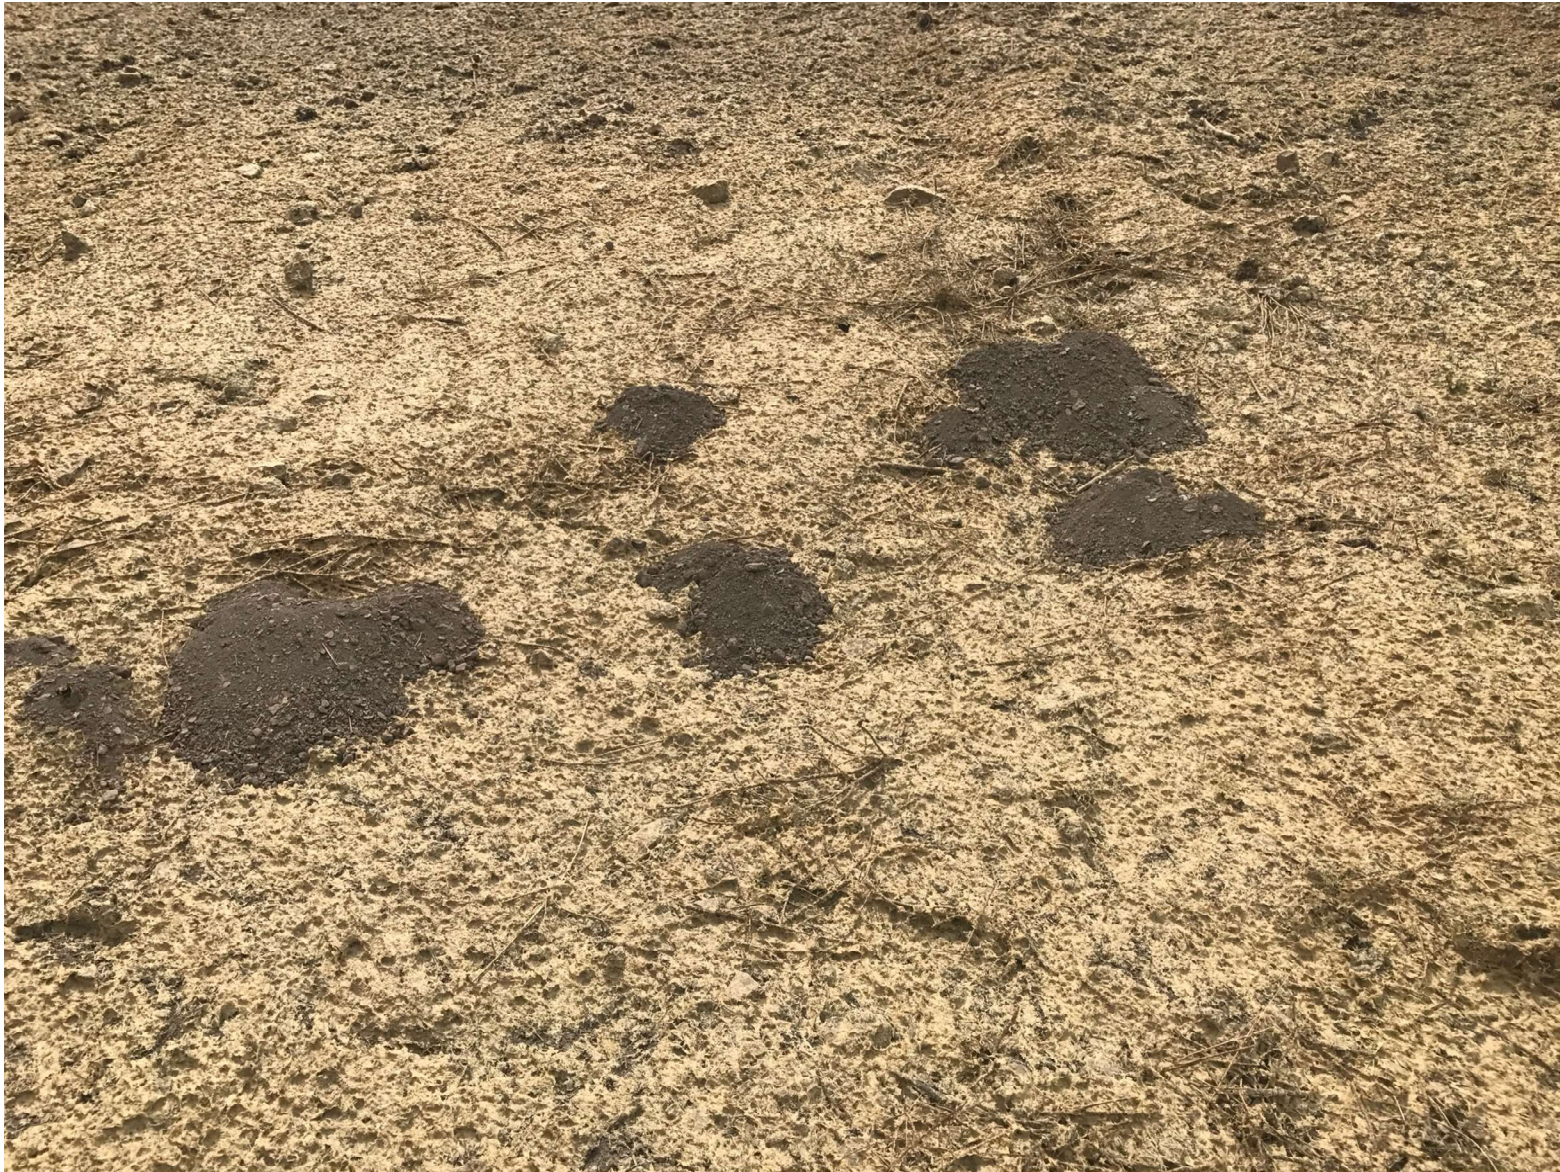
PHOTO 3: CLOSE UP PHOTO OF CUT SLOPE SOIL CONDITIONS WHERE MOLES ARE DISTURBING THE SOIL.

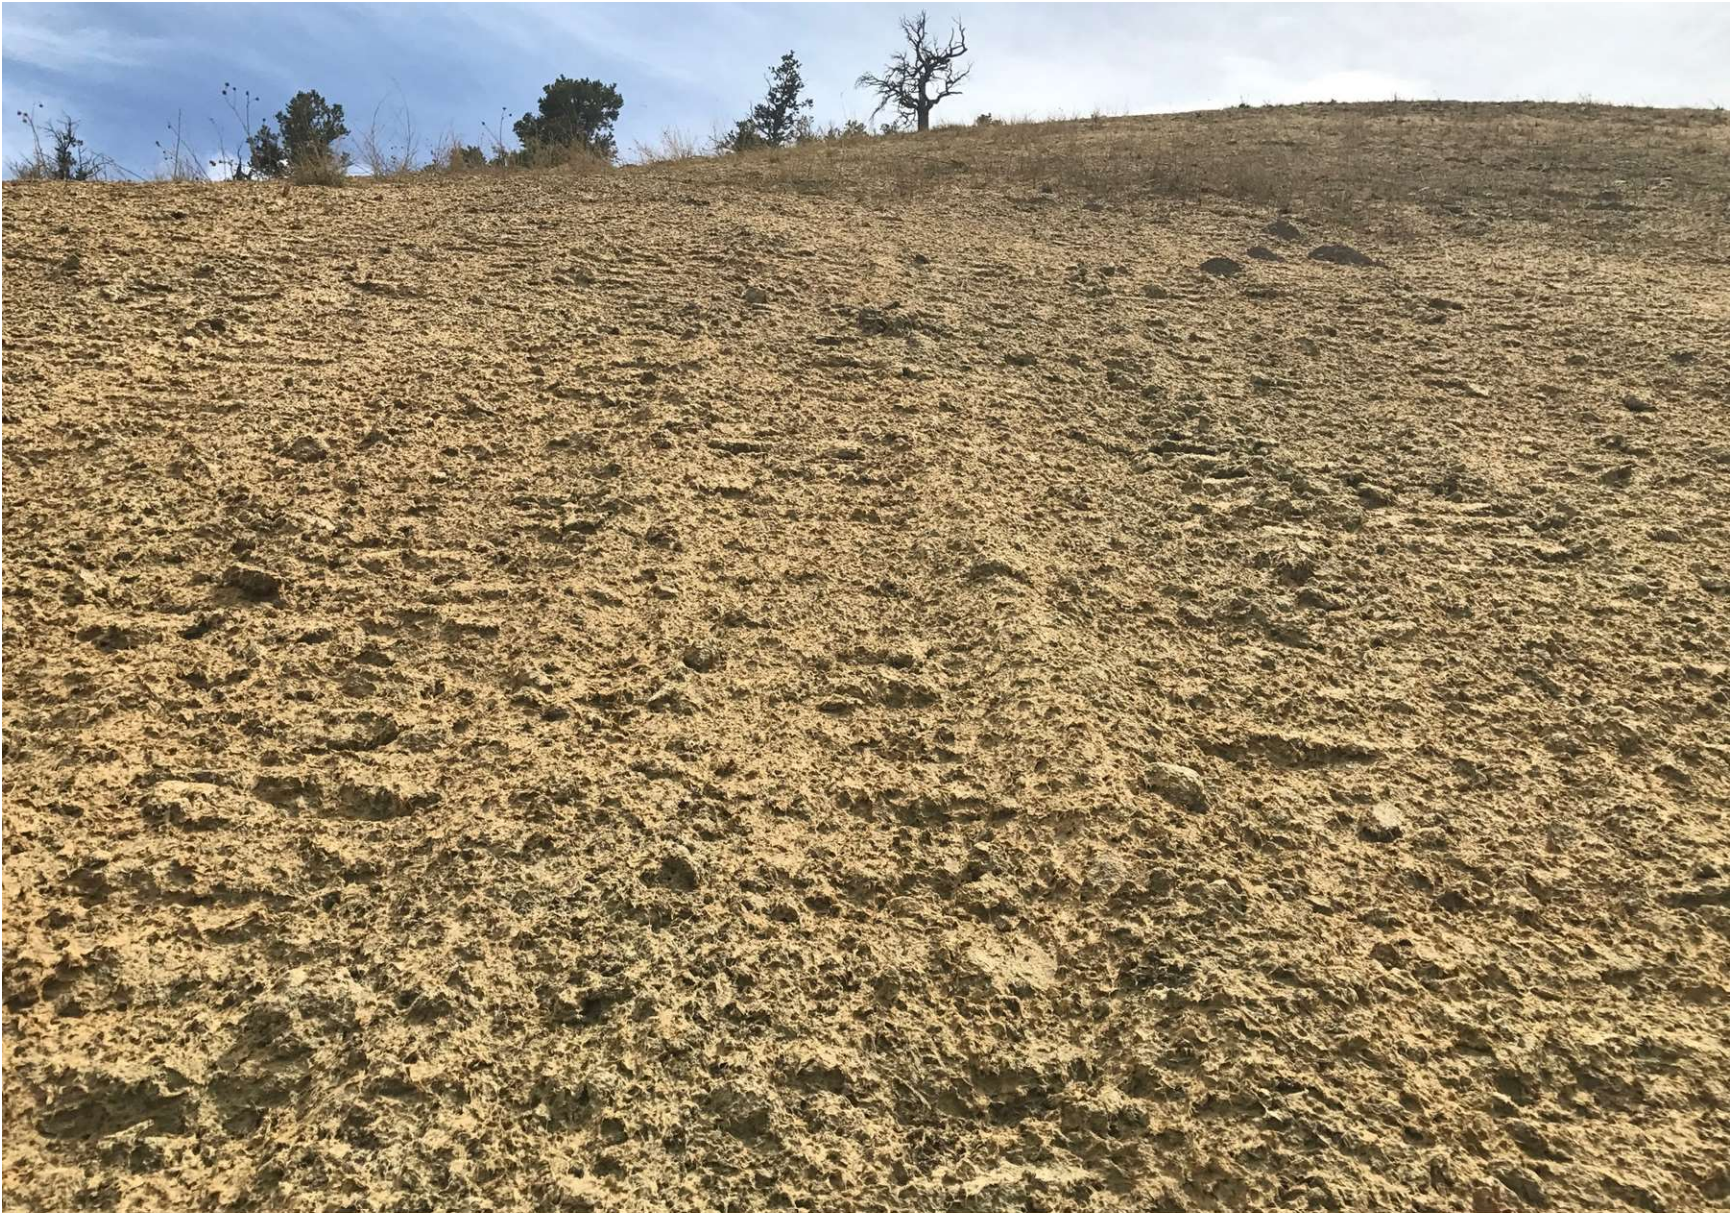
PHOTO 4: GRADING TECHNIQUES WHERE INSTALLED TO REMOVE RILL FORMATION.

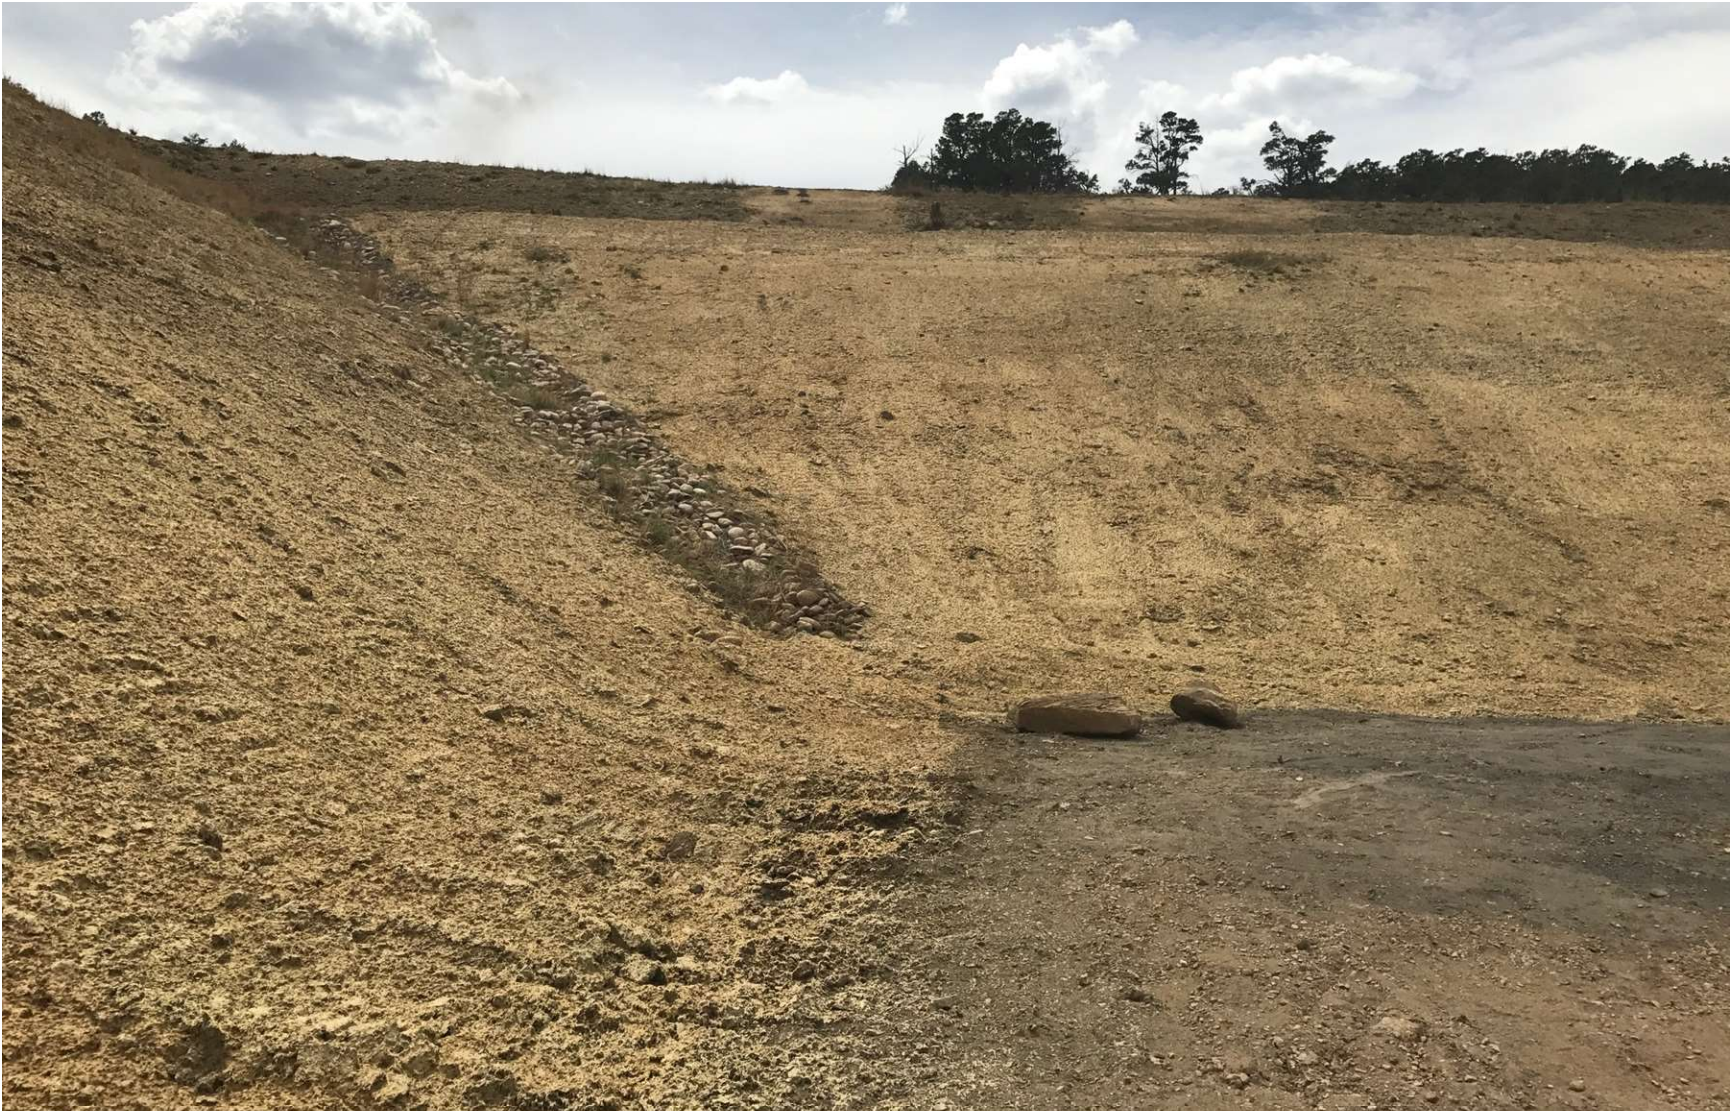
PHOTO 5: GRADING TECHNIQUES WERE INSTALLED ON THE CONTOUR TO CORRECT RILL FORMATION. THE EARTH DISTURBANCE WAS STABILIZED BY HYDRO-SEEDING USING AN APPROVED HILL RANCH SEED MIX TO PROMOTE THE ESTABLISHMENT OF VEGETATION.

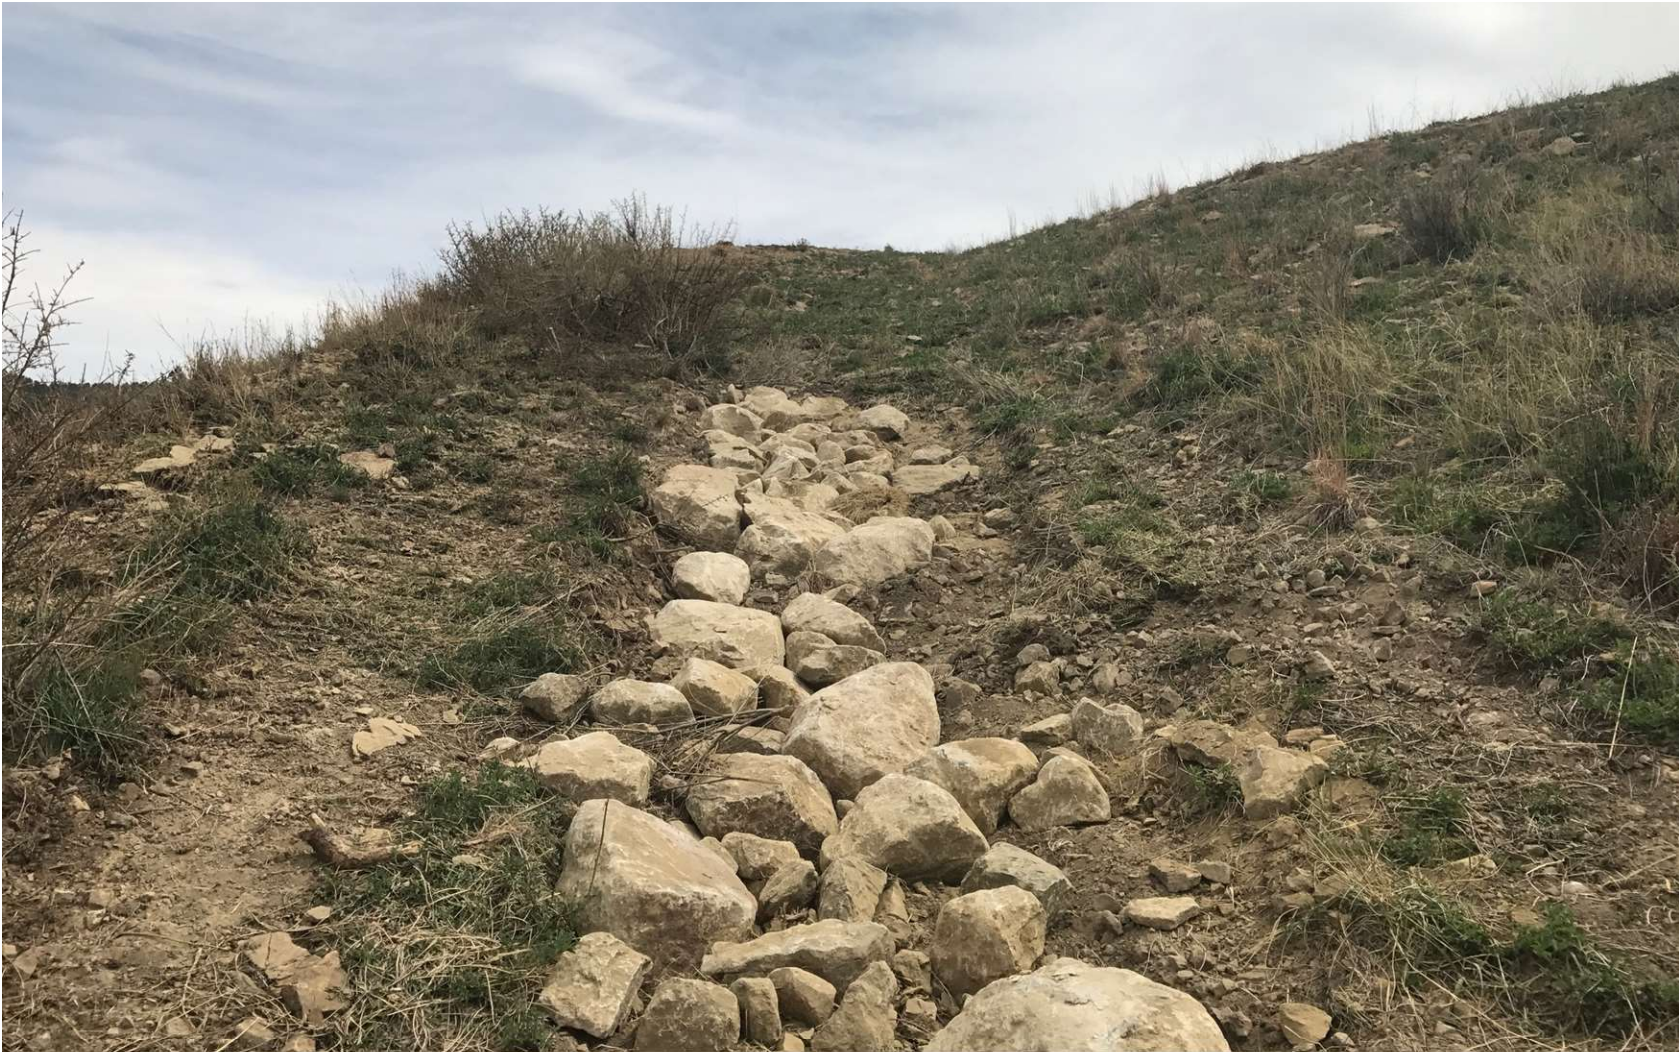
PHOTO 6: RIP RAP WAS PLACED IN THE PORTION OF THE TERRACED SLOPE THAT WAS ERODING TO CONTROL THE EROSION.

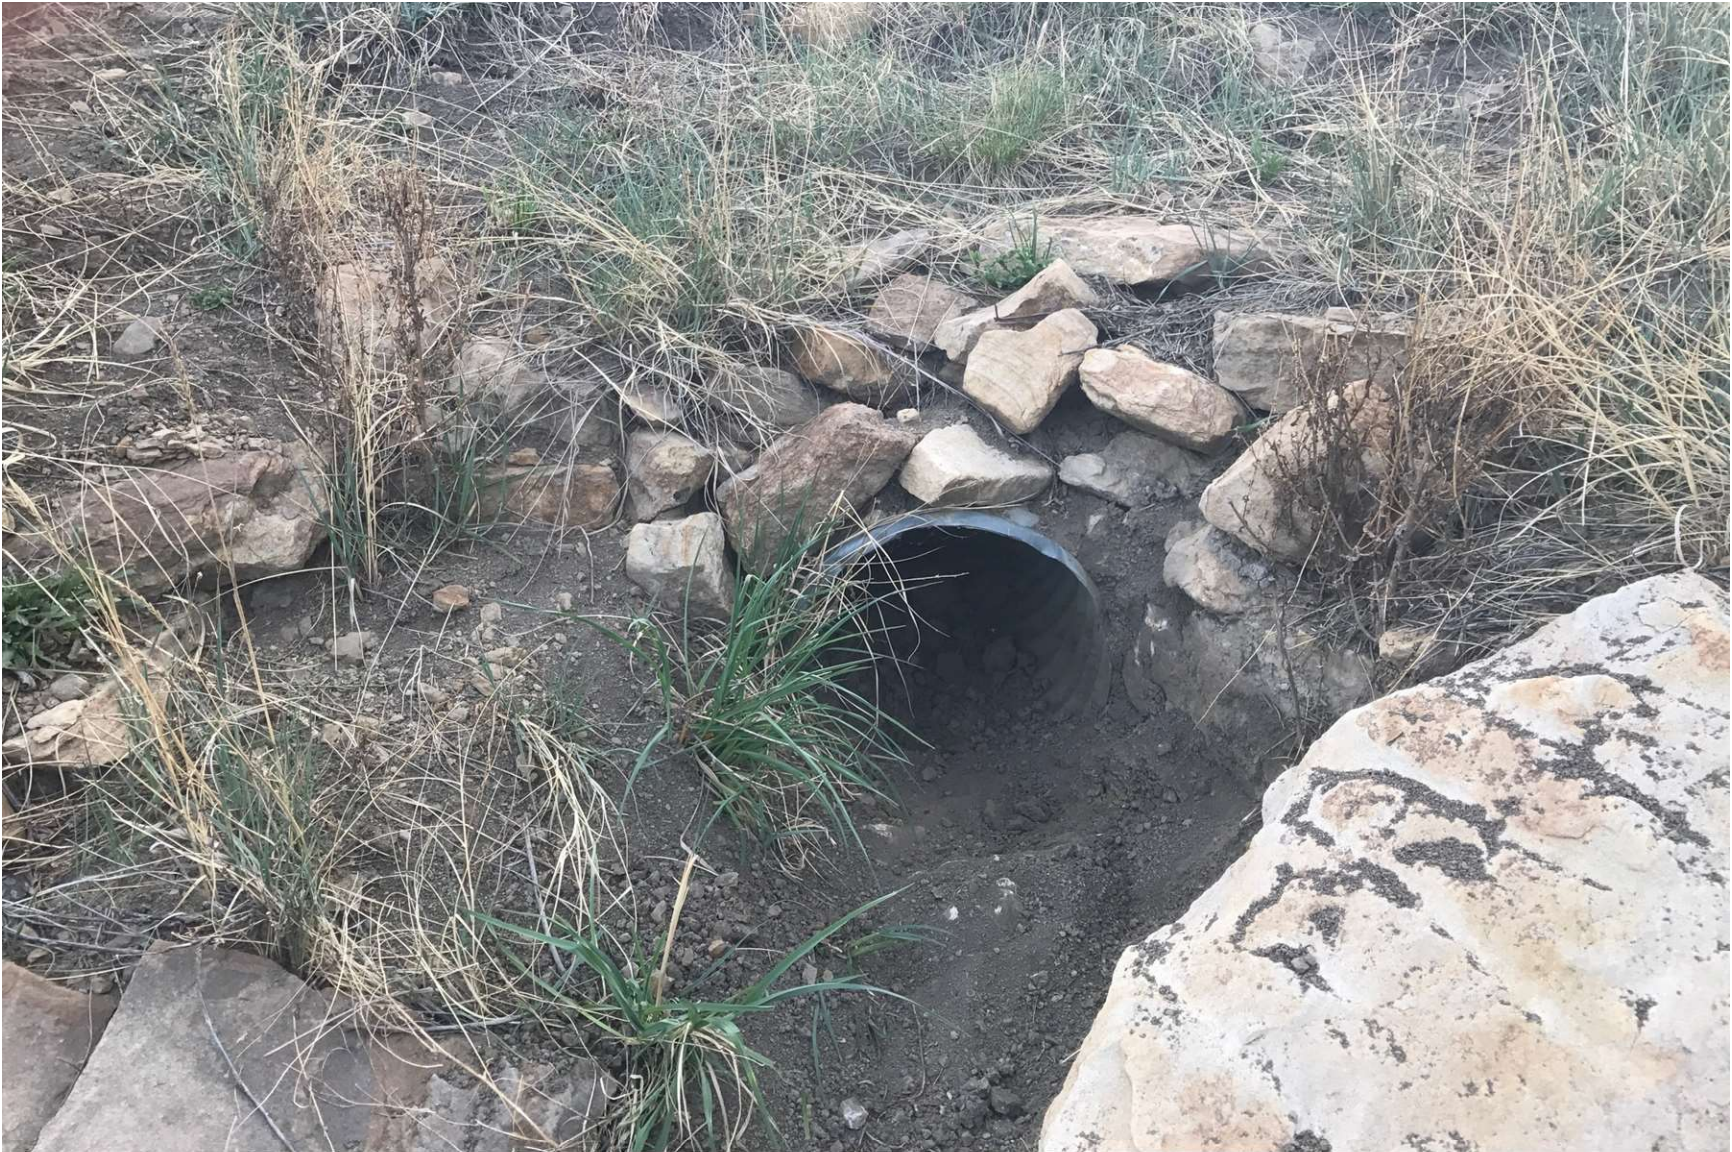
PHOTO 7: THE LOOSE SOIL WAS REMOVED FROM THE CULVERT OUTLET.
