Final Reclamation Inspection

Operator: KERR MCGEE OIL & GAS ONSHORE LP #47120

API: 05-123-08199

Inspection Photos
Location Name: VALLEY 66 UNIT #1
API: 05-123-08199

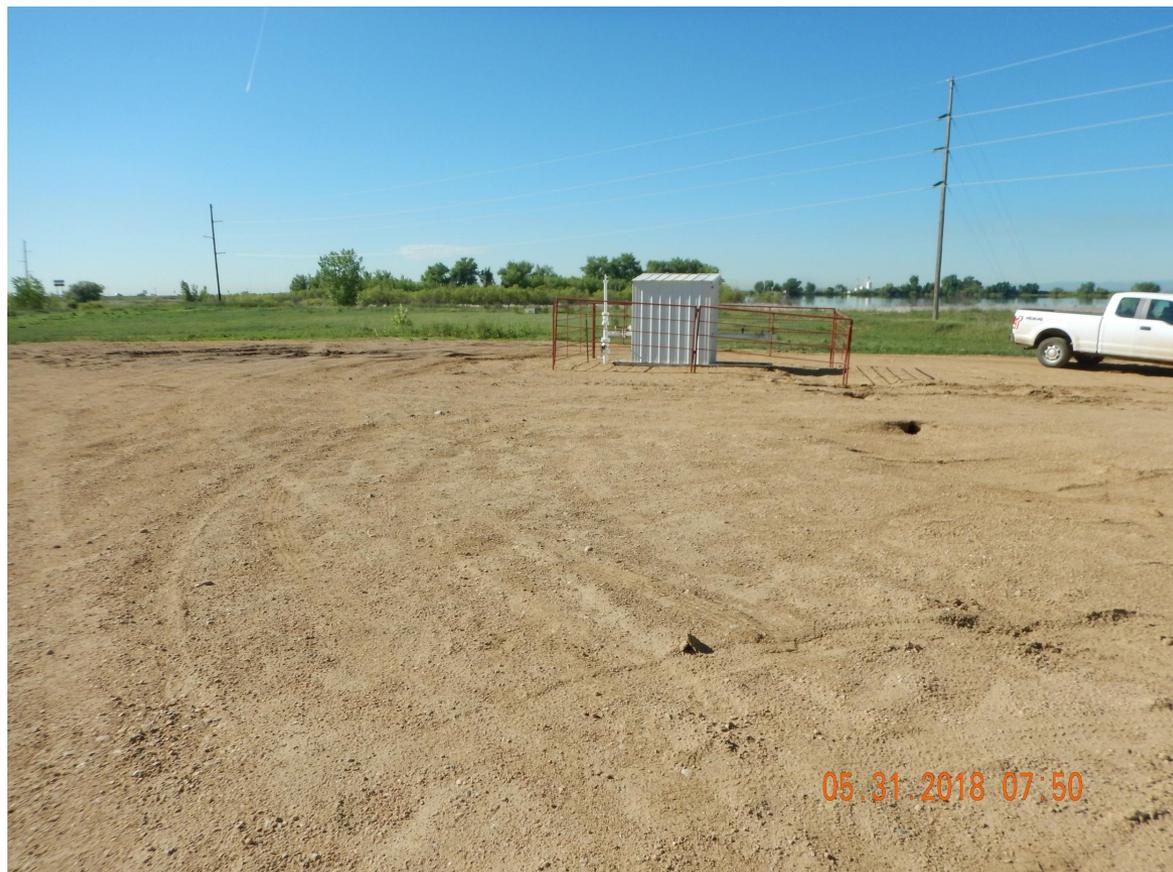
Photo 1. Photo taken from the battery location, facing South. Photo illustrates equipment left on location (meter shed) that needs to be removed. Operator shall conduct final reclamation activities per Rule 1004 by 1/12/2019 and remove equipment ASAP.

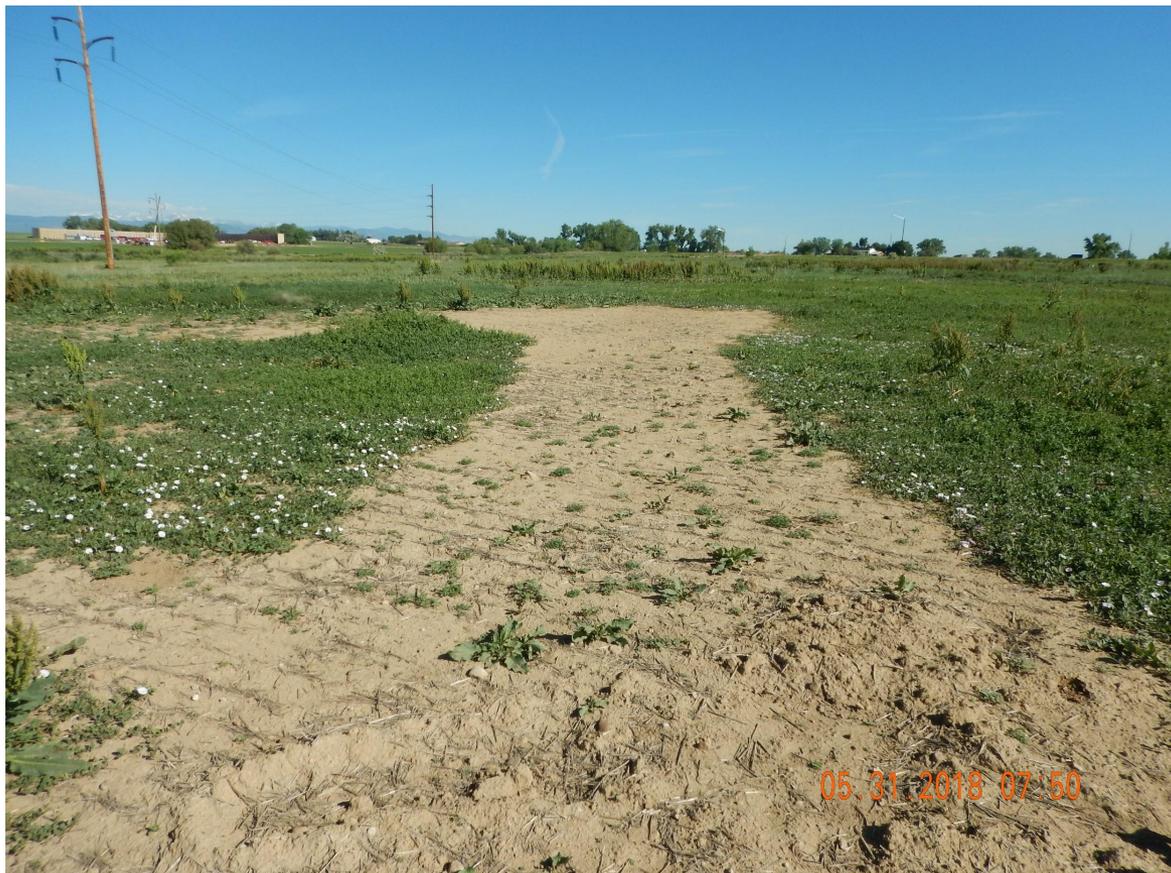
Photo 2. Photo taken from the well location, facing North. Well has been plugged and abandoned. Operator shall conduct final reclamation activities per Rule 1004 by 7/27/2018.

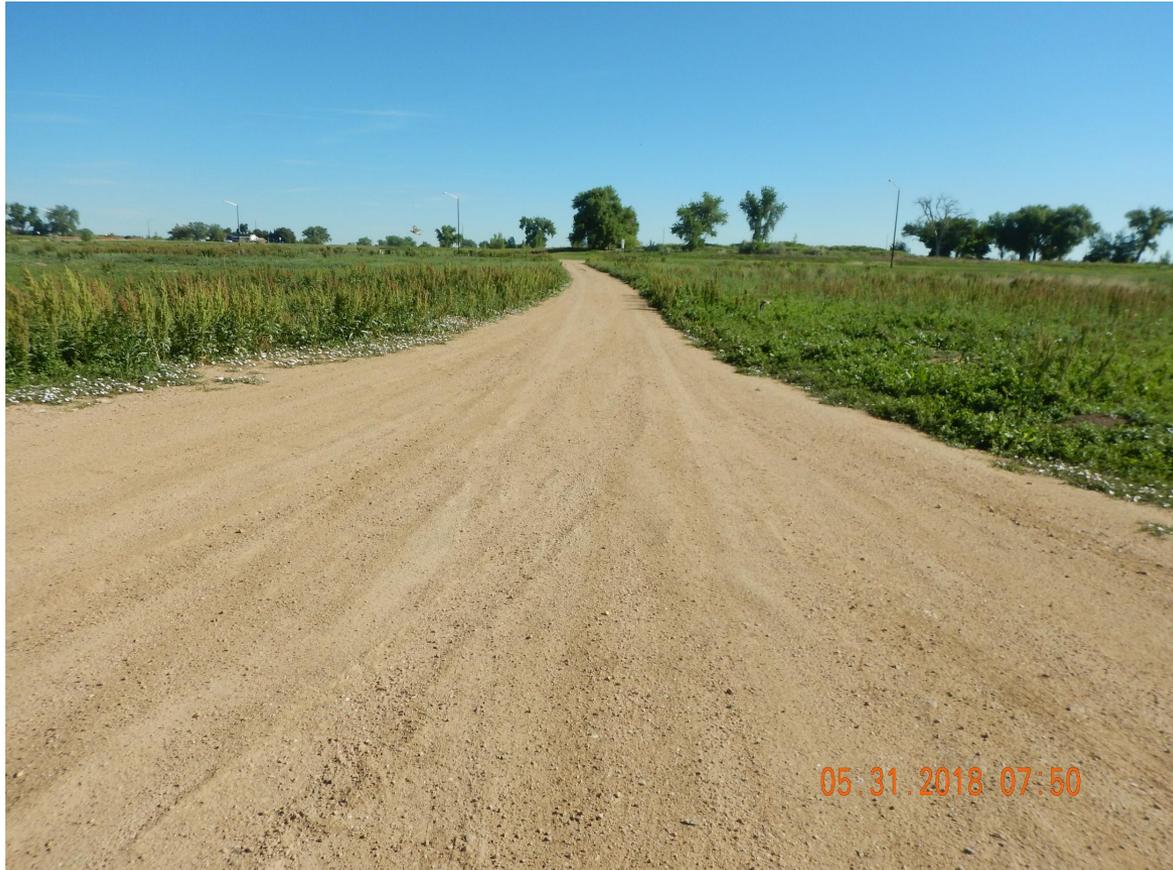
Photo 3. Photo taken from the battery location, facing North. Access road remains. Operator shall conduct final reclamation activities per Rule 1004 by 1/12/2019.
