# Final Reclamation Inspection

Operator: EDDY OIL COMPANY - #26420

API: 05-123-14110

Inspection Photos  
Location Name: OGILVIE #24-3  
API: 05-123-14110

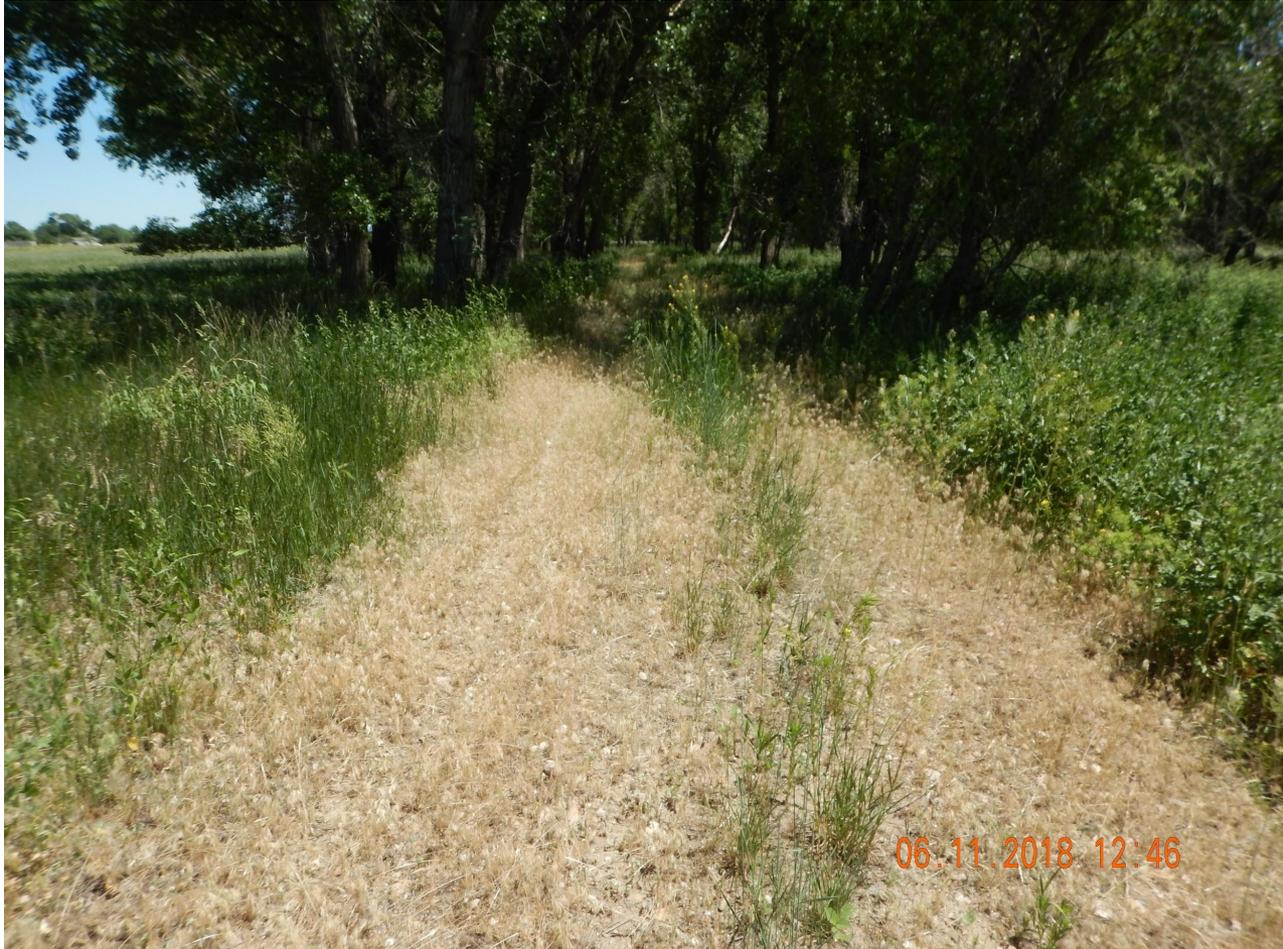
**Photo 1.** Photo taken from the start of the access road, facing East. Access road is evident and does not meet Rule 1004 standards. Access road appears to be compacted with undesirable vegetation, including noxious weeds (Canada and Musk Thistle).

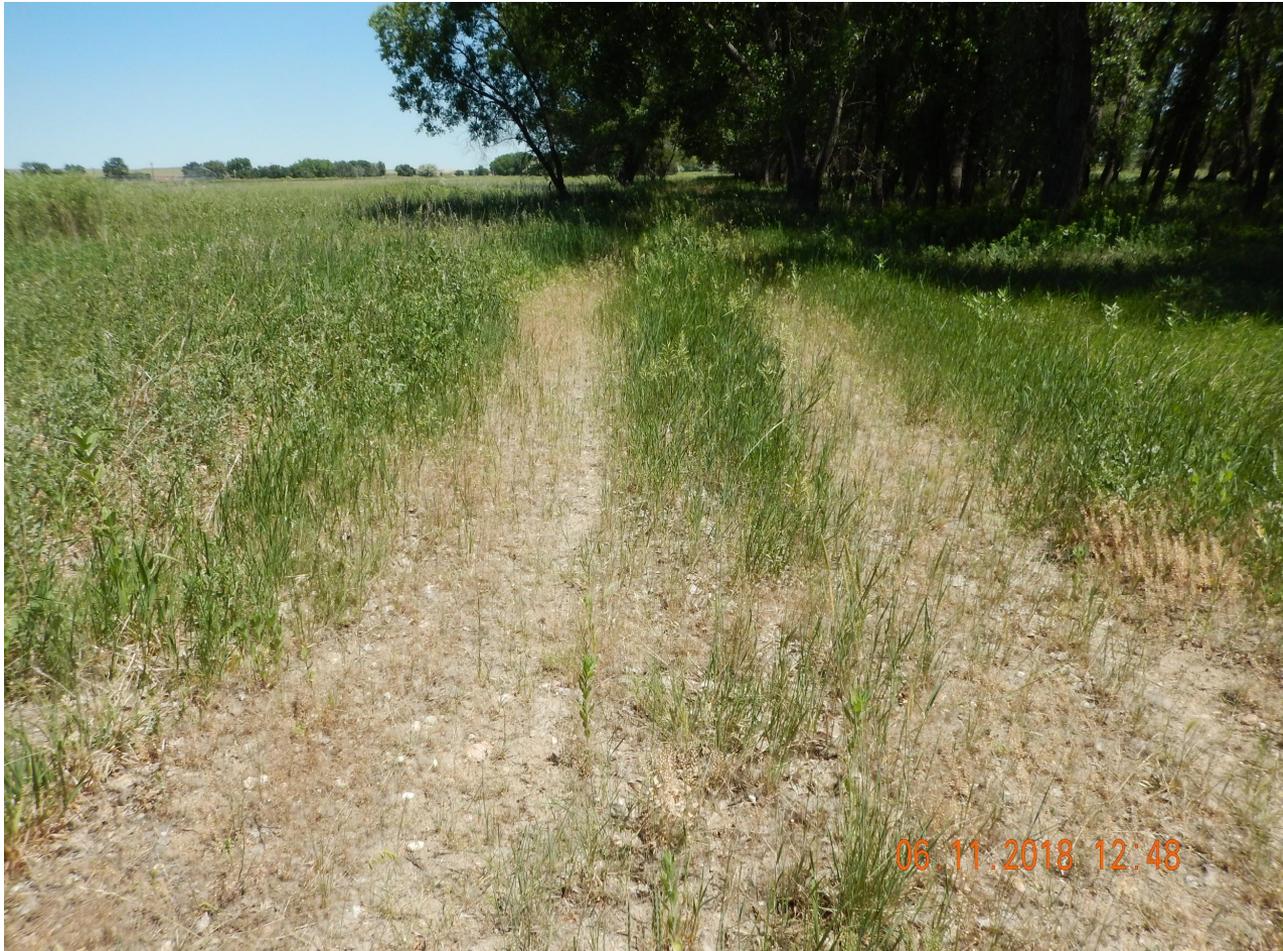
**Photo 2.** Photo taken along the approximate midway point of the access road, facing East. See comments under Photo 1. Some desirable vegetation was observed along the middle portion of the access road.

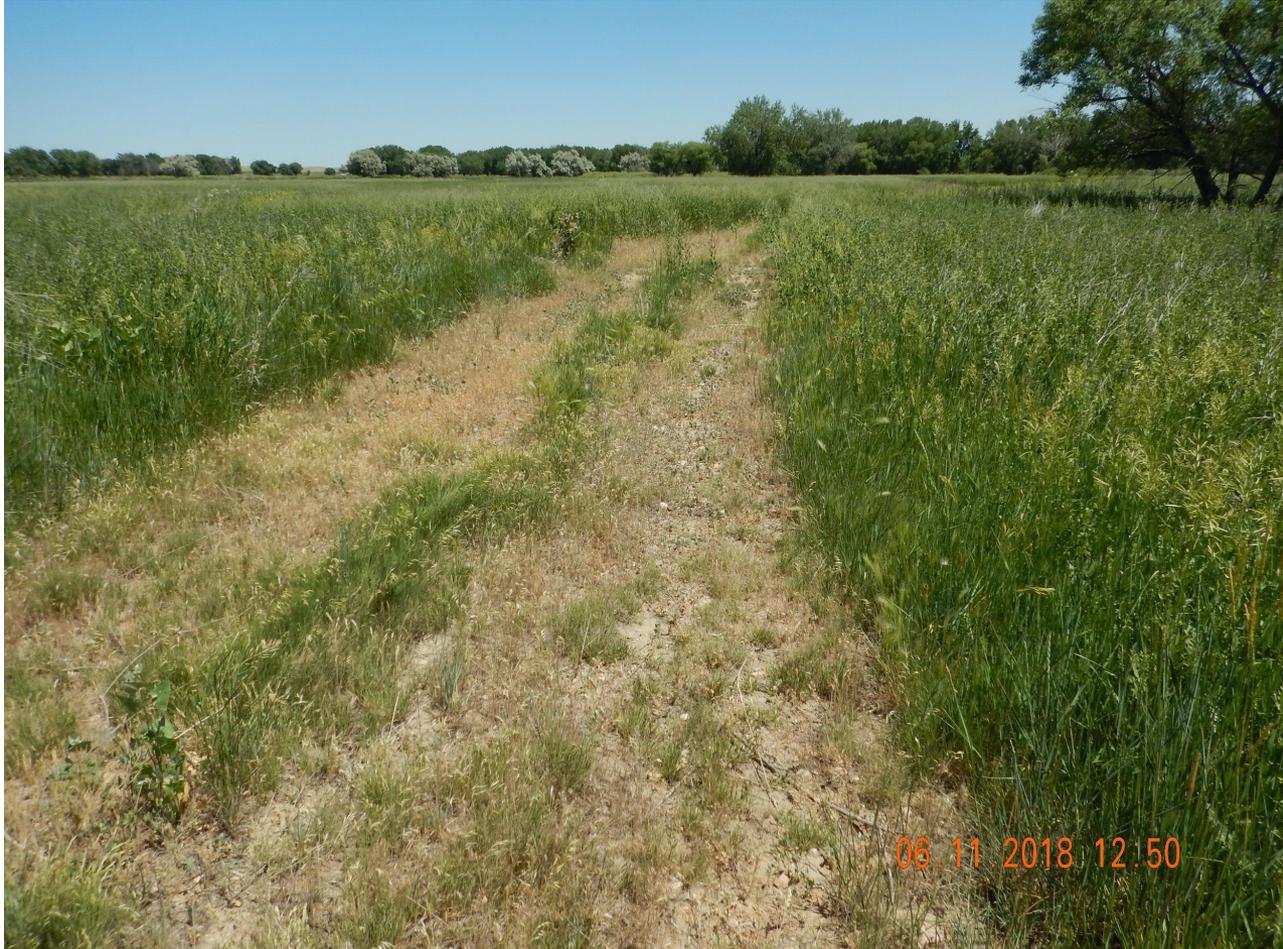
**Photo 3.** Photo taken along the eastern access road, facing East. See comments under Photo 2.

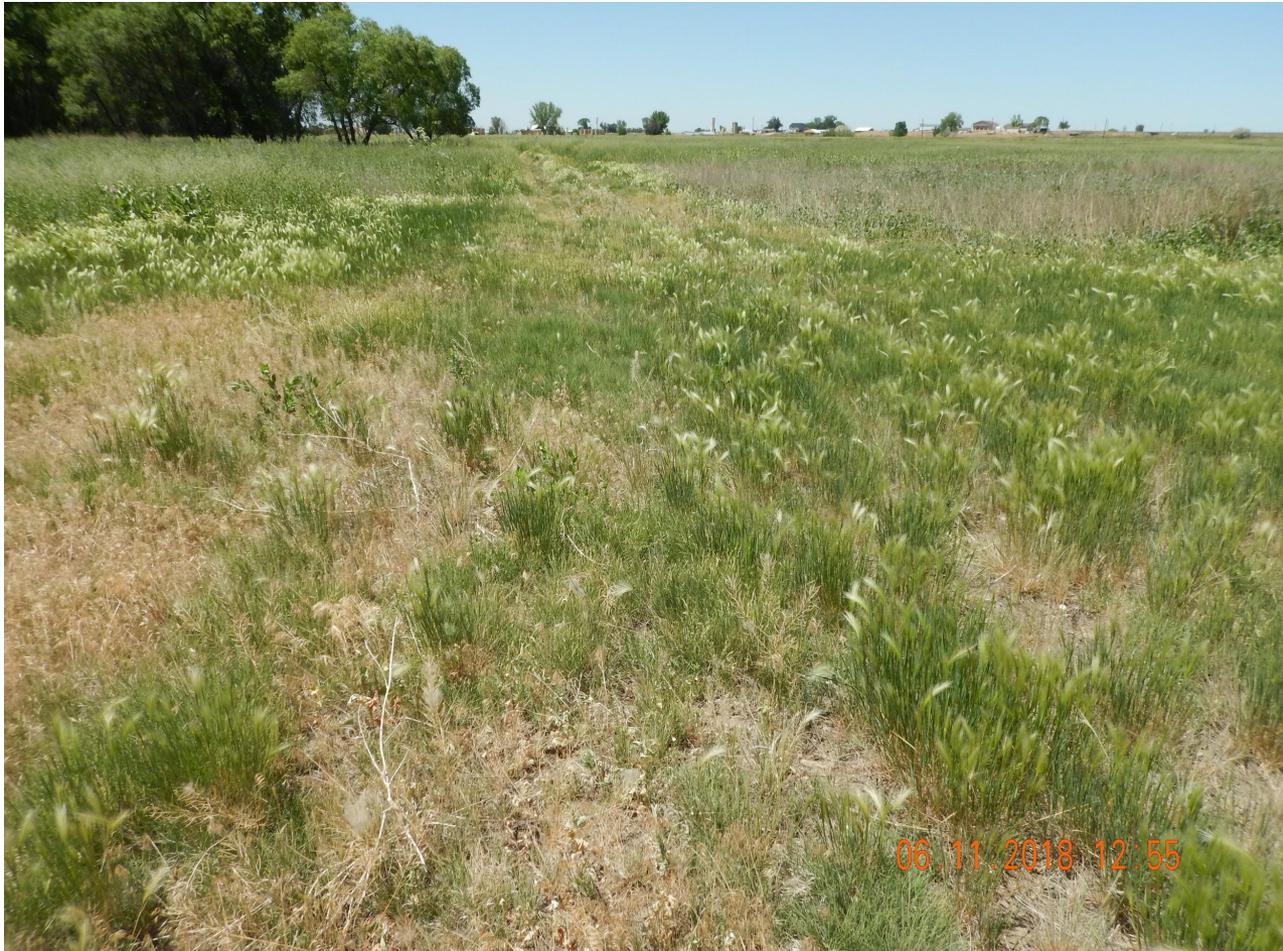
**Photo 4.** Photo taken from the approximate well location, facing West. Desirable vegetation was observed throughout the well location and would appear to meet Rule 1004 standards.

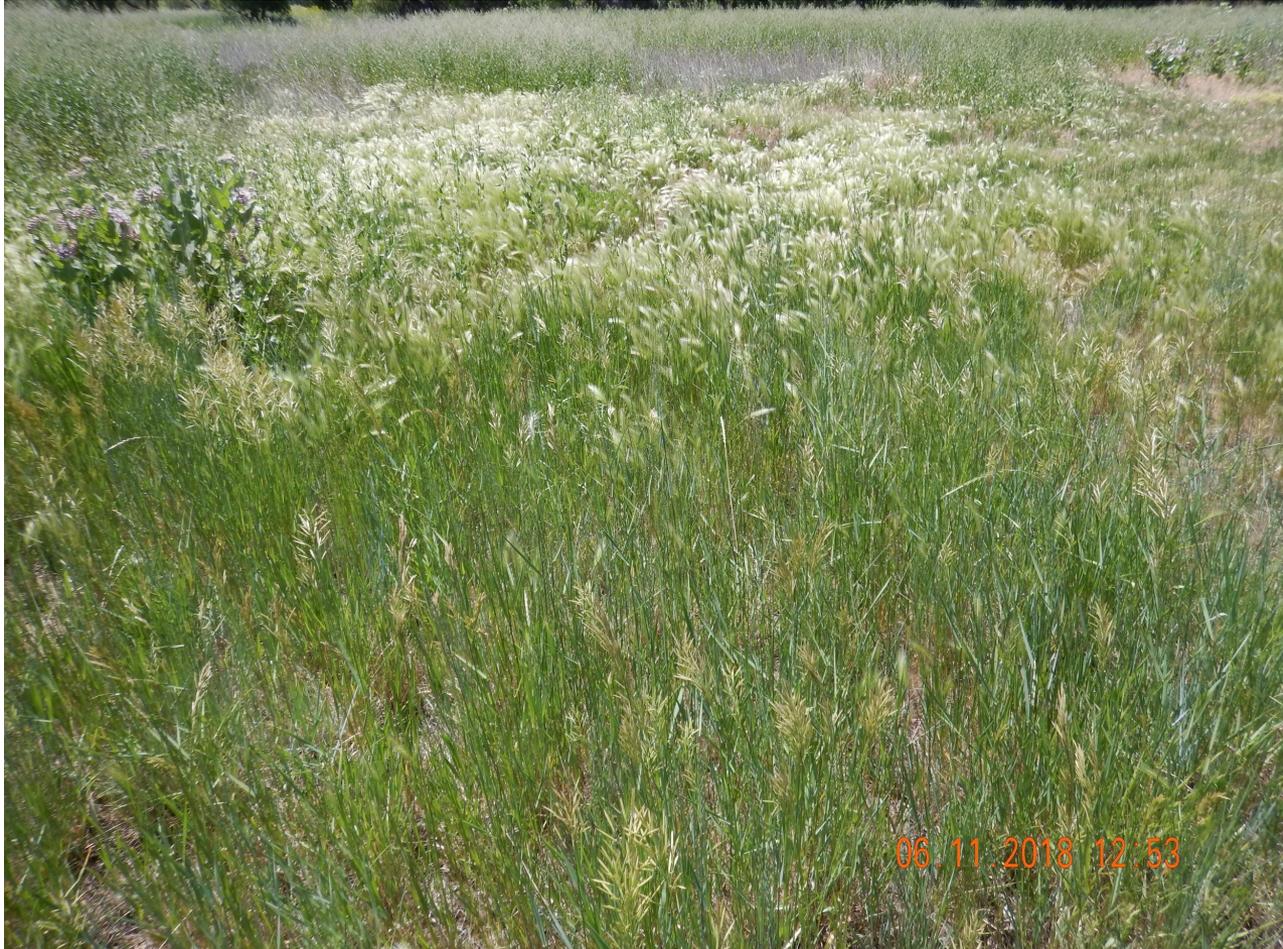
**Photo 5.** Photo taken from the approximate well location, facing South. See comments under Photo 4.
