Inspection Photos

Operator: FOUNDATION ENERGY
MANAGEMENT LLC - 10112

Location ID: 447525

Inspection Doc. Number: 682503491
Weld County, CO

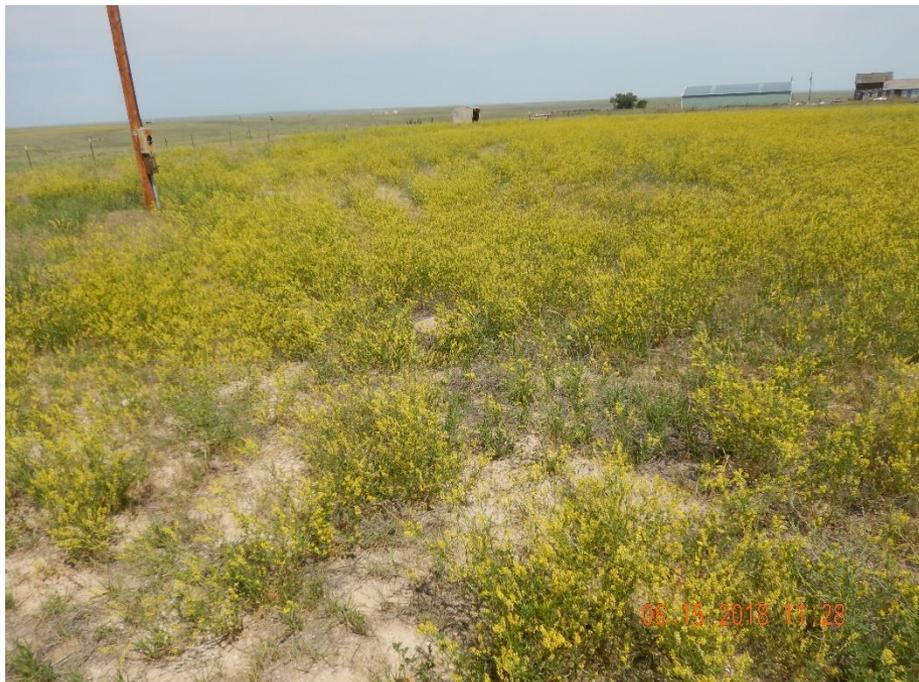
Photo 1: Photo taken from the southwest end of the location, facing north. Photos 1-3 show an overview of the location from north, northeast to east.

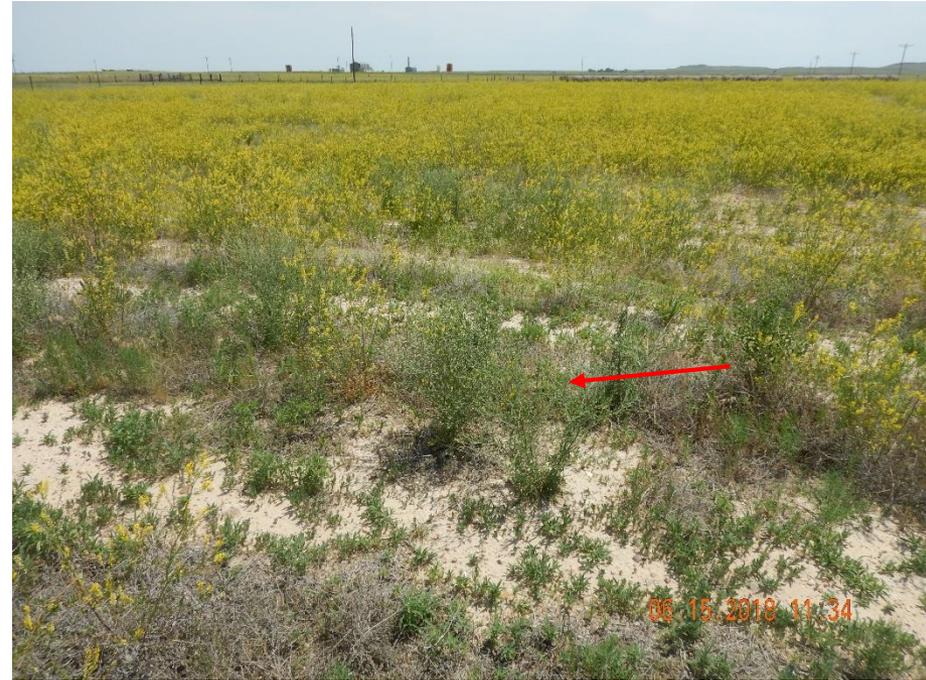
Photo 4: Photo taken from the west end of the location, facing east. Photo shows that Diffuse Knapweed (lighter green plant in photo, red arrow) is prevalent throughout the majority of the location. Yellow plant observed is Yellow Sweetclover .

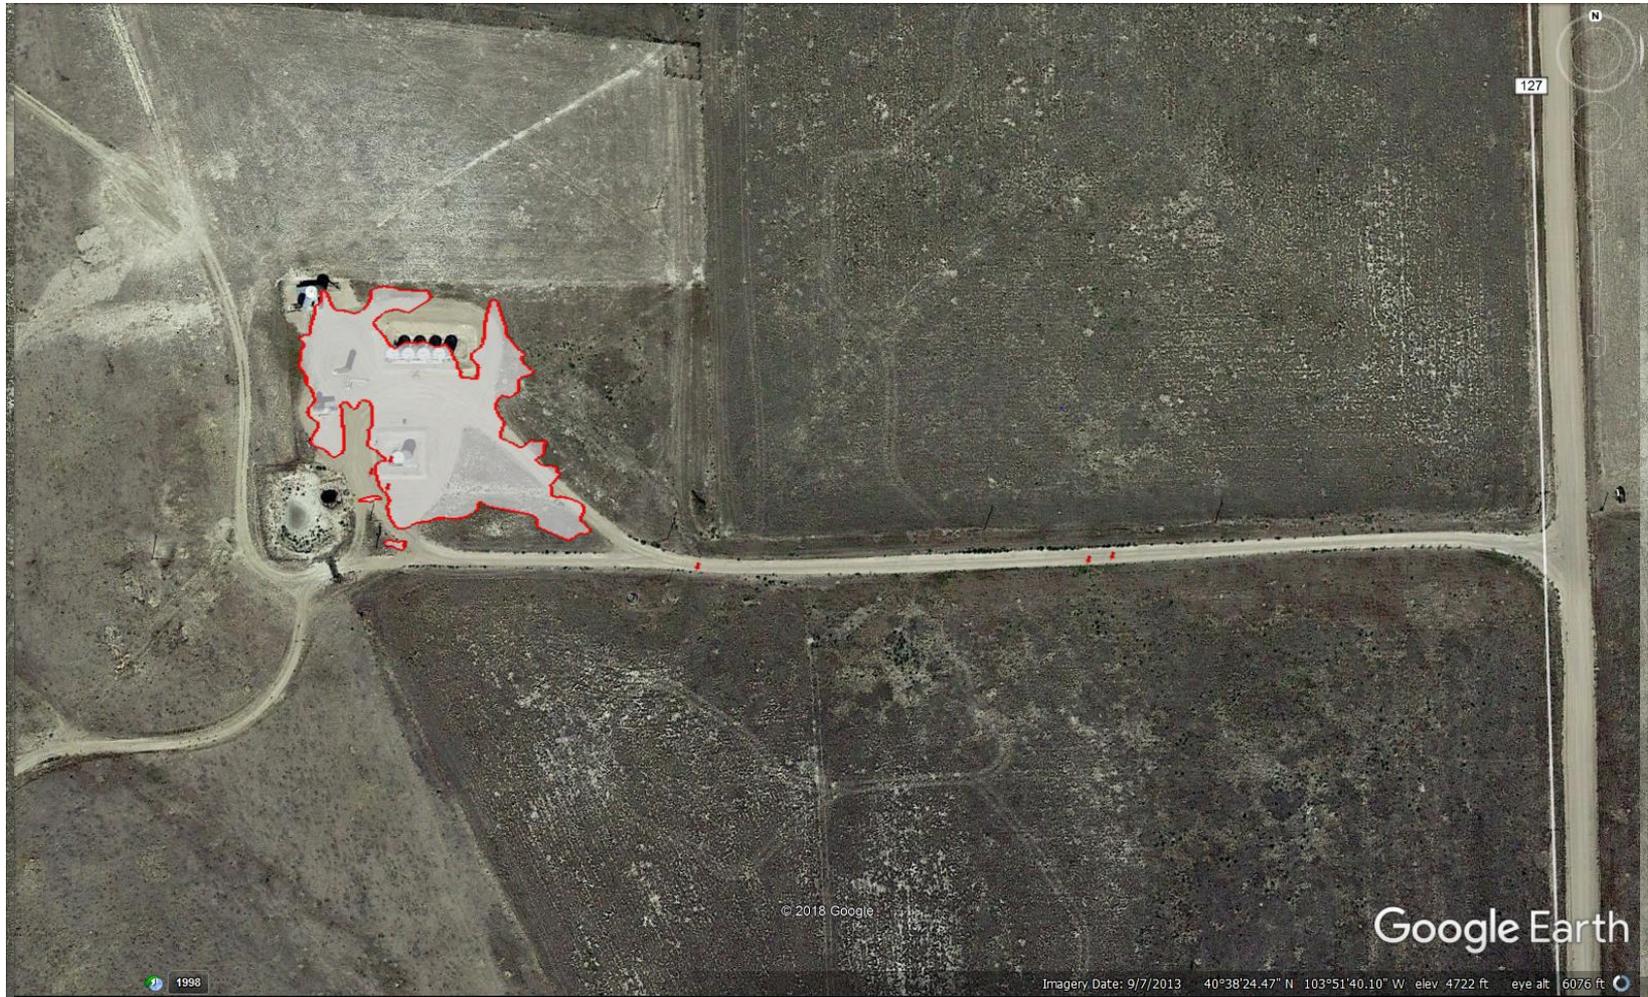
Photo 5: 2013 Aerial imagery. Photo shows areas (red polygon) where Noxious Weeds were observed on location and access road, and mapped using a GPS.
