Inspection Photos

Operator: NOBLE ENERGY INC - 100322

Location ID: 318182

Inspection Doc. Number: 682503619

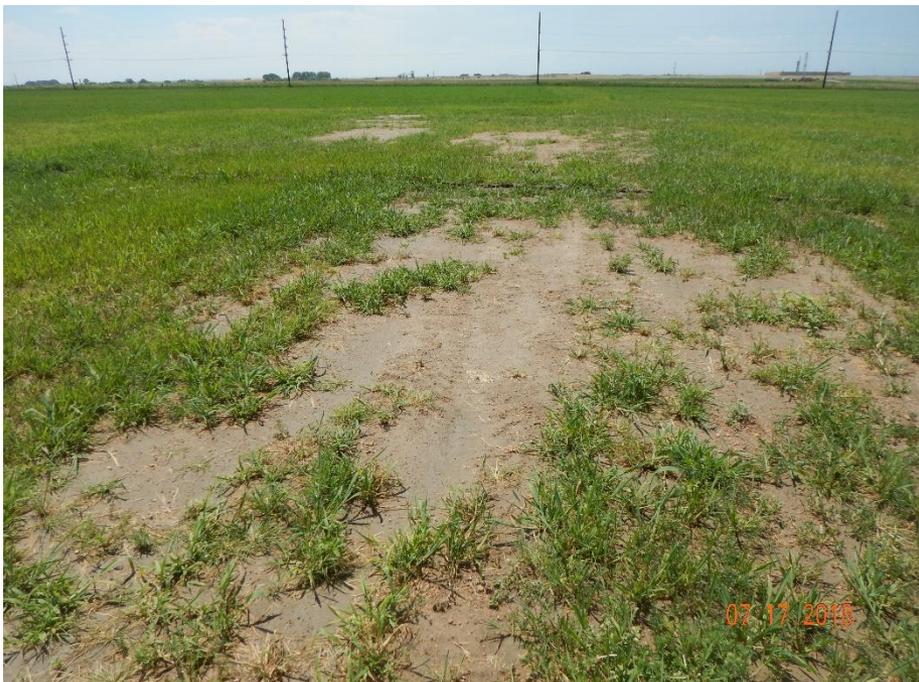
Photo 1: Photo taken from the battery location, facing west. Photo shows large areas of the battery location that remains bare and exposed soil. Operator appears to have planted *Echinochloa crus-galli* (Barnyardgrass) at the well and battery location. This is an annual grass that can be weedy according to the USDA, reference area is perennial alfalfa cropland; vegetation is not reflective of the reference area.

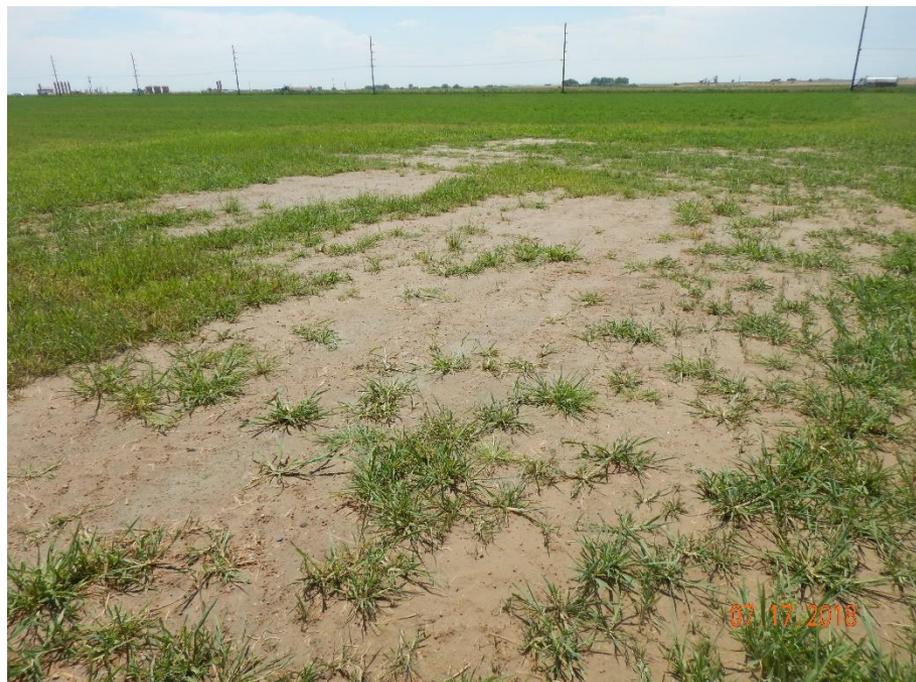
Photo 2: Photo taken from the battery location, facing southwest. See comments under photo 1.
