Inspection Photos

Operator: CITATION OIL & GAS CORP - 17180

Location ID: 324930

Inspection Doc. Number: 682503743

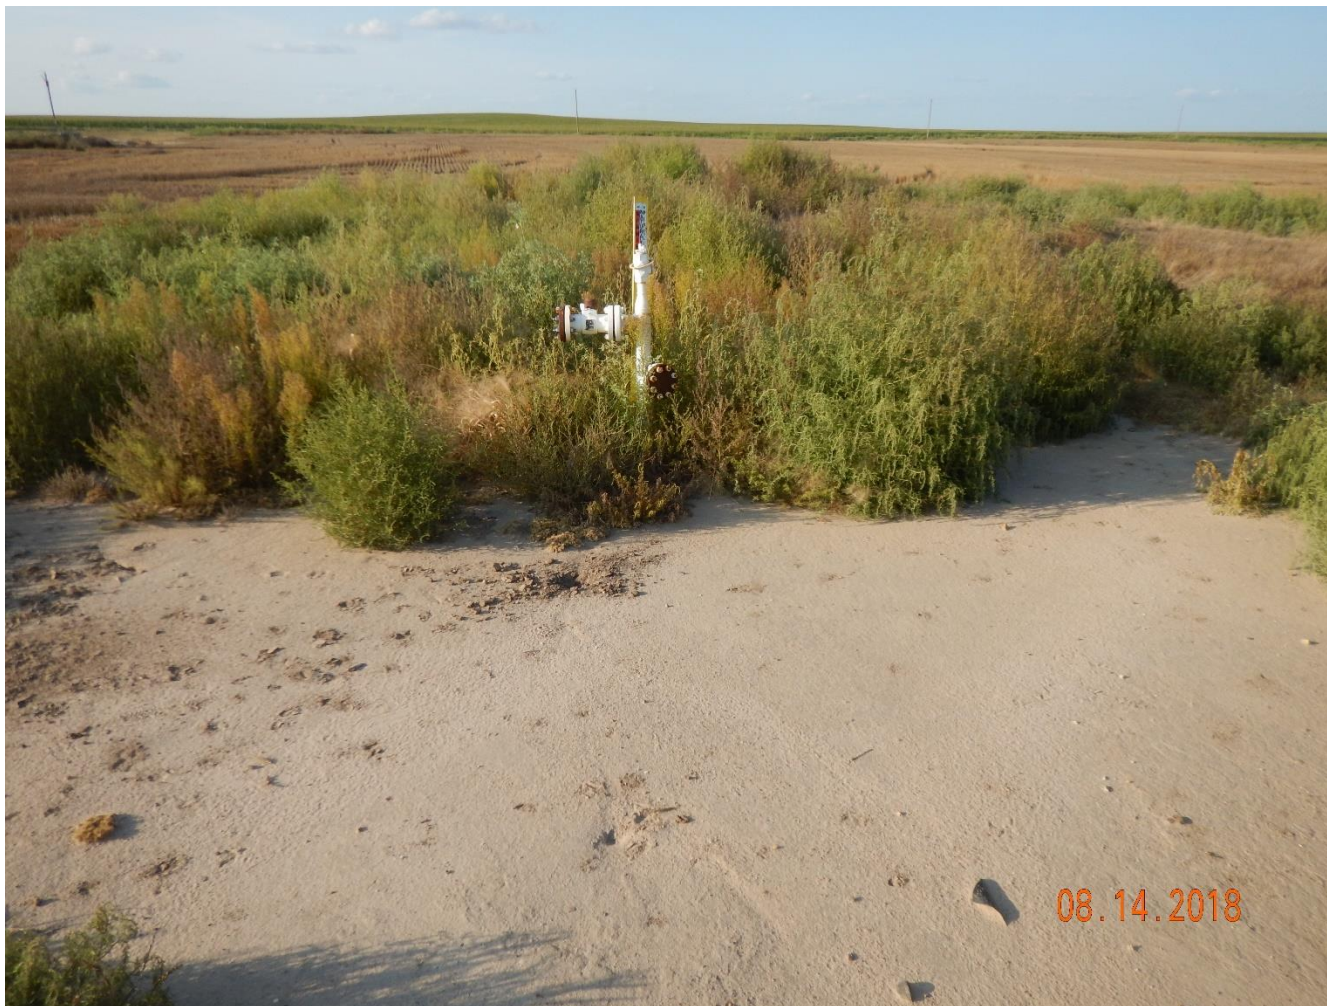
Photo 1: Photo taken from the location, facing north. Photo shows riser remaining on the location. Riser appears to be interfering with farming activities as farmer appears to have to travel around equipment while planting crop. Area around riser remains bare and exposed soil or predominantly undesirable weedy plant species. Riser requires removal in accordance to 1004.a

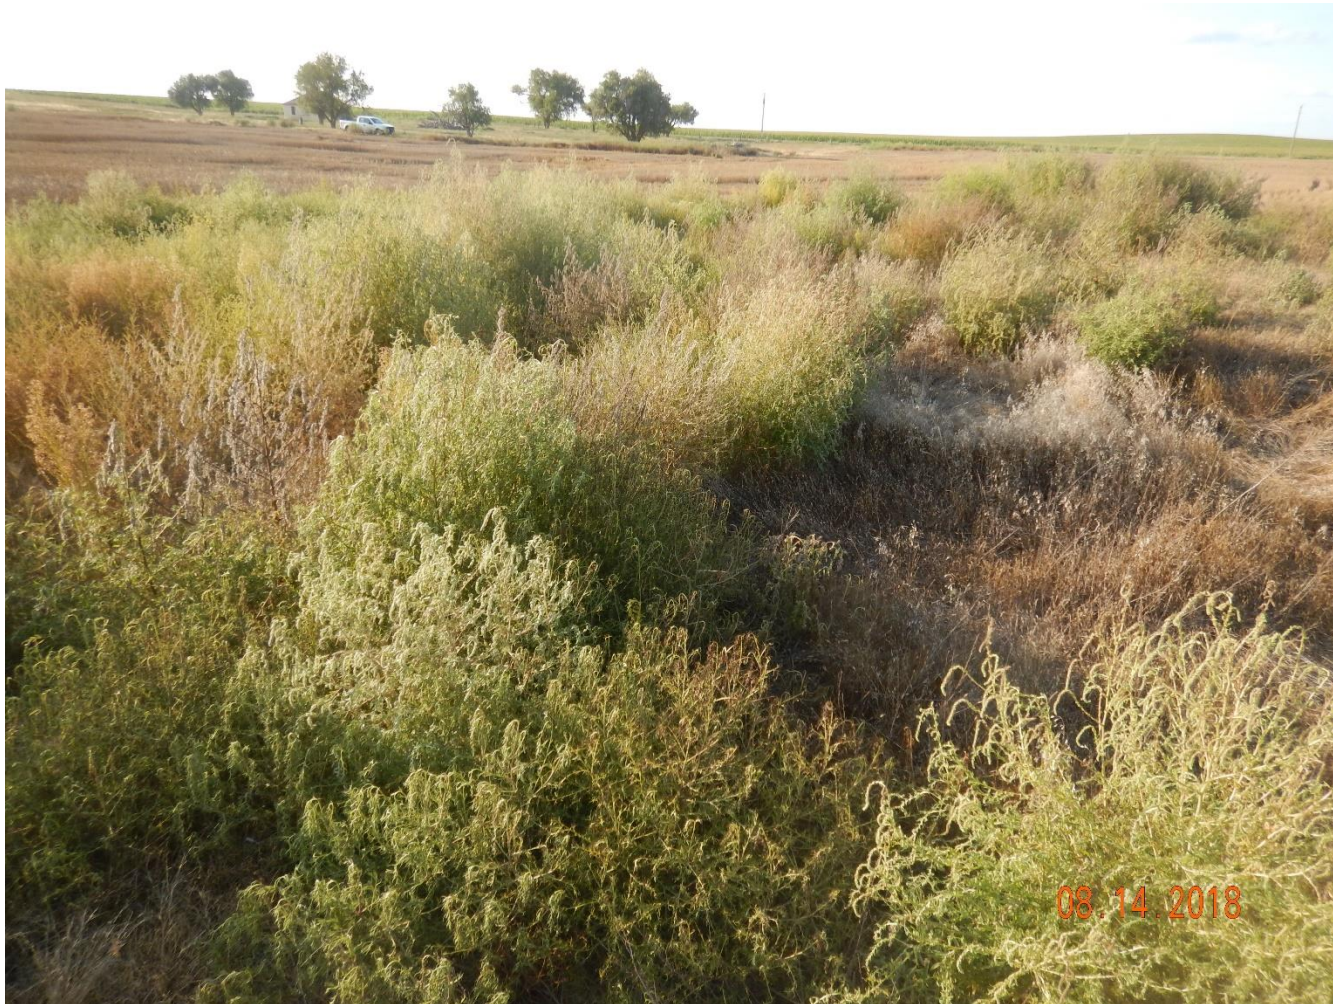
Photo 2: Photo taken from the area of the riser, facing northwest. Photo shows location remains predominately undesirable weedy plant species and is not reflective of the reference area.

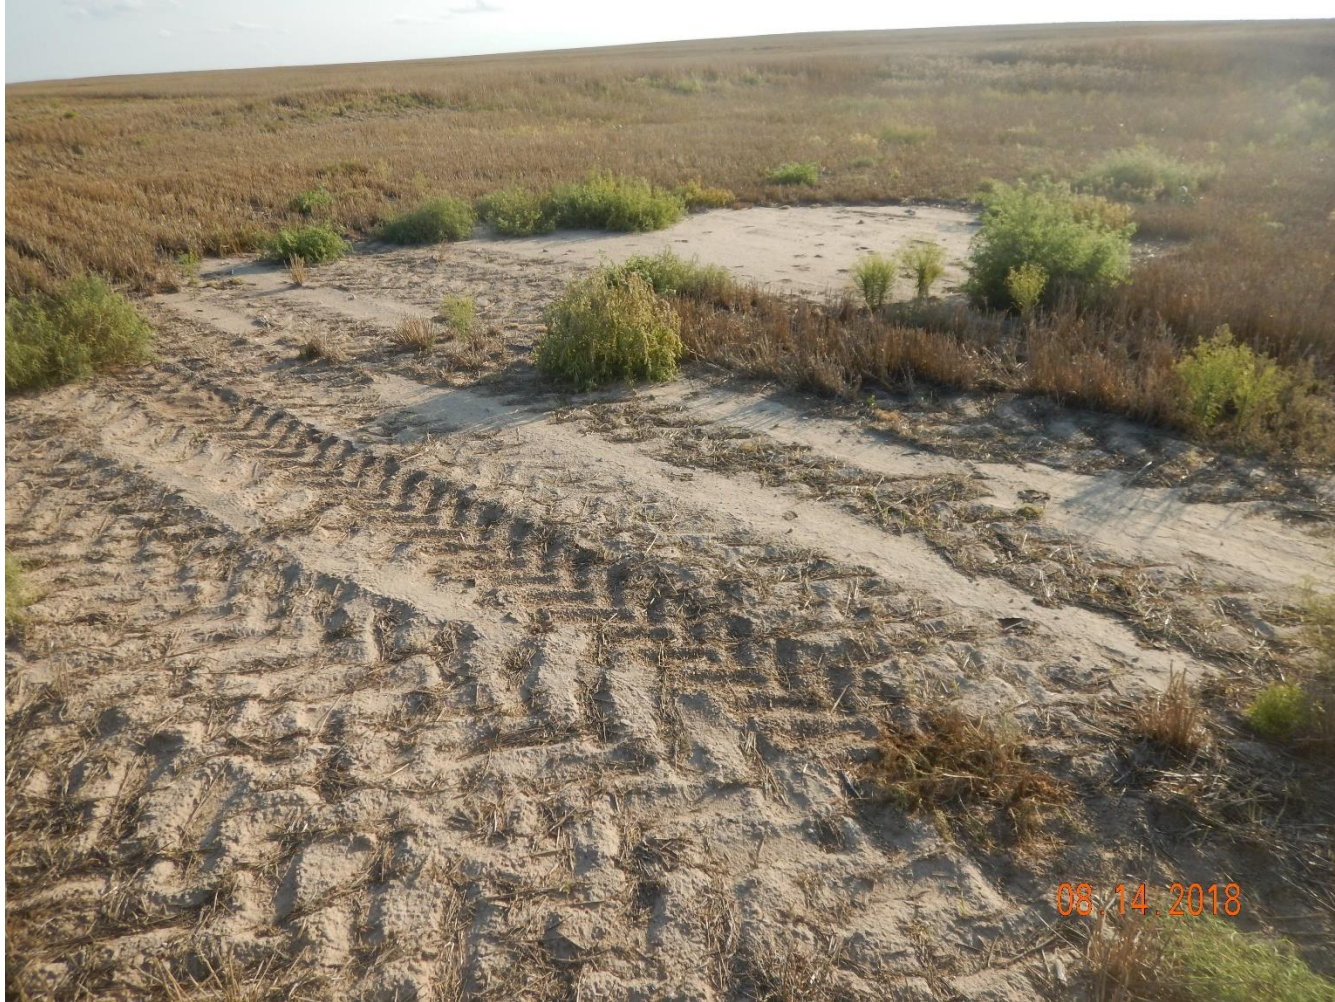
Photo 3: Photo taken from the location, facing southwest. Photo shows areas of the location where crop has been unable to establish. Additional reclamation activities required.
