Inspection Photos

Operator: FOUNDATION ENERGY
MANAGEMENT LLC - 10112

Location ID: 327445

Inspection Doc. Number: 682504494
Weld County, CO

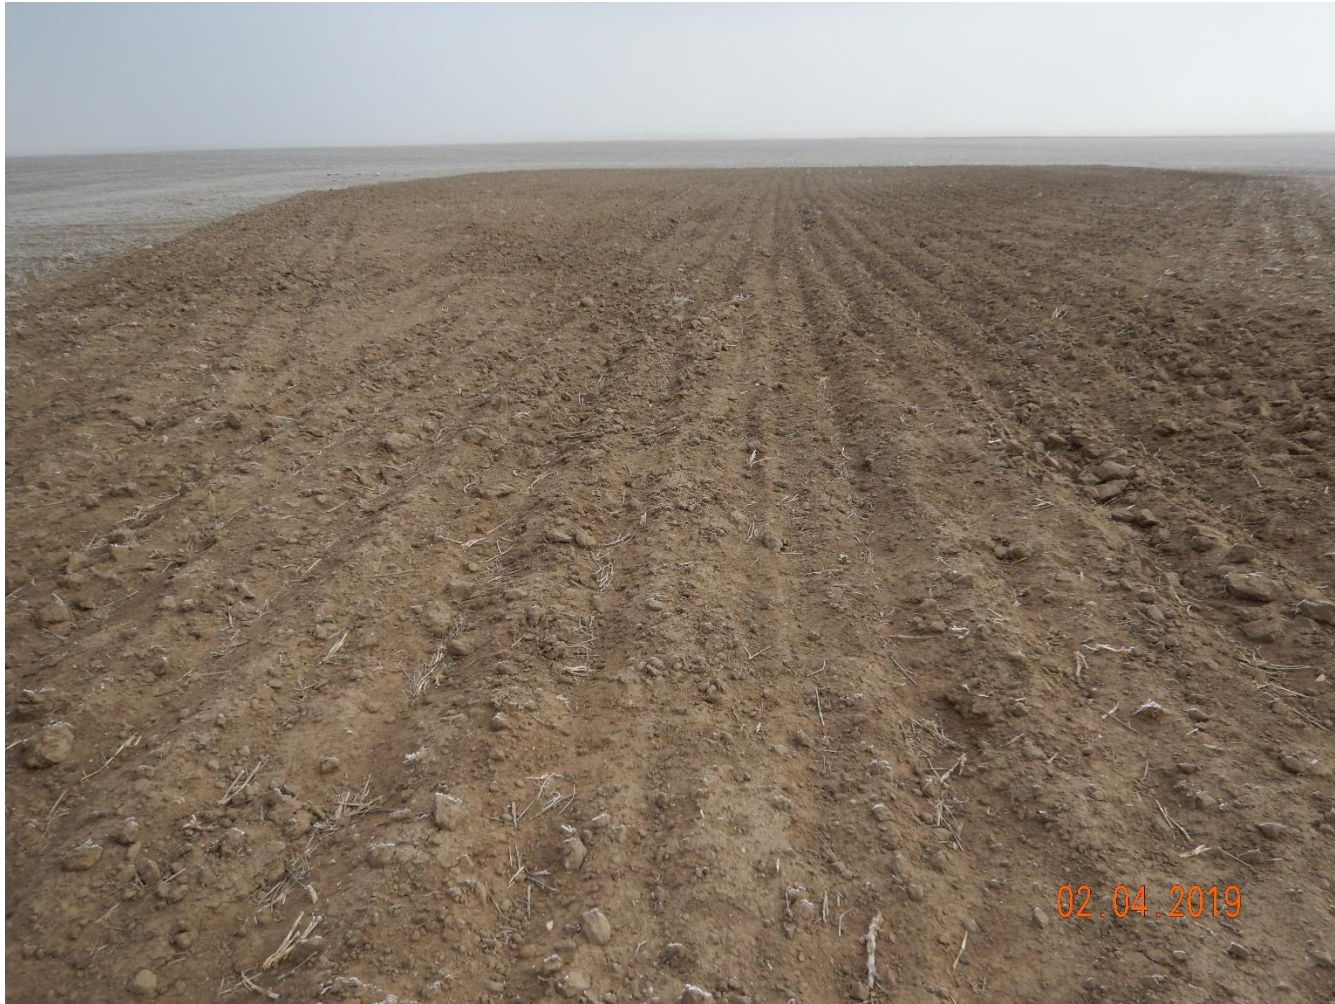
Photo 1: Photo taken from the west end of the location, facing east. Previous inspection documented that location had not been cross-ripped in accordance to COGCC 1000 series rules. Photo shows location remains unchanged since previous inspection; compaction alleviation has not been conducted in accordance with reclamation requirements.

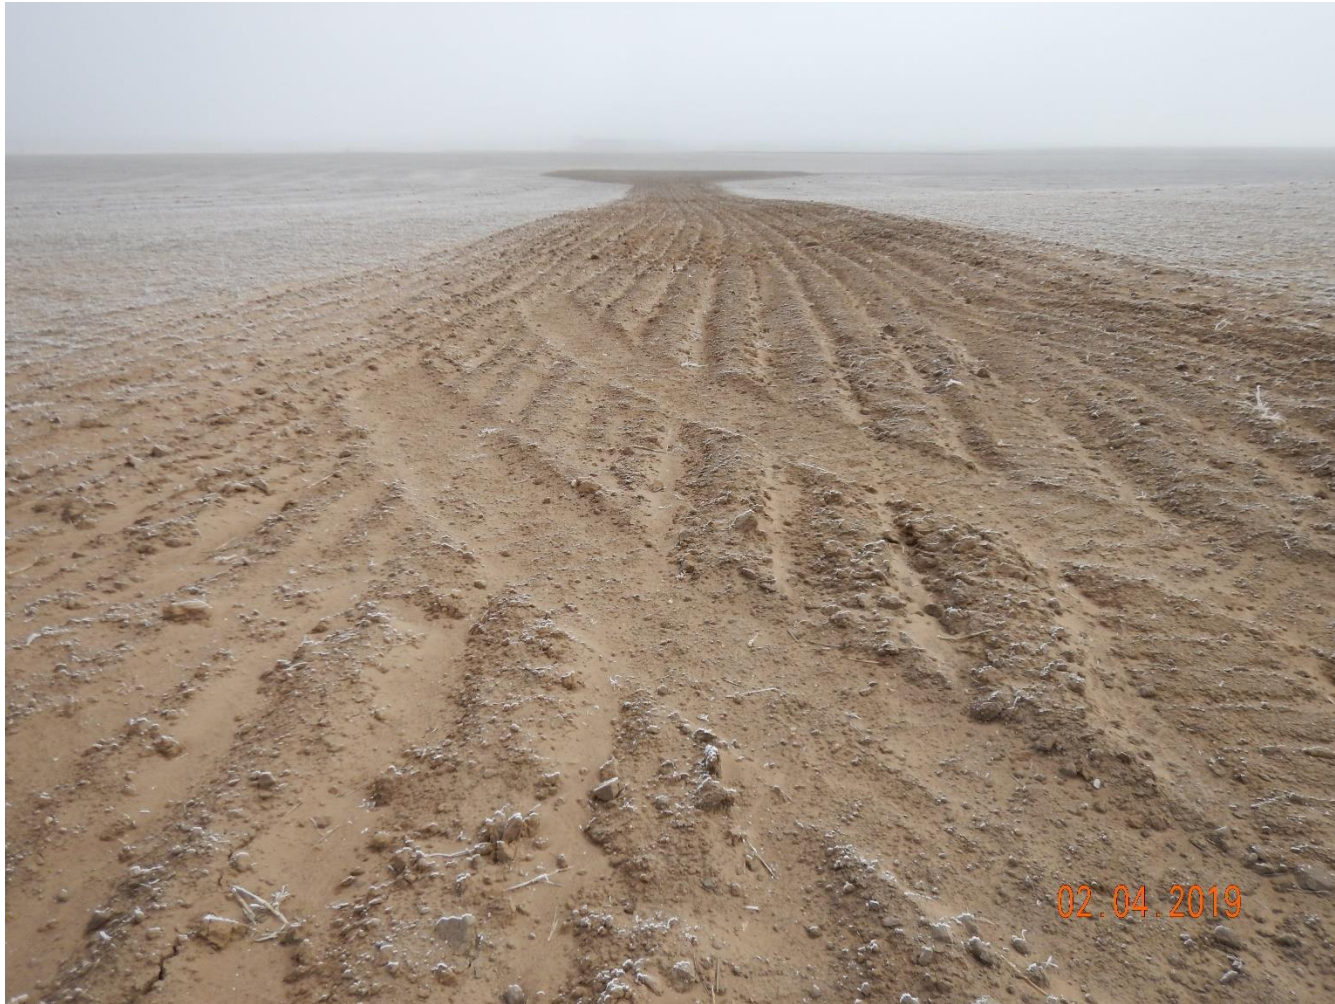
Photo 2: Photo taken from the access road, facing east. Access road appears unchanged since previous inspection; Unable to find evidence that compaction alleviation has been conducted in accordance with 1004.a on access road.
