Williams 16" Pipeline Spill Status Update – January 20, 2019.

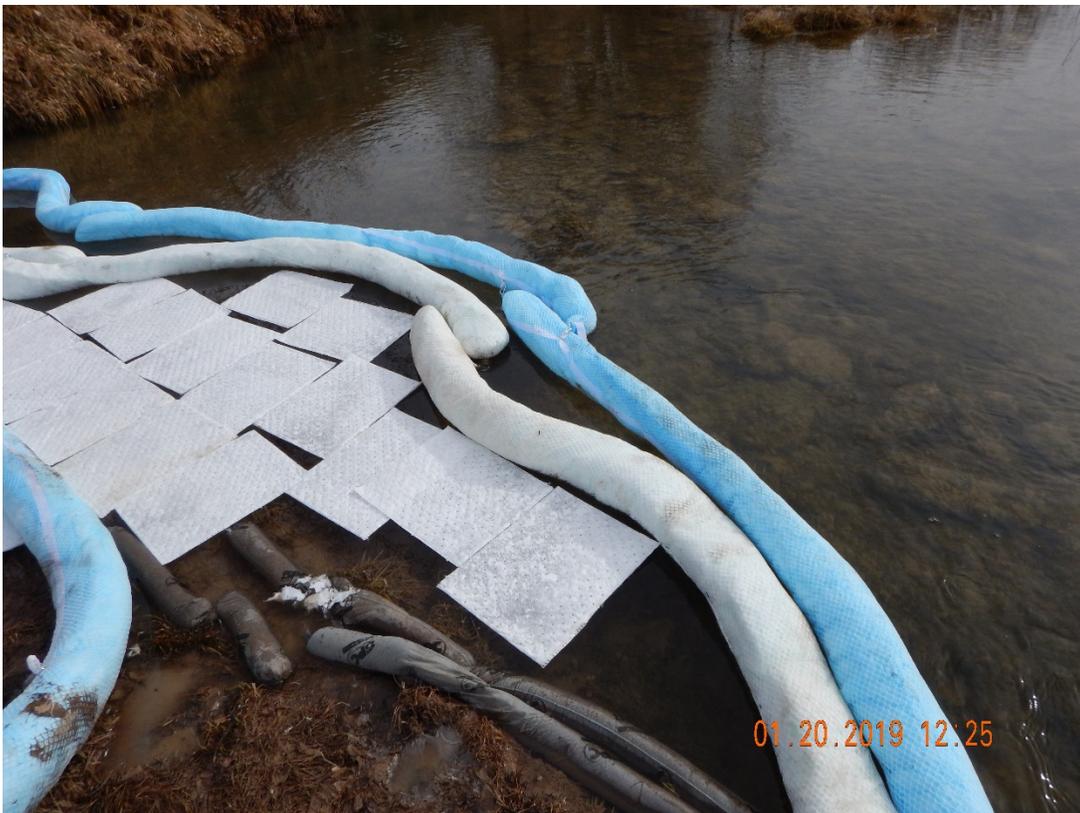
- No visible sheen or hydrocarbon odors were observed at the Parachute Creek confluence area (i.e., where surface runoff from impacted areas had entered the creek). Photo below.

Booms located at confluence area of Parachute Creek.

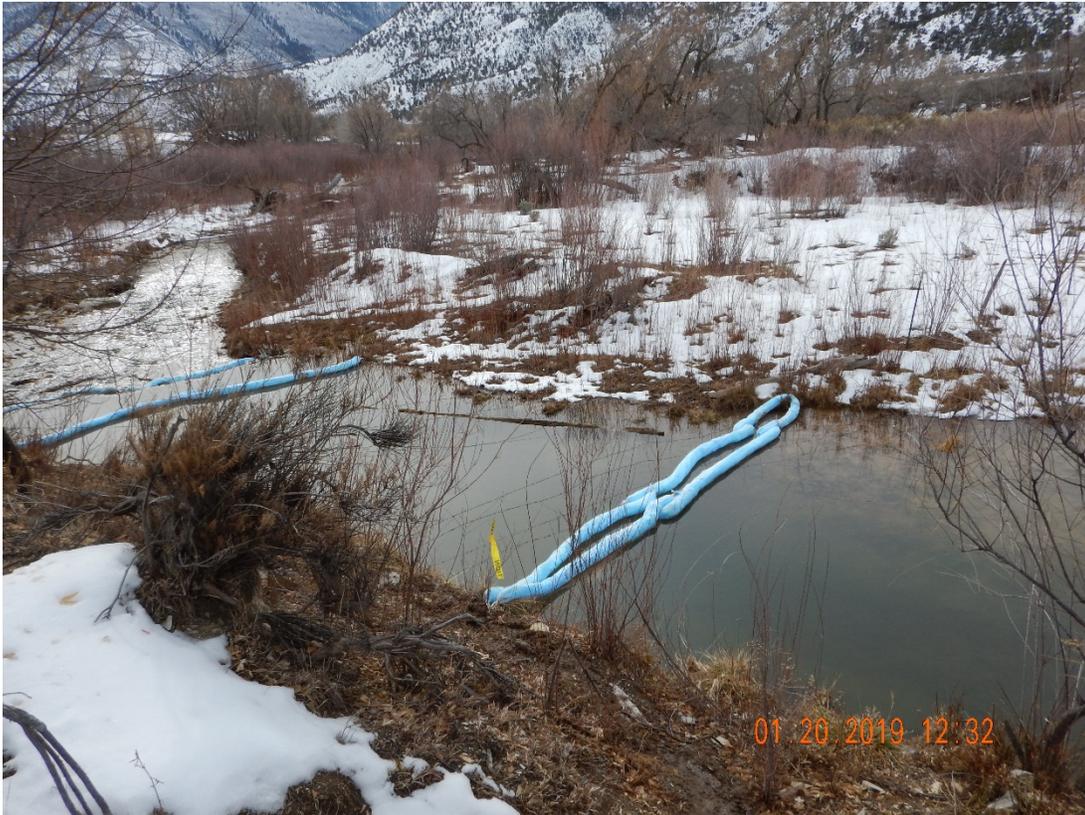
Additional booms installed downstream from confluence area
