GOLDEN EAGLE 30-14 API # 05-071-08650 - TIMBER CREEK
OGCC OPERATOR NUMBER 10672 DATE: FEBRUARY 19, 2019
CORRECTIVE ACTIONS COMPLETED REGARDING COGCC FIR DOCUMENT # 688401124

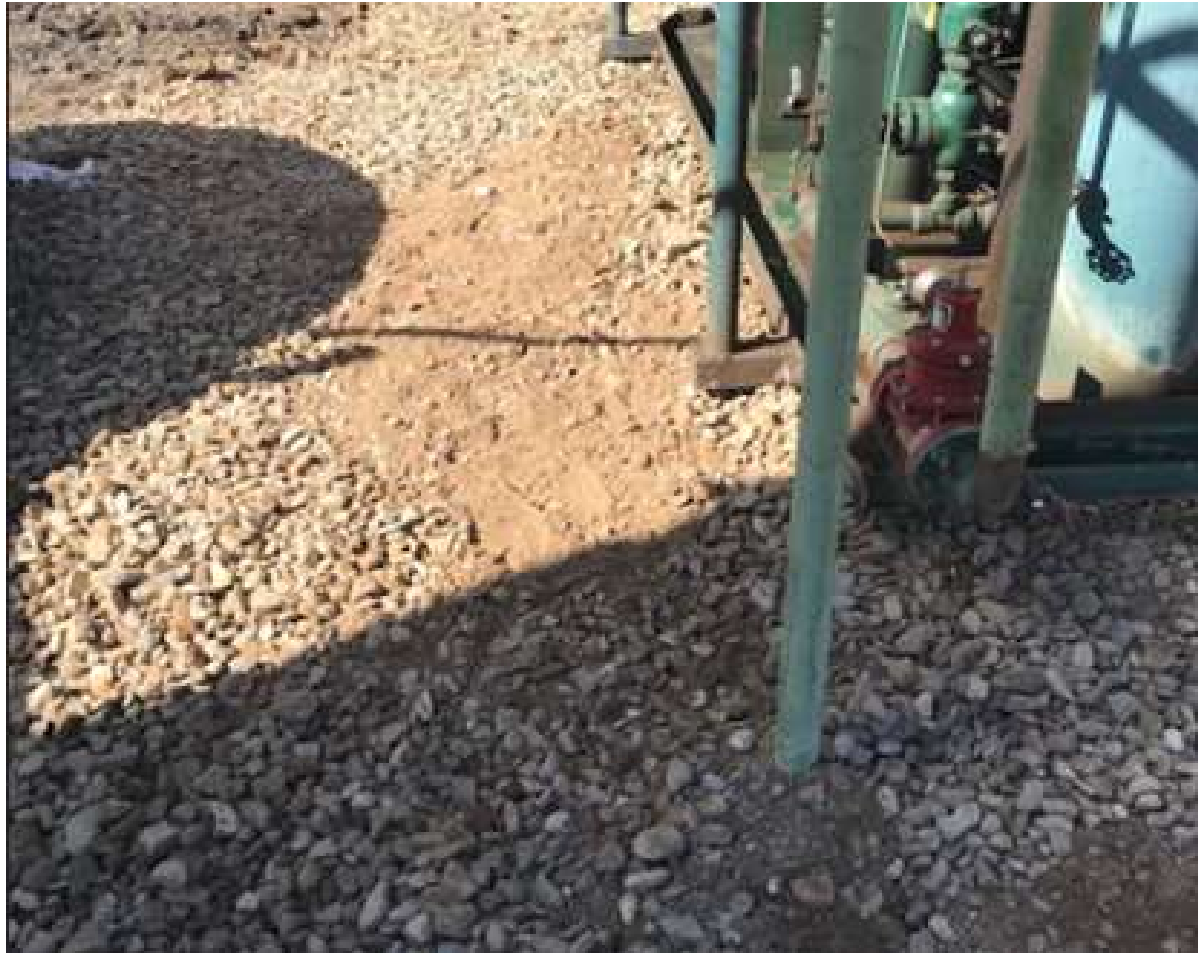
PHOTO 1: THE STAINS ON THE GROUND AROUND THE LIQUID RING HAVE BEEN REMOVED.

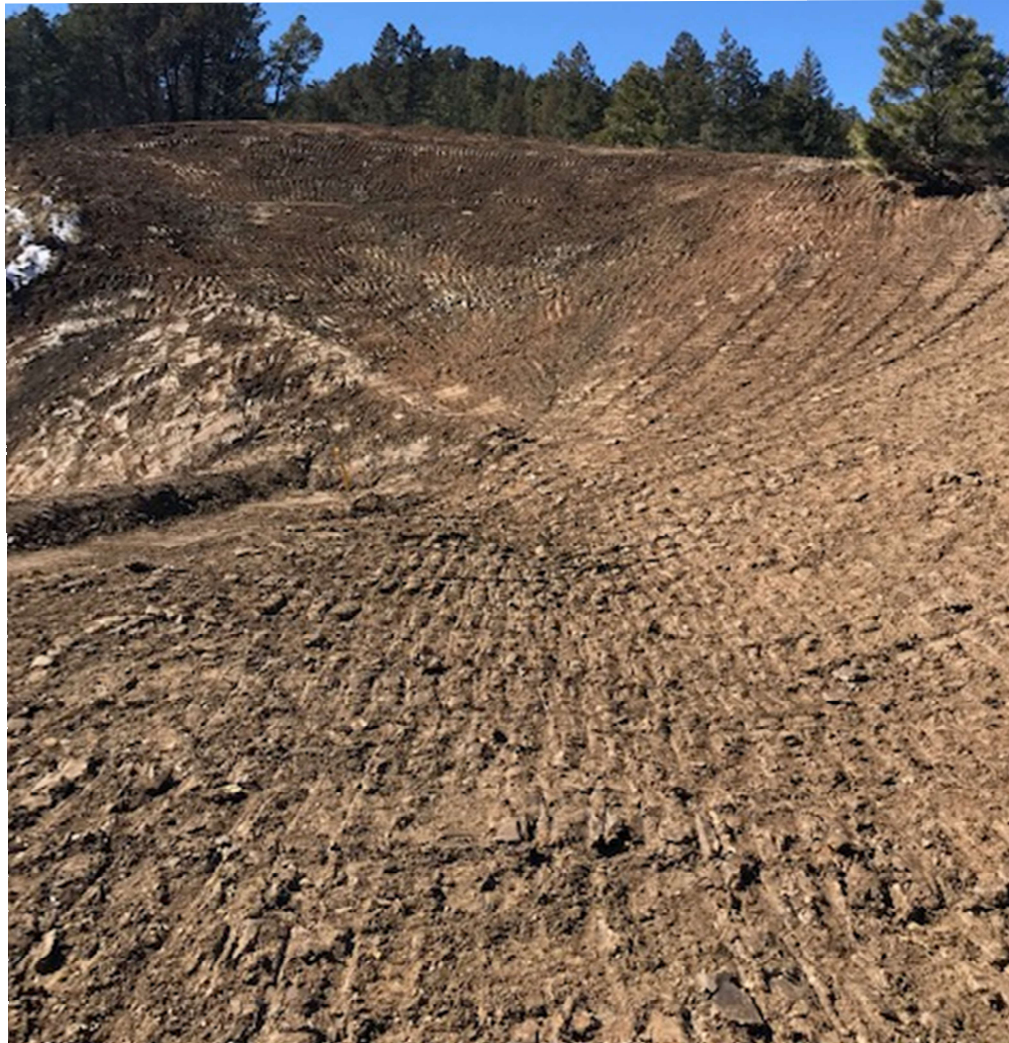
PHOTO 2: THE MATERIAL FROM THE PORTION OF THE CUT SLOPE THAT SLOUGHED OFF WAS REGRADED BACK TO THE ORIGINAL GRADE. GRADING TECHNIQUES WERE INSTALLED ON THE CONTOUR FOR TEMPORARY SOIL STABILIZATION. THE DISTURBED SOIL ON THE CUT SLOPE WILL BE HYDRO-SEEDED USING THE APPROVED COLORADO PARKS AND WILDLIFE SEED/SCRUB MIX, ALONG WITH FERTILIZER, SOIL ENHANCER & FLEXTERRA FLEXIBLE GROWTH MEDIUM DURING THE NEXT FAVORABLE GROWING SEASON.

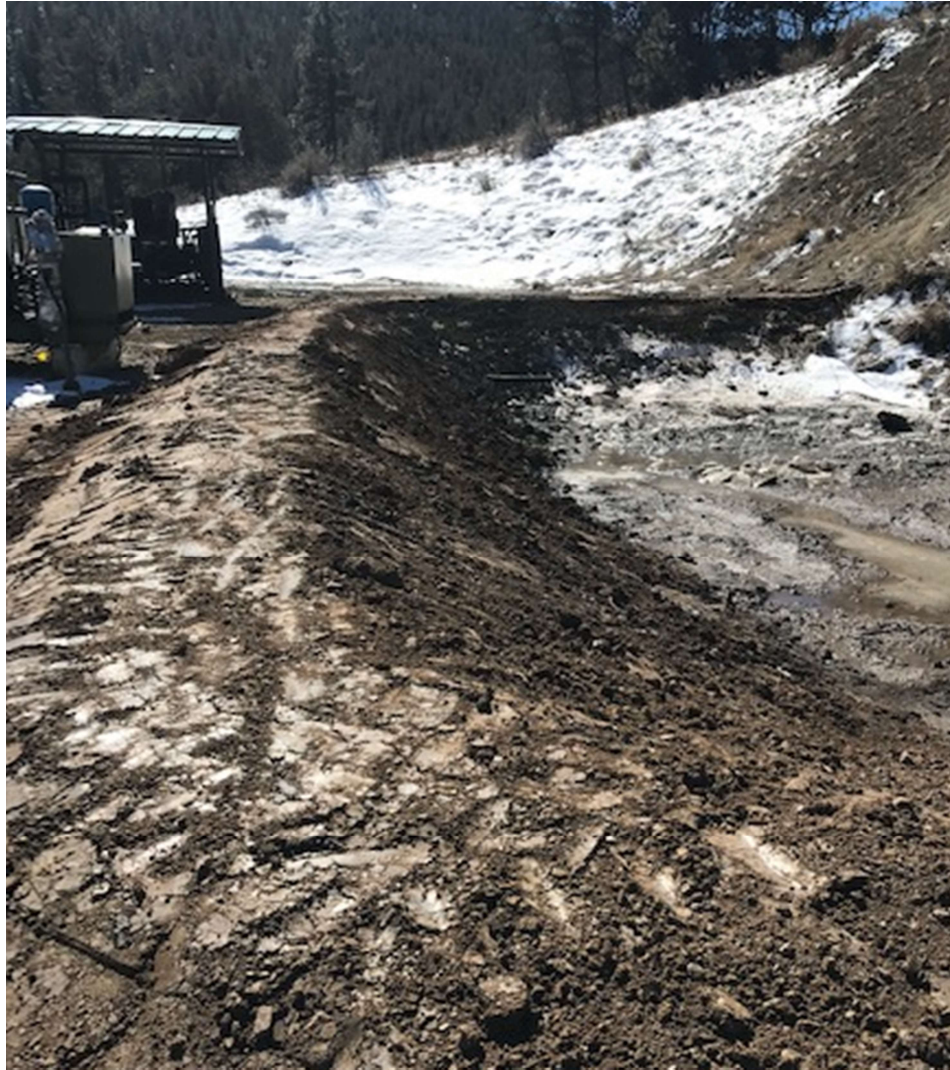
PHOTO 3: THE DIRT BERM SURROUNDING THE PRODUCTION PIT WAS DOMINATED.

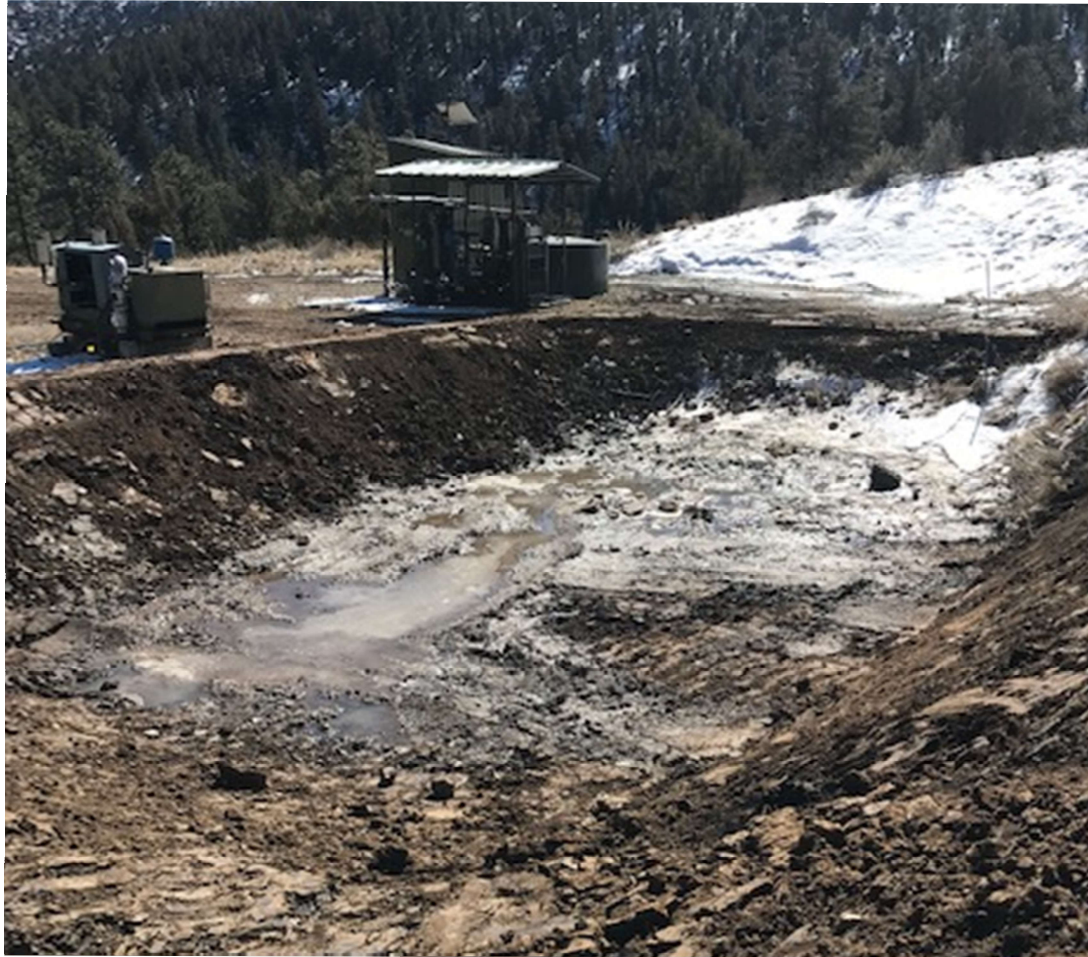
PHOTO 4: THE SOIL THAT SLOUGHED OFF INTO THE PIT WAS REMOVED.
