# Final Reclamation and Stormwater Inspection

Operator: NOBLE ENERGY INC # 100322

Location ID: 328587

Weld County, CO

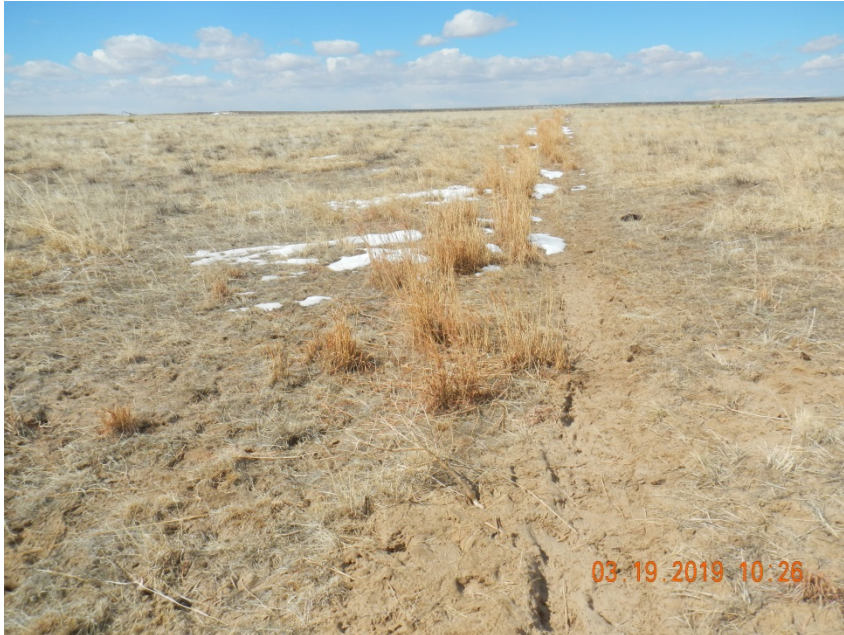
**Photo 1.** Photo taken from the access road, facing West. Appears Operator has performed final reclamation activities along the access road and location with native perennial grass establishment in some areas.

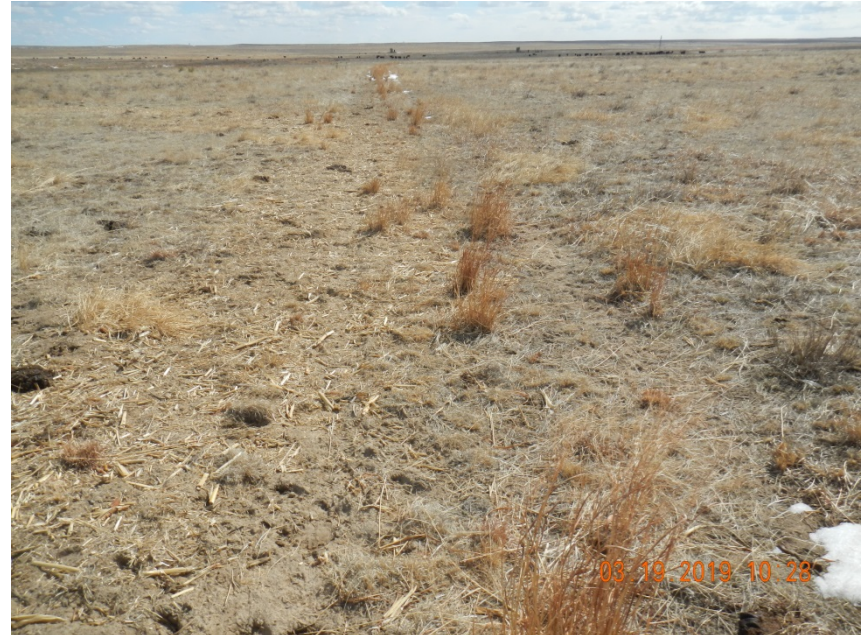
**Photo 2.** Photo taken from the access road, facing East. Photo depicts the removal of all equipment has been performed. However it appears the well location is not reflective of the adjacent reference crop areas.

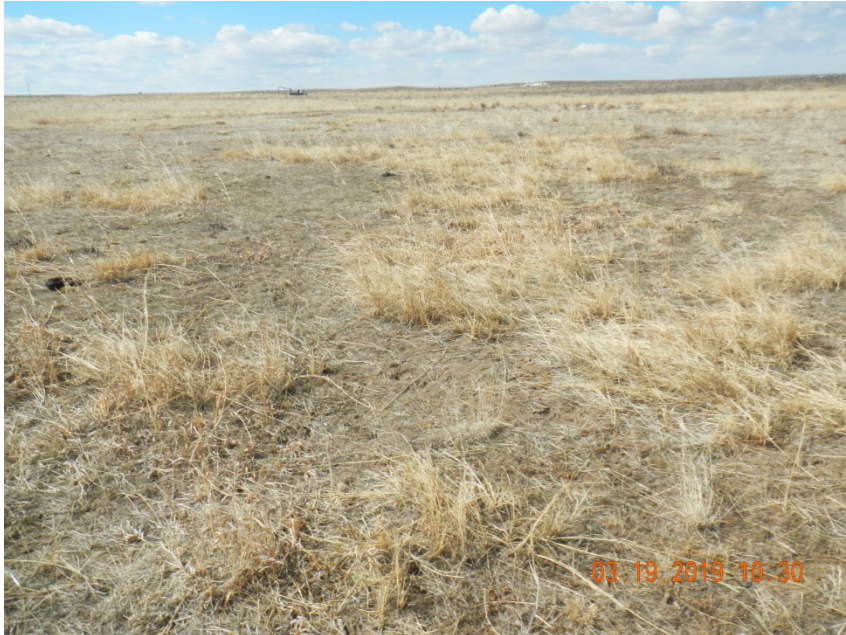
**Photo 3.** Photo taken from the location, facing East. Photo depicts the removal of all equipment has been performed. However the reclamation is not at percent cover and has non-uniform establishment of perennial cover. The Photo depicts the presence of undesirable species including but not limited to cheatgrass.

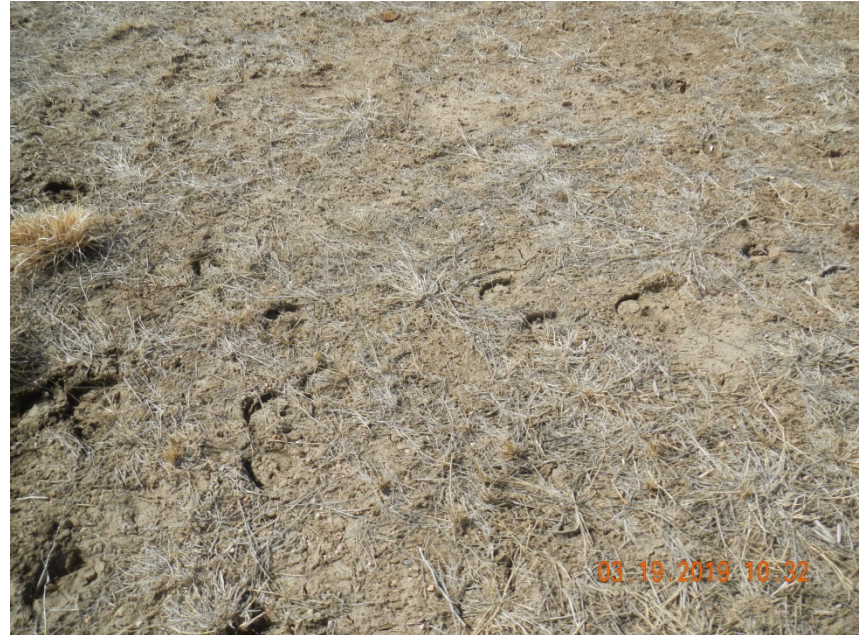
**Photo 4.** Photo taken from the location, facing South. See comments from Photo 3.
