Inspection Photos

Location Name: APACHE CANYON 25-04

API #: 05-071-06133

Insp. Doc. # 695100502

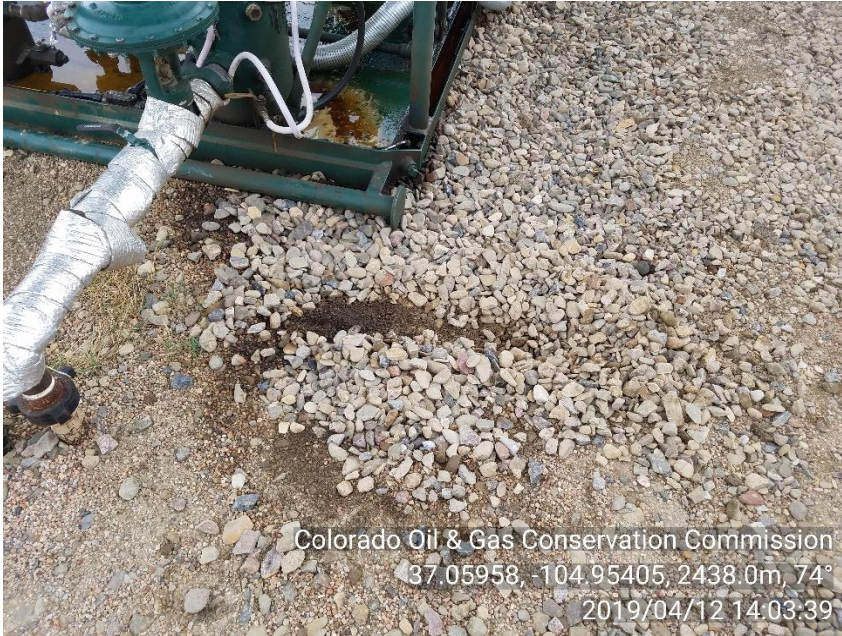
PHOTO 3: IT APPEARS THAT THERE WAS AN ATTEMPT TO REMOVE SOME IMPACTED SOIL IN THE NEAR PAST AS THERE IS SOIL REMOVED FROM THE SOUTH SIDE OF COMPRESSOR SKID BUT AS SHOWN IN THIS PHOTO SOME OF THE IMPACTED SOIL WAS NOT REMOVED AND WAS COVERED UP WITH CLEAN GRAVEL.

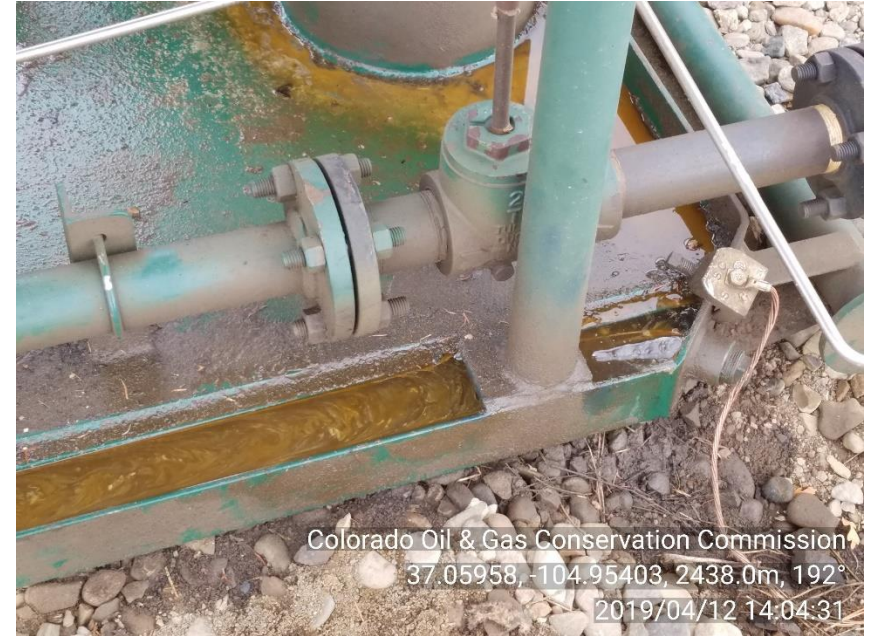
PHOTO 4: COMPRESSOR SKID CONTAINMENT IS FULL OF OILY WATER AND IS SPILLING OVER ON LOCATION IMPACTING SOIL ON NORTHWEST CORNER OF COMPRESSOR SKID.
