**Inspection Photos**  
**Location Name: Shannon-Roberts #1A**  
**Location ID: 321499**

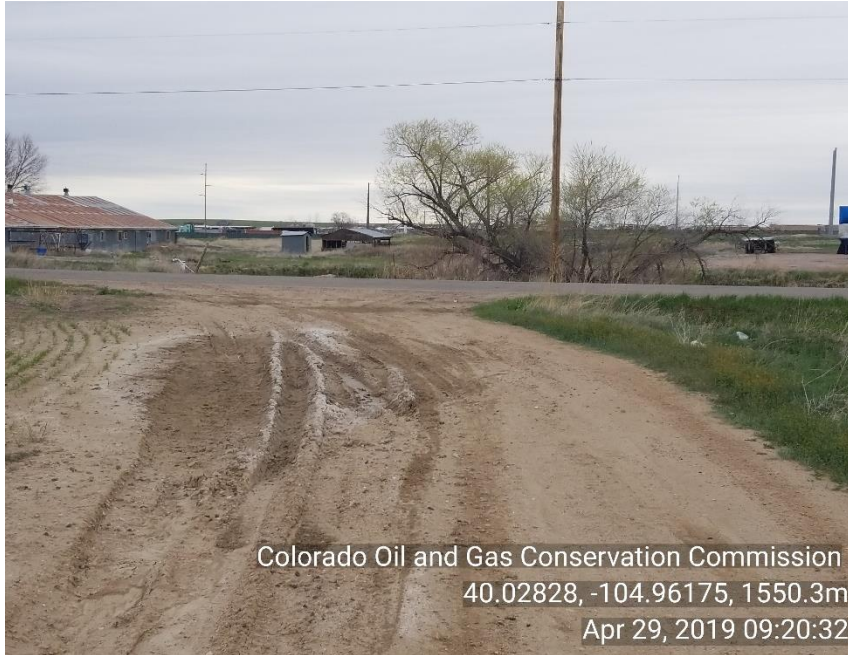
**Photo 1 No tracking pad at entrance to location. Possibility of tracking sediment on to county road. Deep ruts on in road at time of inspection.**
