Final Reclamation Inspection

Operator: NOBLE ENERGY INC - #100322

Location ID: 329929

Inspection Photos
Location Name: UPV #23-714
Location ID: 329929

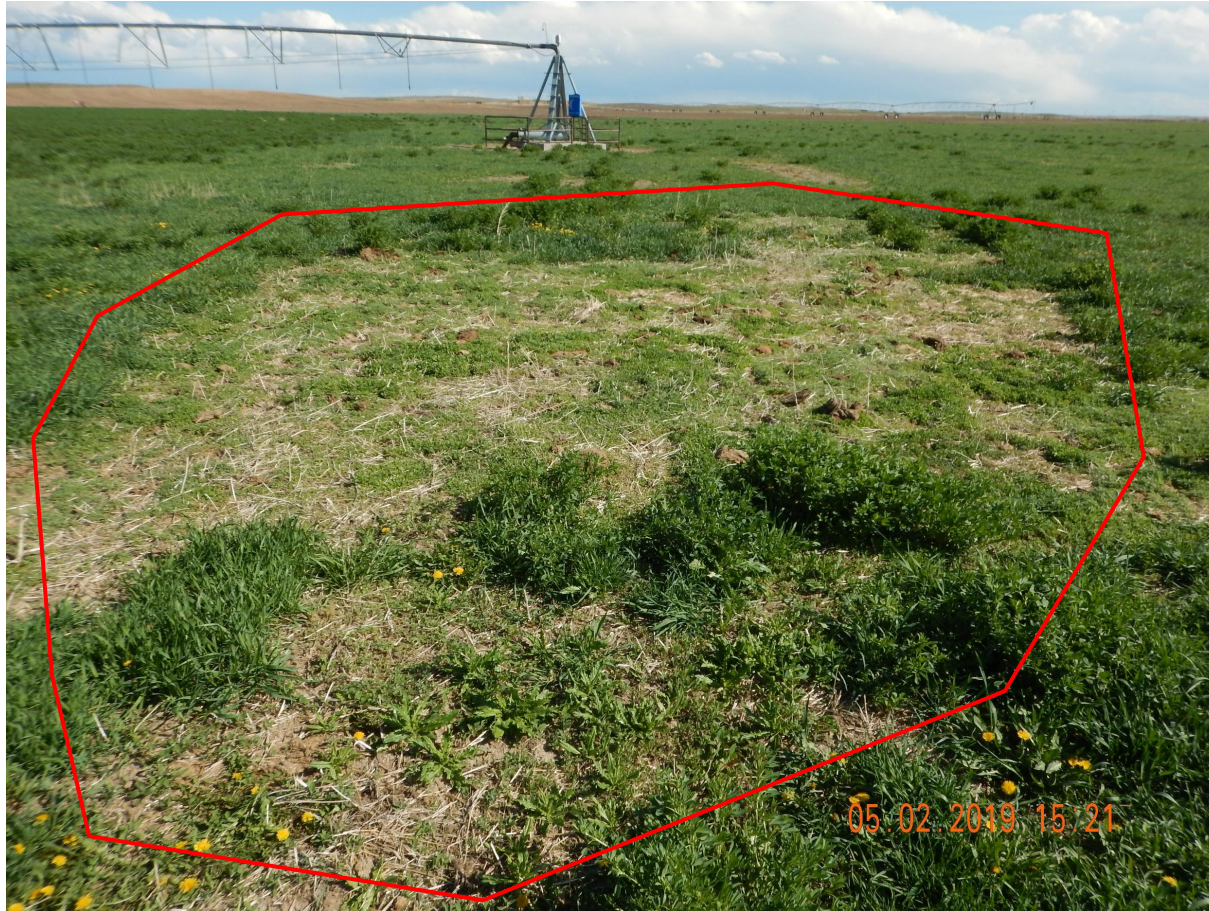
Photo 1. Photo taken within the PA well location, facing South. Well location does not meet Rule 1004 standards. There was little, to no, desirable vegetation observed at the well location.

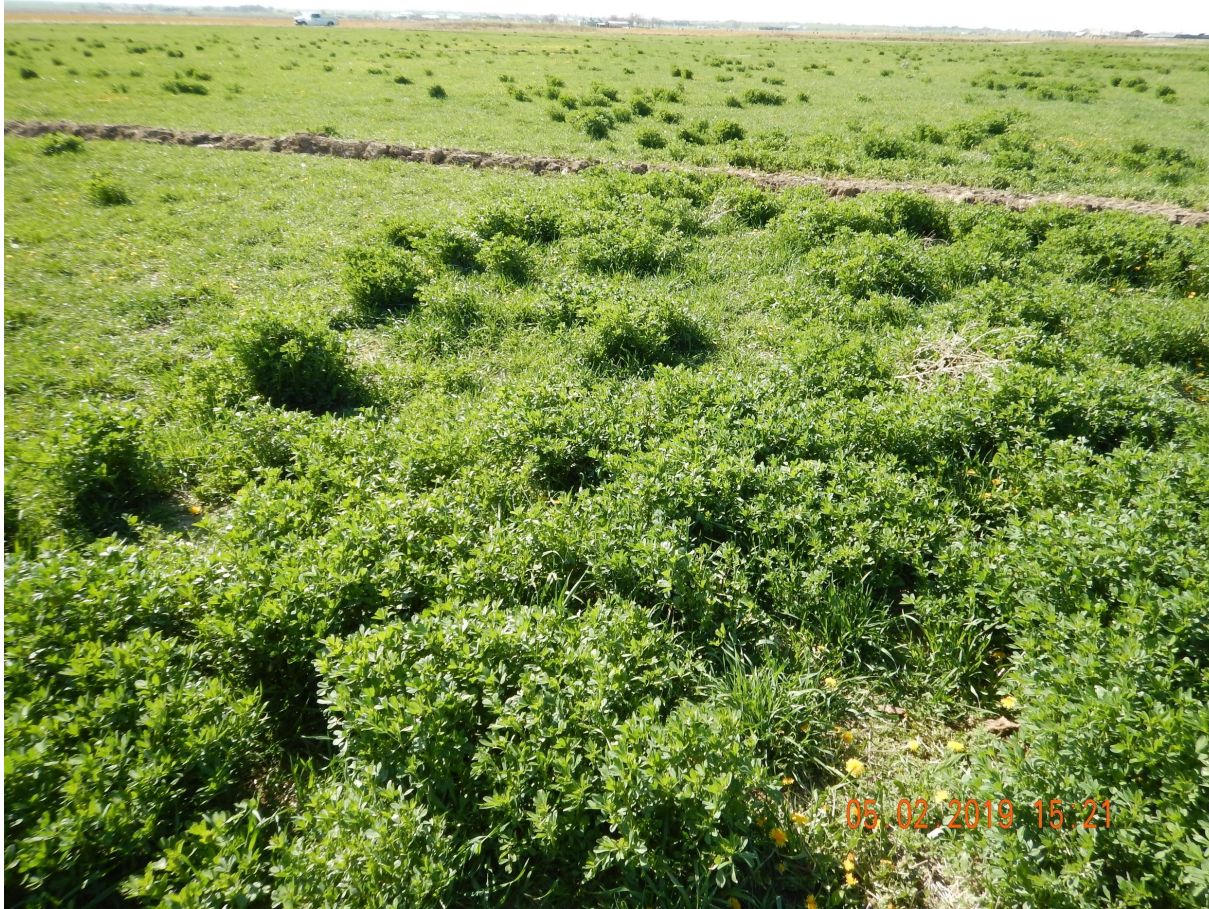
Photo 2. Reference photo taken just west of the PA well location, facing West. See comments under Photo 1.
