Final Reclamation Inspection

Operator: KERR MCGEE OIL & GAS ONSHORE LP #47120

Location ID: 333204

Inspection Photos
Location Name: GRANT BROTHERS 41-11 #1
Location ID: 333204

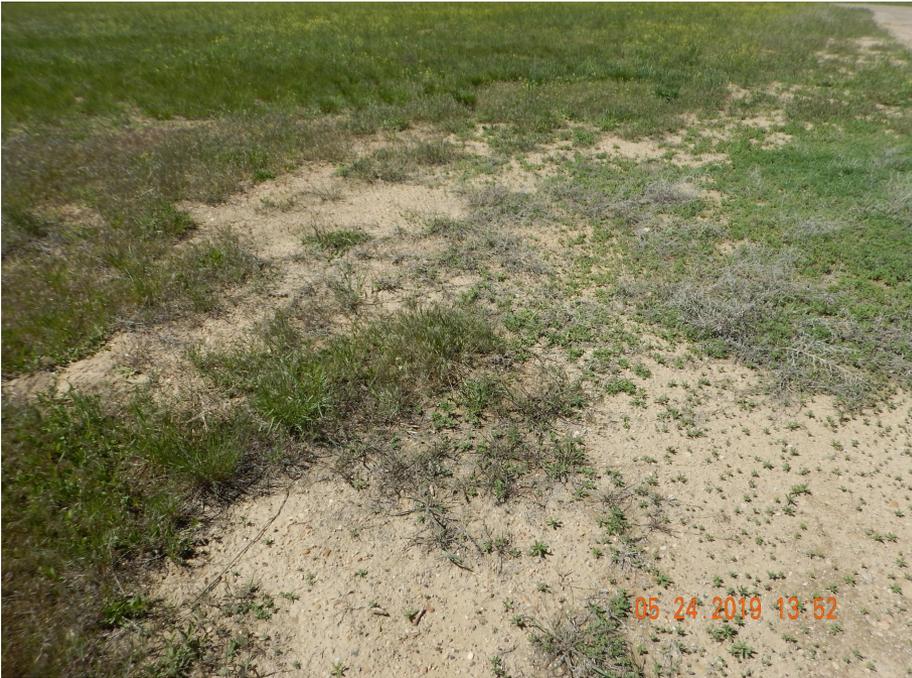
Photo 1. Photo taken from the well location, facing North. This location is not in compliance with Rule 1004 vegetative standards, as there are bare patches with weedy, annual vegetation (Kochia).

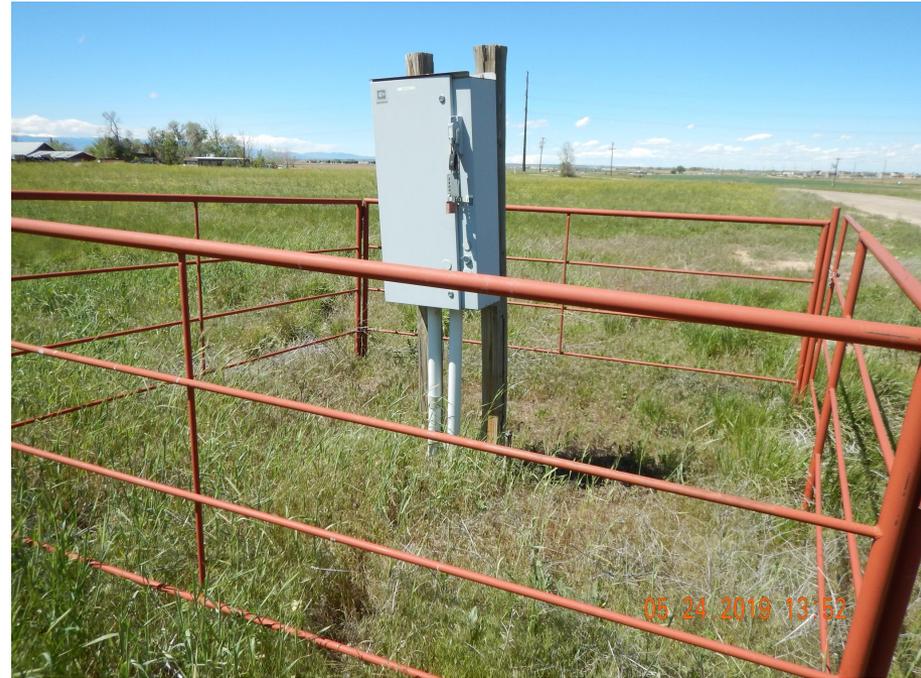
Photo 2. Photo taken from the well location, facing South. Operator has failed to remove all equipment from location.

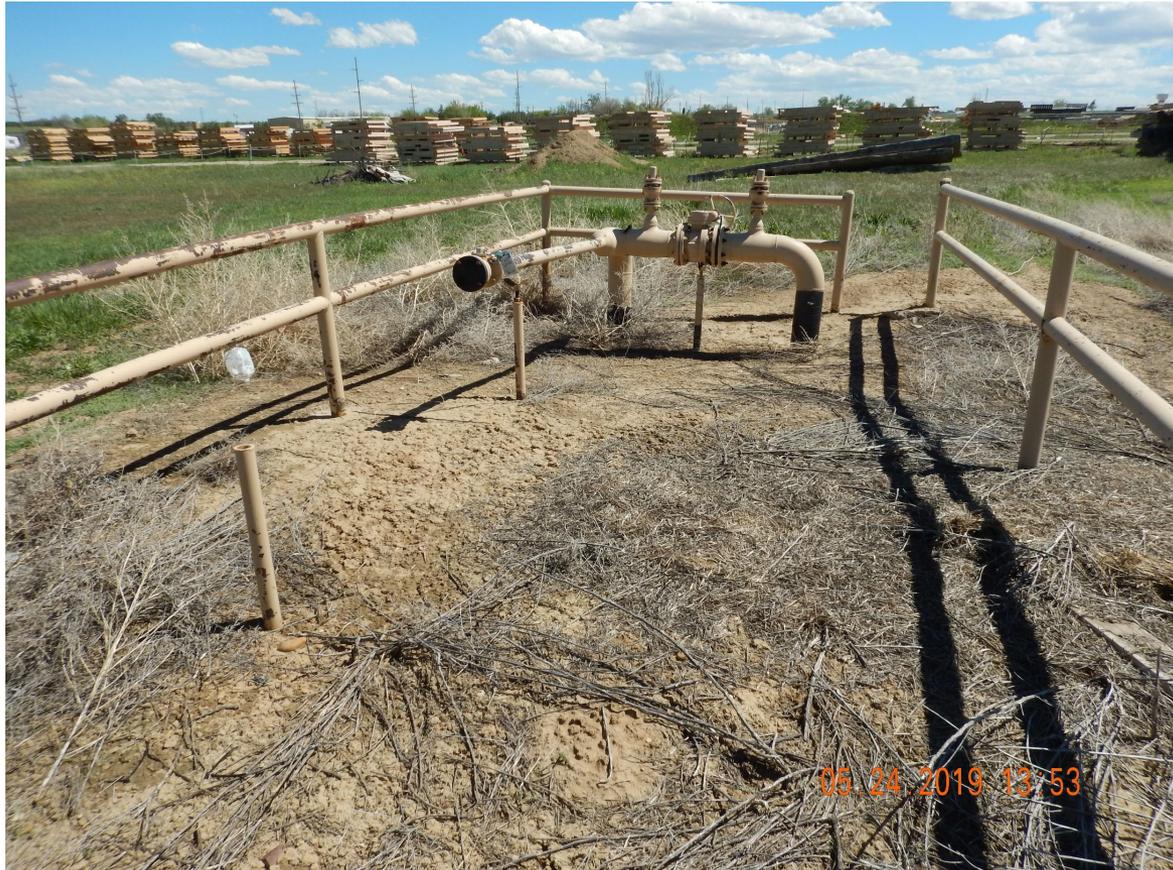
Photo 3. Photo taken from the tank battery location, facing South. Operator has failed to remove equipment from location.

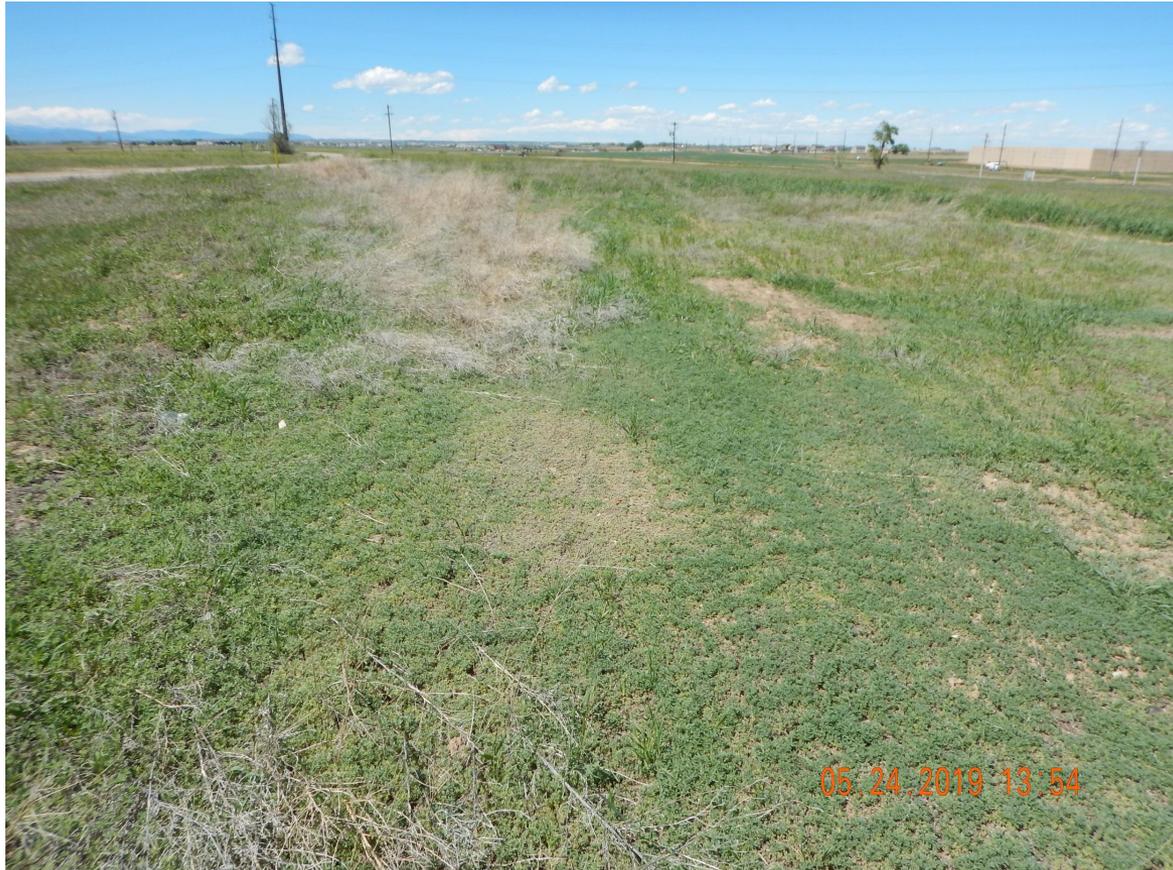
Photo 4. Photo taken from the tank battery location, facing North. This location is not in compliance with Rule 1004 vegetative standards, as the location is dominated by weedy, annual vegetation (Kochia).
