Final Reclamation Inspection

Operator: KERR MCGEE OIL & GAS ONSHORE LP #47120

Location ID: 333204

Inspection Photos
Location Name: WINFREY #41-11
Location ID: 333204

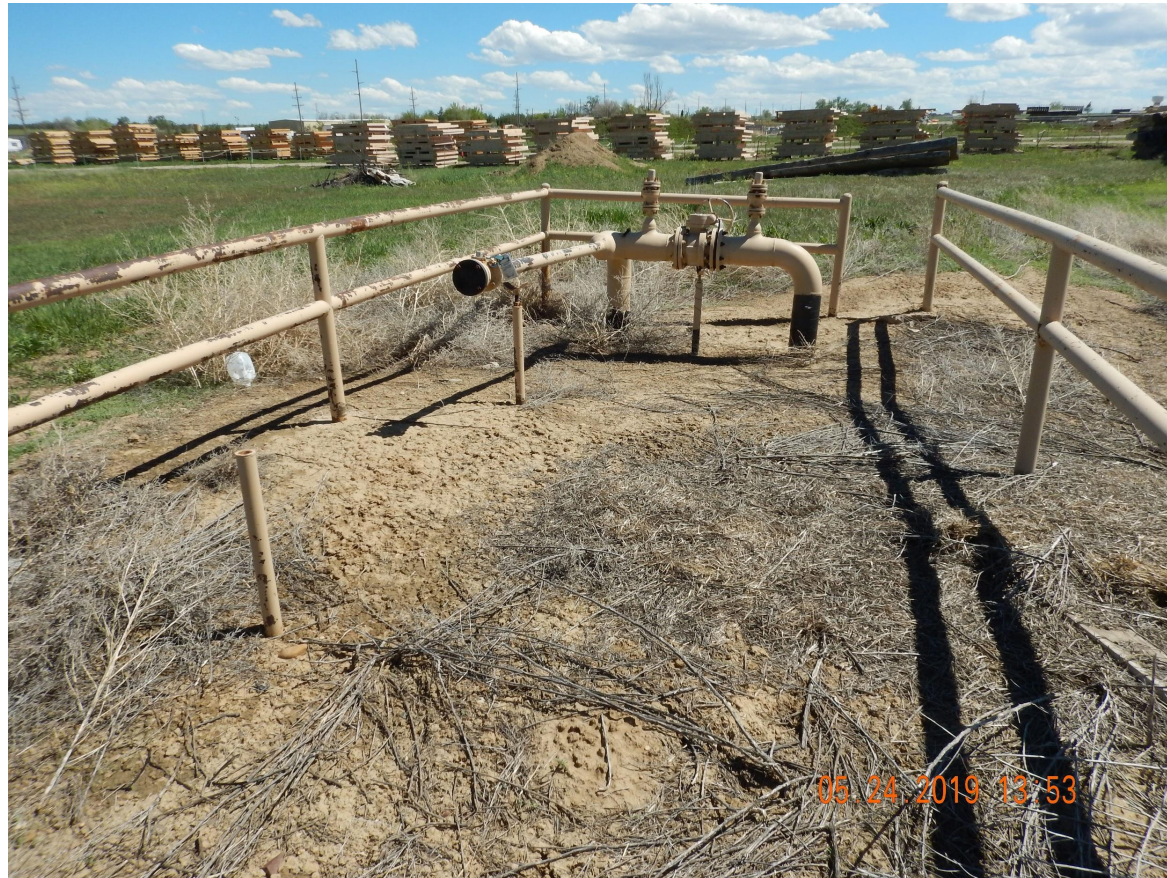
Photo 1. Photo taken from the tank battery location, facing South. Operator has failed to remove equipment from location.

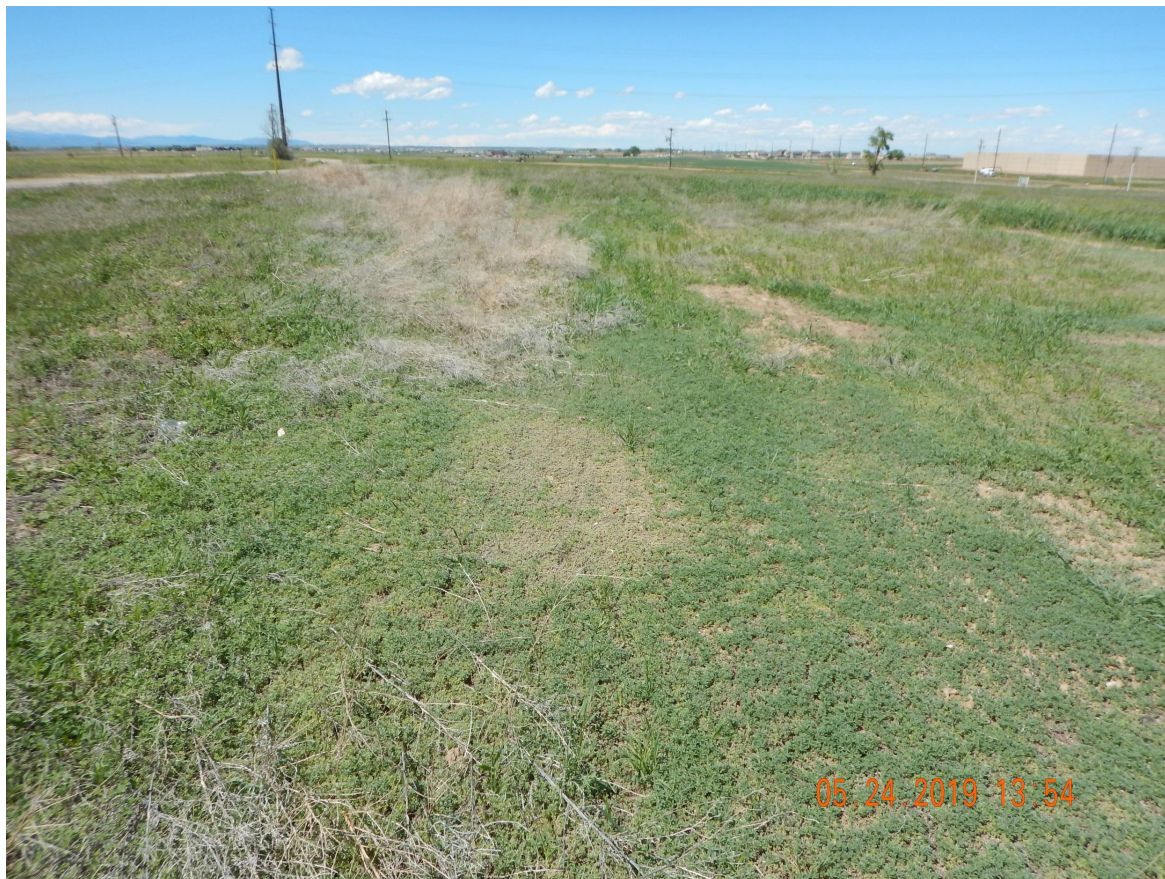
Photo 2. Photo taken from the tank battery location, facing North. This location is not in compliance with Rule 1004 vegetative standards, as the location is dominated by weedy, annual vegetation (Kochia).
