Huber #3-24

Corrective Actions Taken on the Huber #3-24 for the COGCC compliance
INC.

Huber #3-24
07/01/19

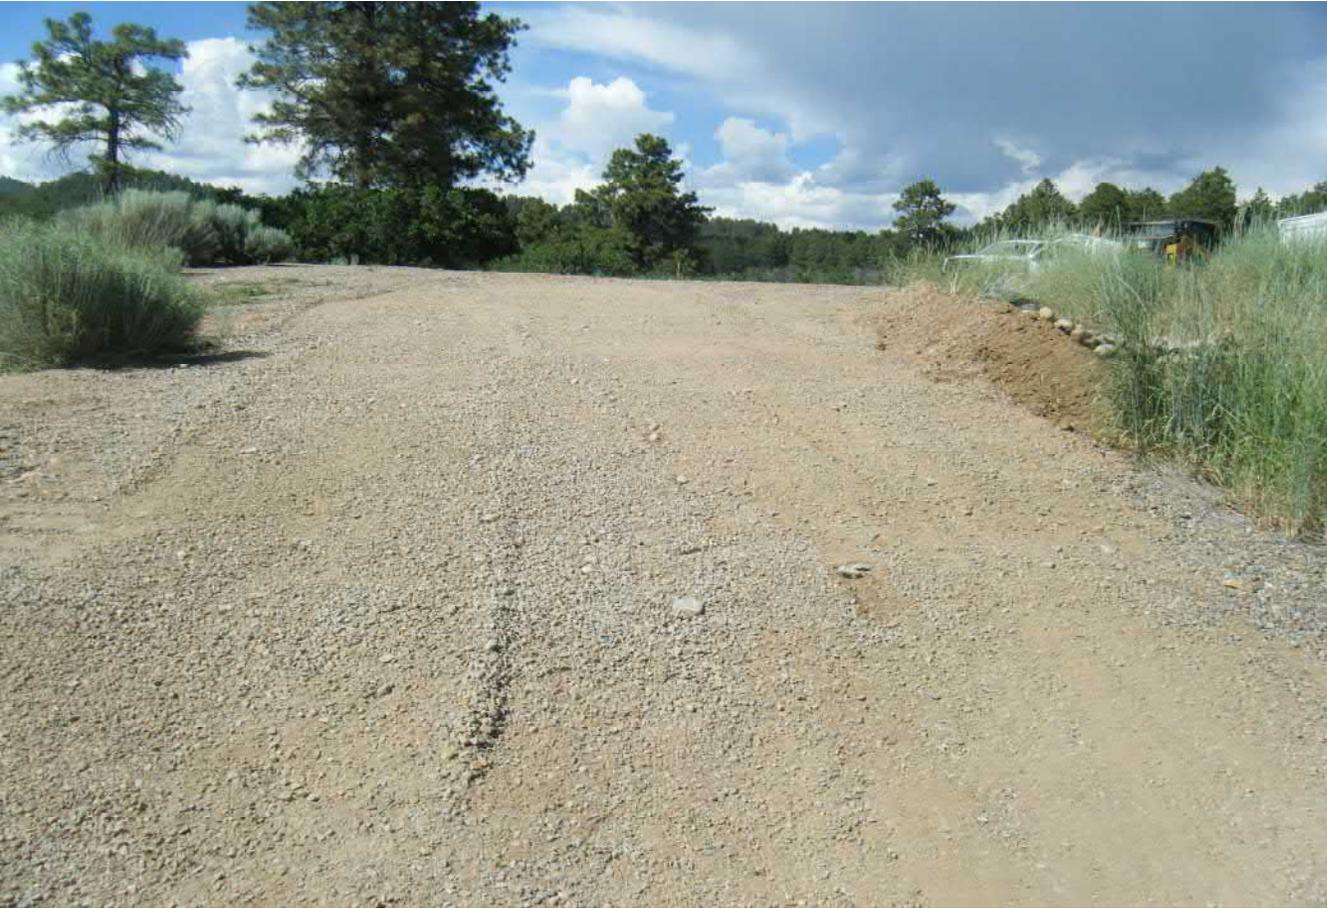
View of access road looking north.

Storm Water management controls have been established to stabilize erosion along western edge of access road. Check dams and diversions were installed to control water run off from location.

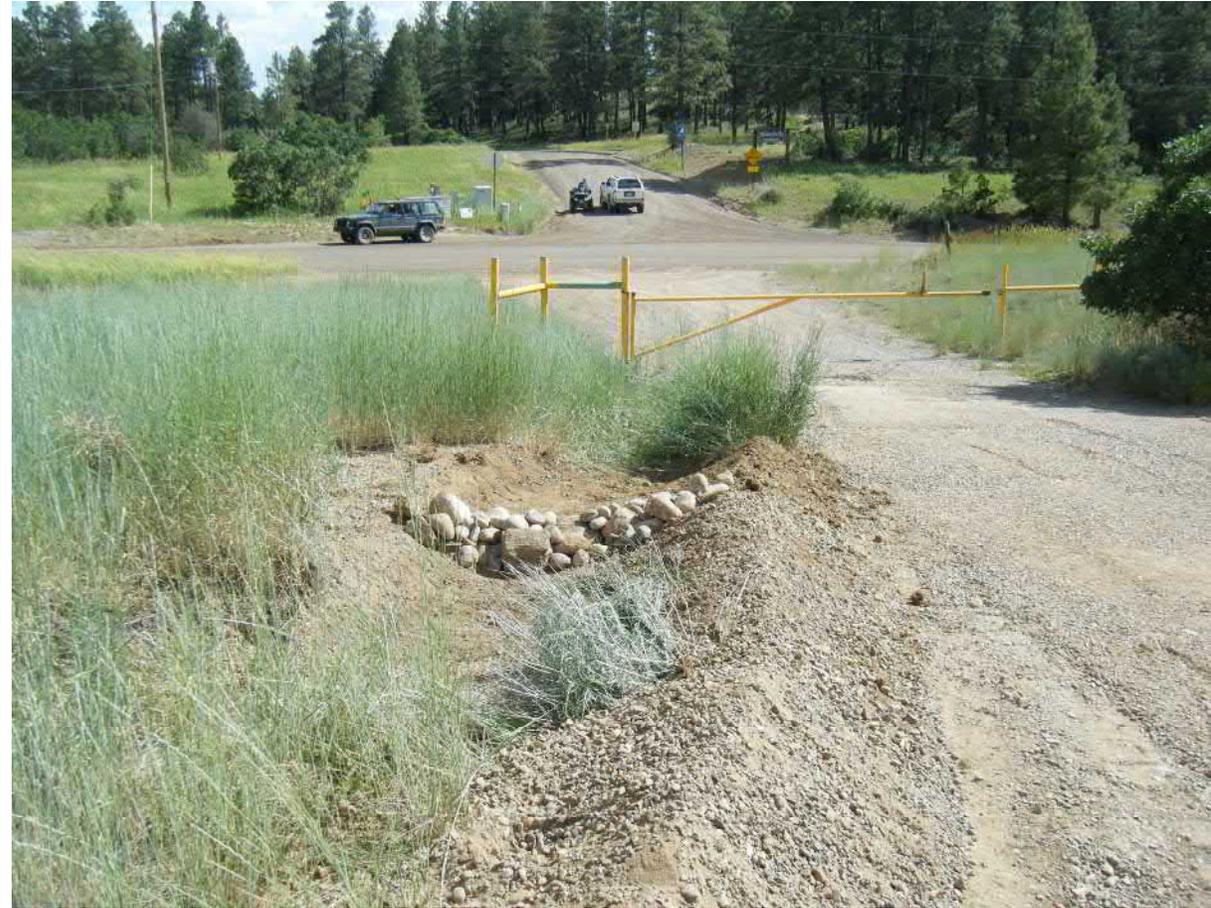
View of check dam and diversion looking south.

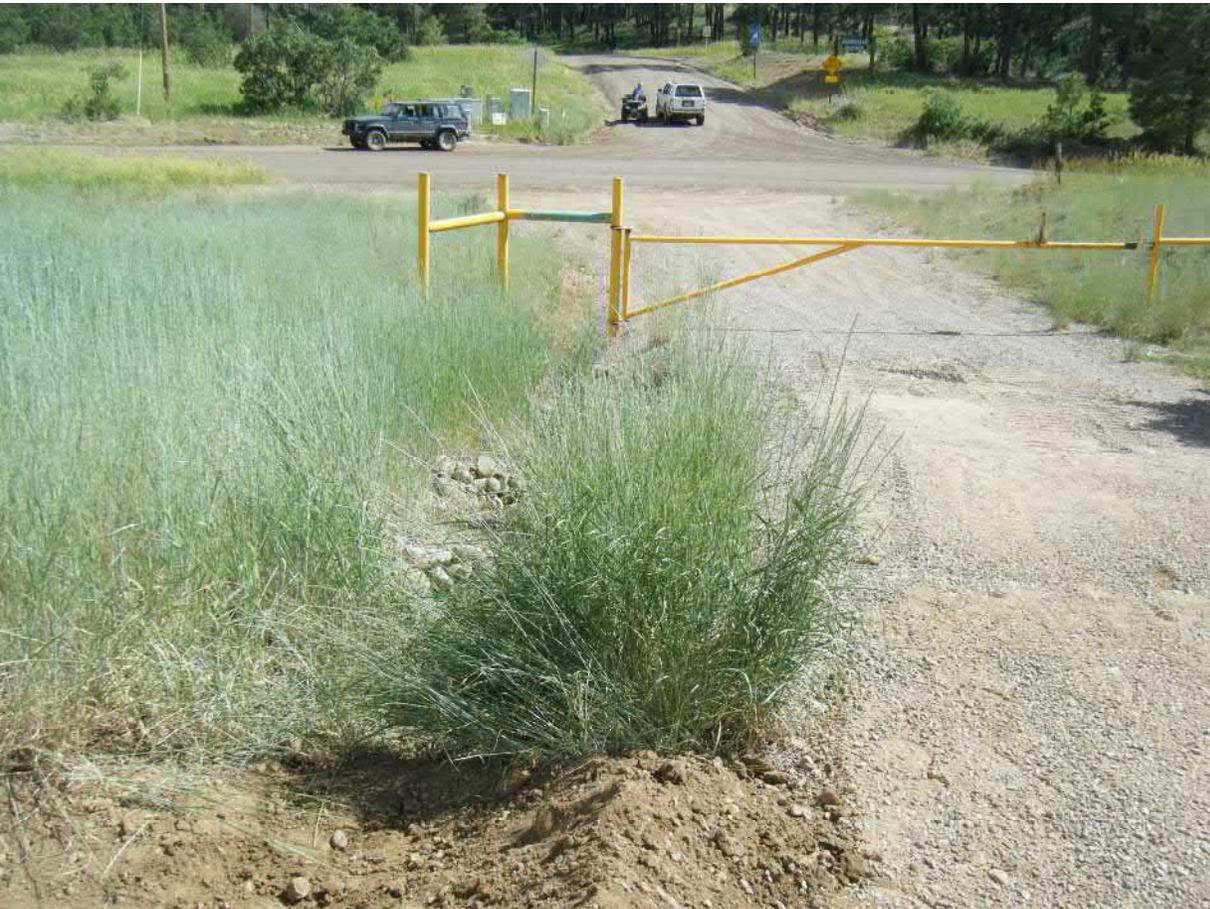
View of check dams and diversion looking south.

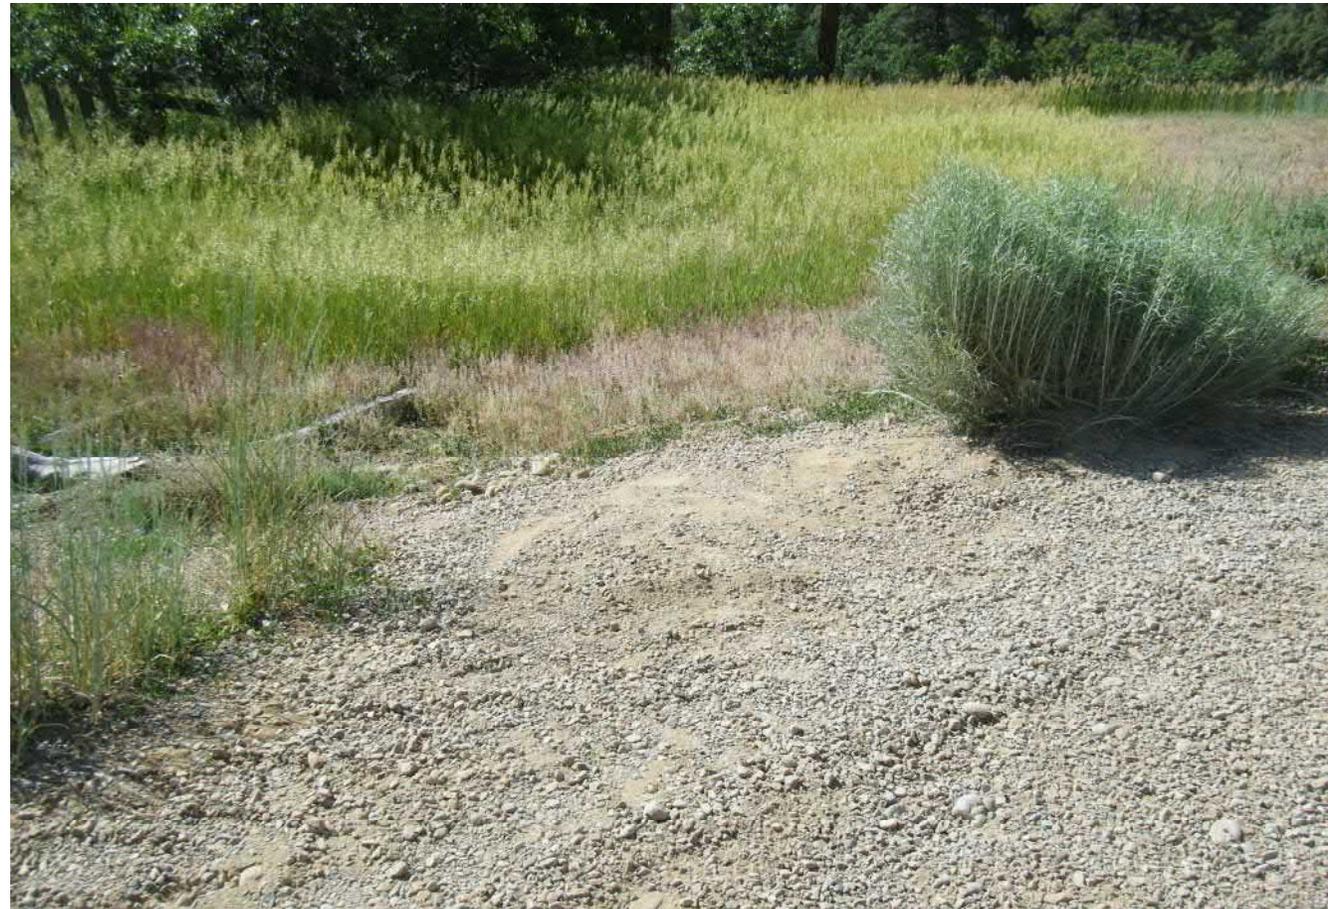
View of western edge of access road.
