Final Reclamation Inspection

Operator: PDC ENERGY INC - 69175

API: 05-123-21351

Inspection Photos
Location Name: ZIMMERMAN #14-17
API: 05-123-21351

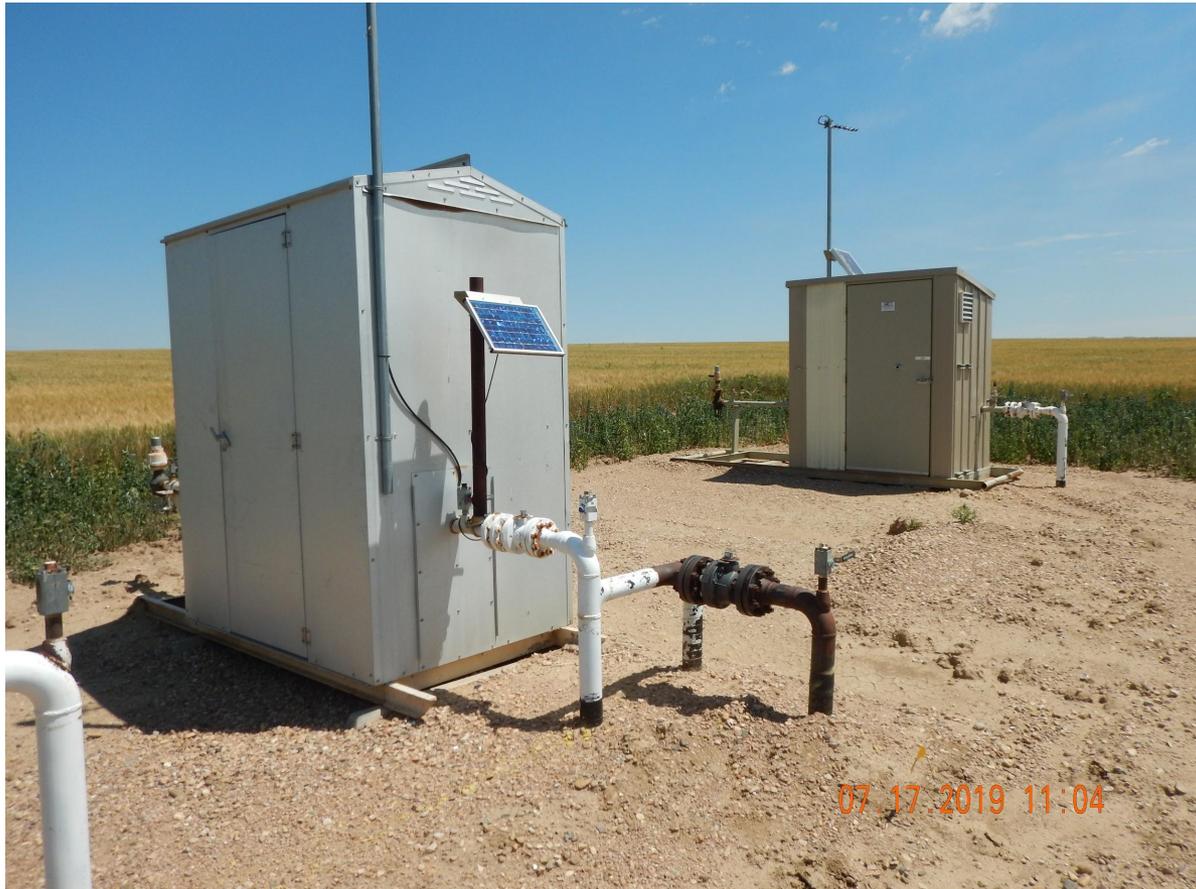
Photo 1. Photo taken from the associated tank battery, facing East. This appears to be shared tank battery with Kerr McGee. Operator has failed to remove their meter shed.

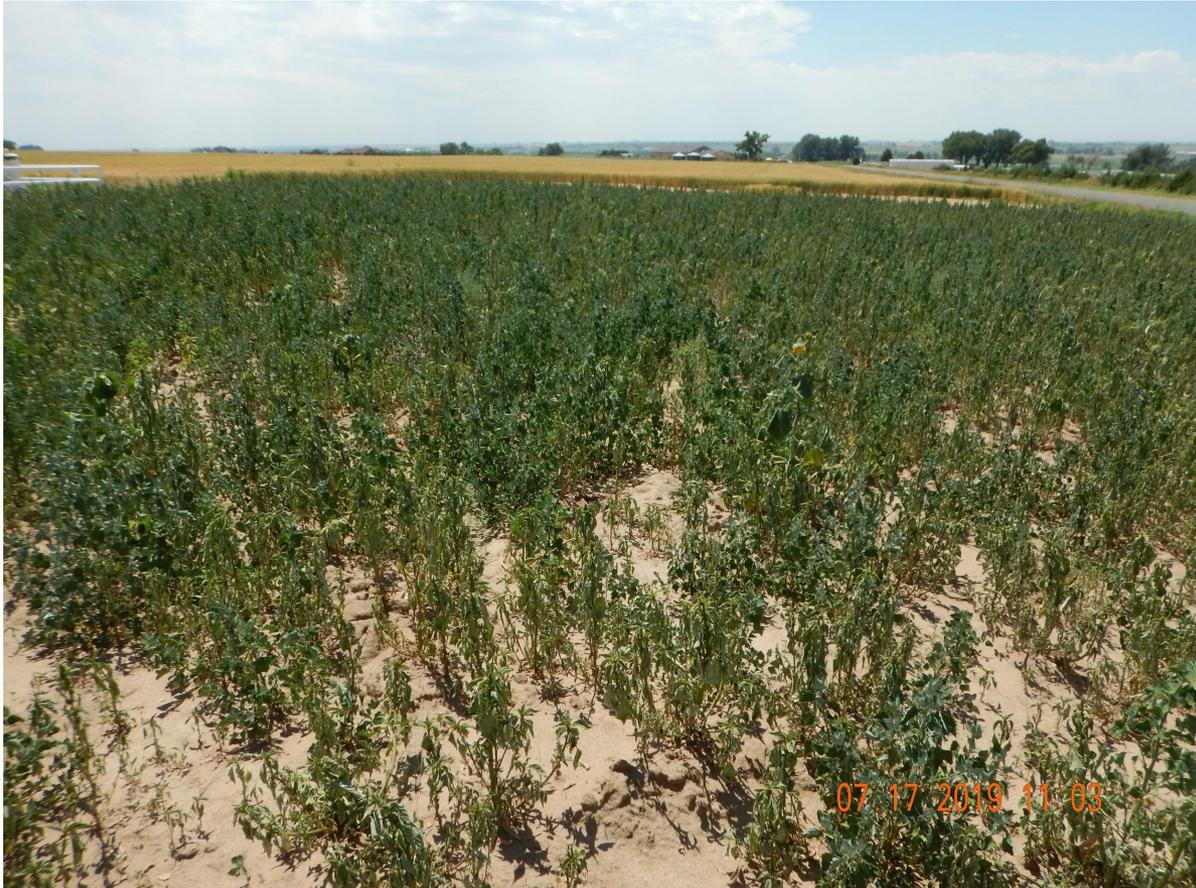
Photo 2. Photo taken from the associated tank battery, facing South. Operator has failed to control and manage weeds.
