# Inspection Photos

API: 05-071-09838

Operator: ARP PRODUCTION COMPANY  
WAPITI OPERATING LLC

Inspection Date: 7/19/2019

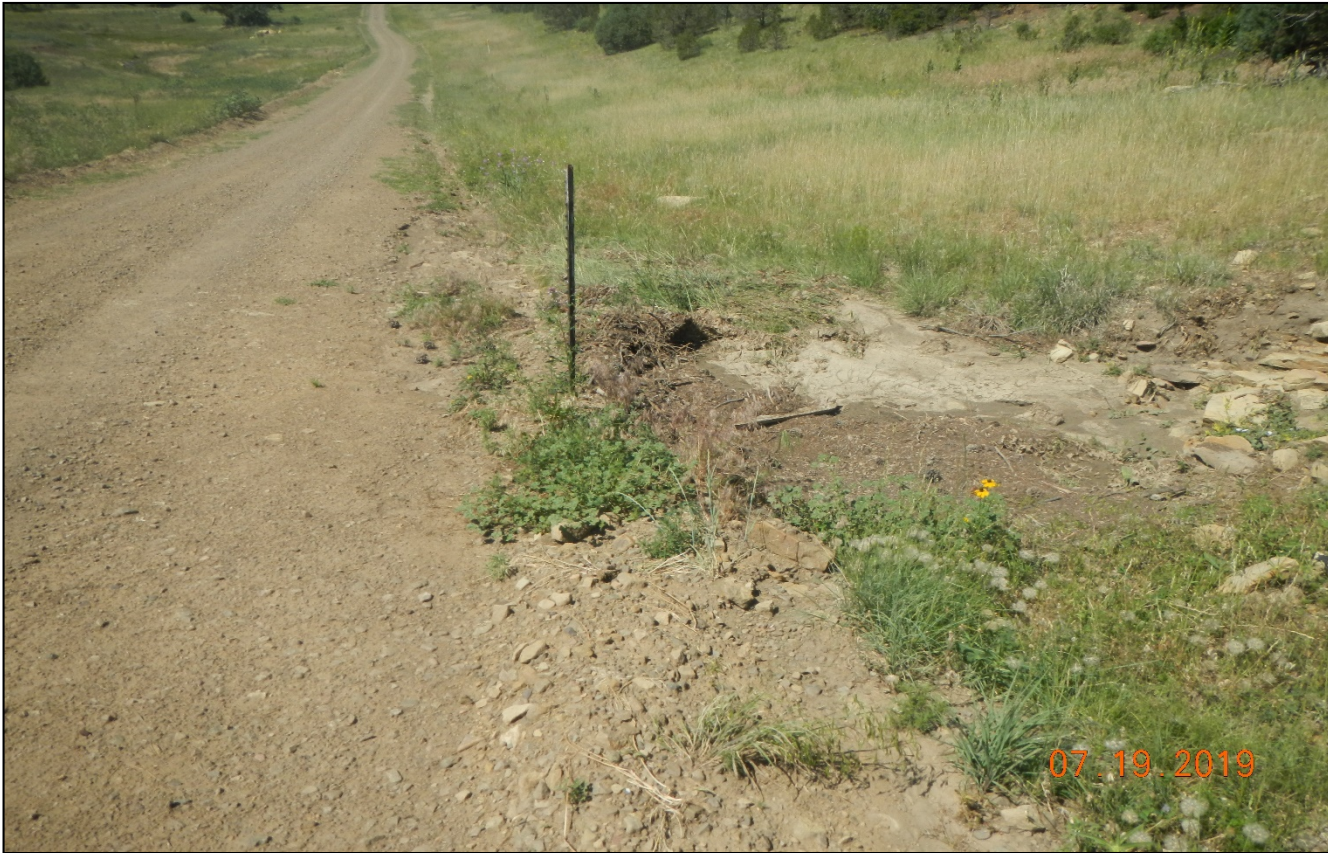
Lat/Long:37.02493,-104.82831

**Photo 1.** The culvert along the main road has filled in with sediment.

Corrective action was not performed since previous inspection.

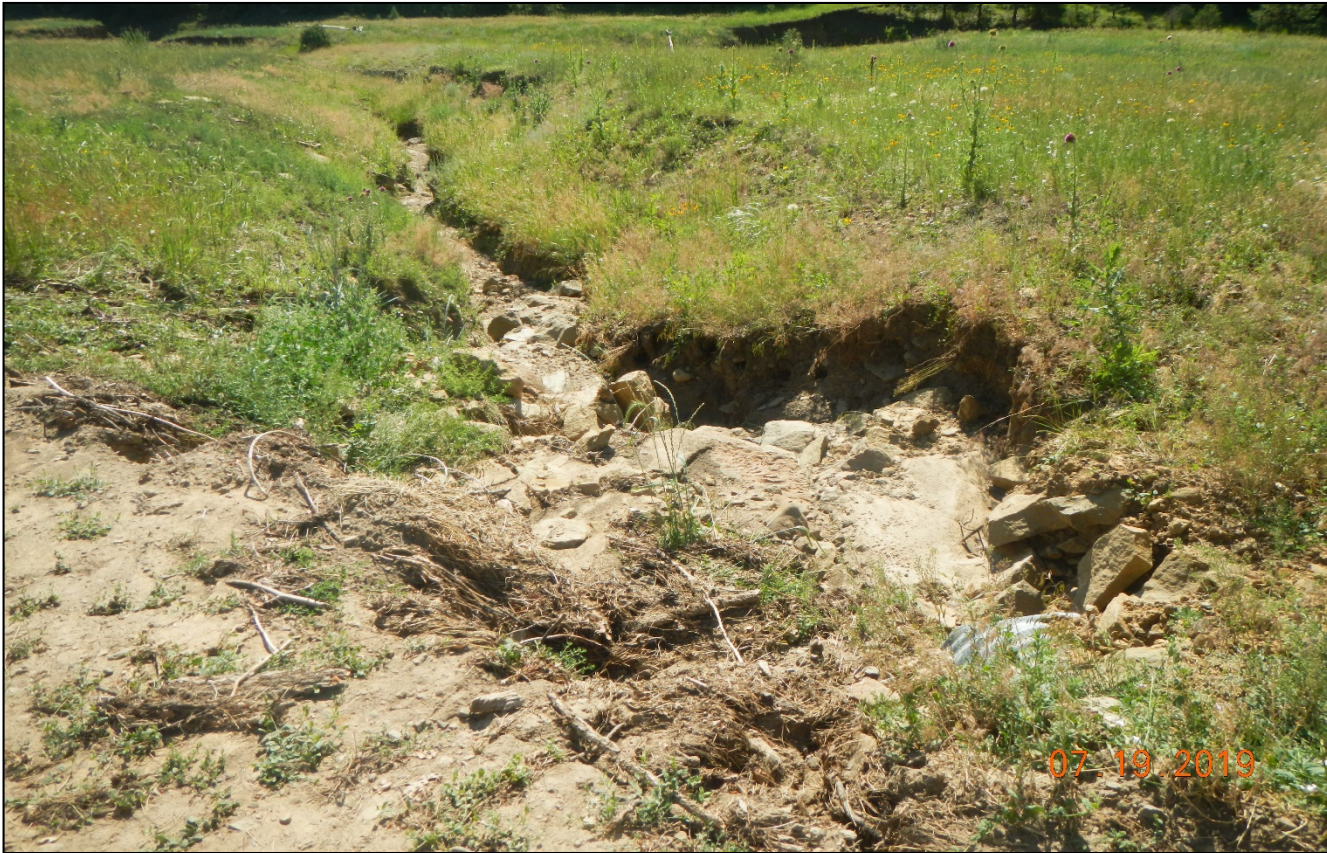
**Photo 2.** There is erosion occurring at the outlet culvert. No BMPs installed for outlet protection or to prevent erosion. Lat/Long:37.02425,-104.82919  
Corrective action was not performed since previous inspection.

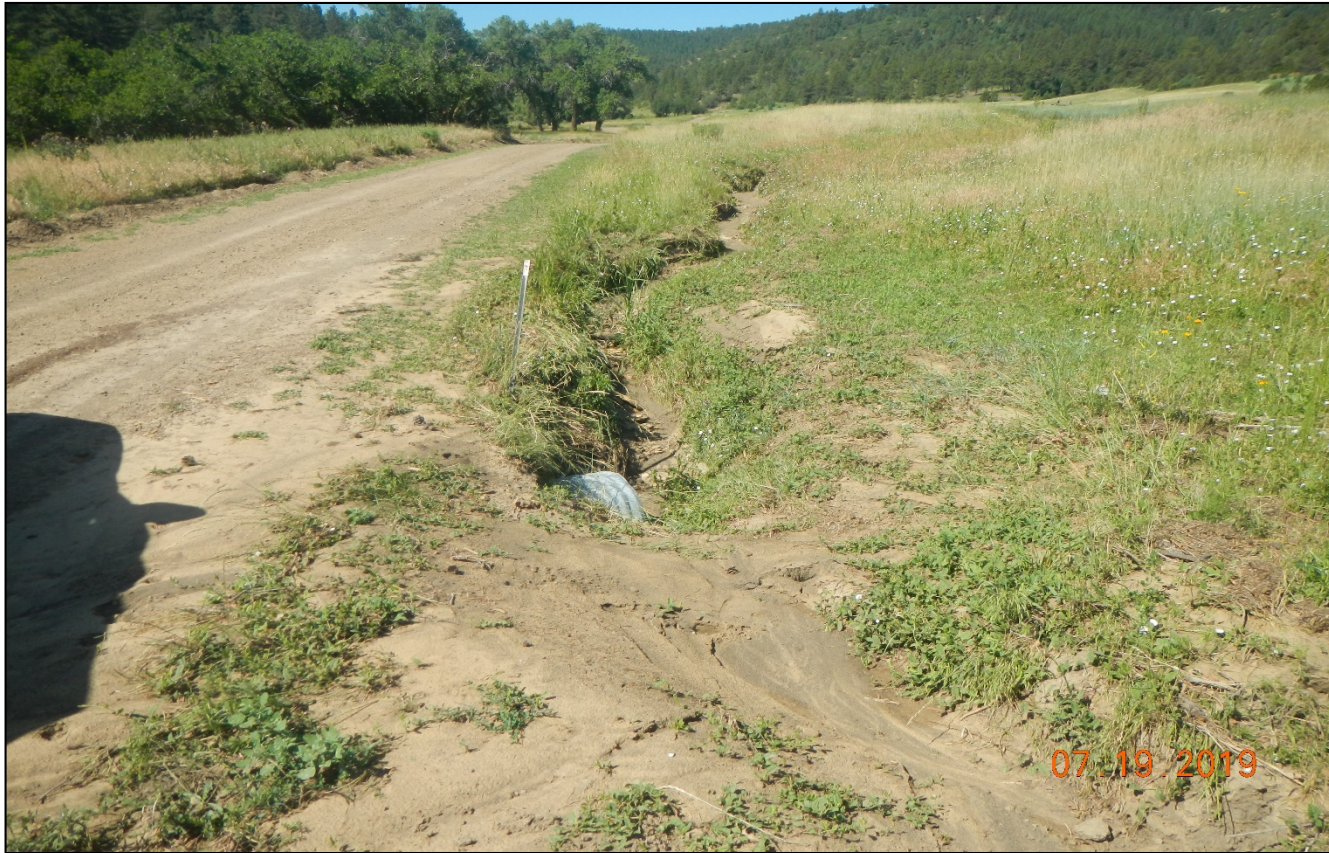
Lat/Long:37.02425,-104.82919

**Photo 3.** The culvert along the main road has filled in with sediment.

Corrective action was not performed since previous inspection.

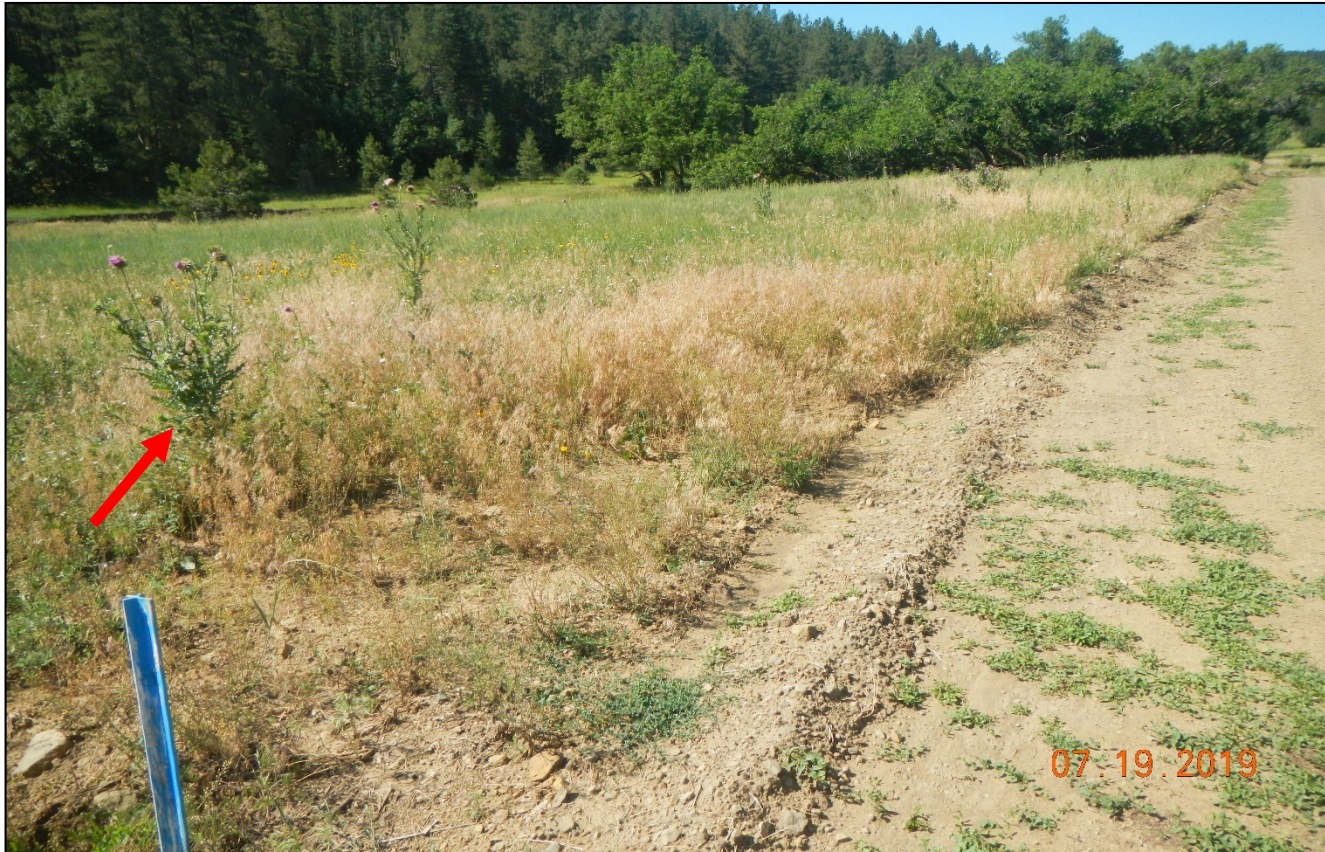
**Photo 4.** There is List B noxious weeds growing along the main & access road to the location. (Musk thistle shown in photo)

Corrective action was not completed since previous inspection.

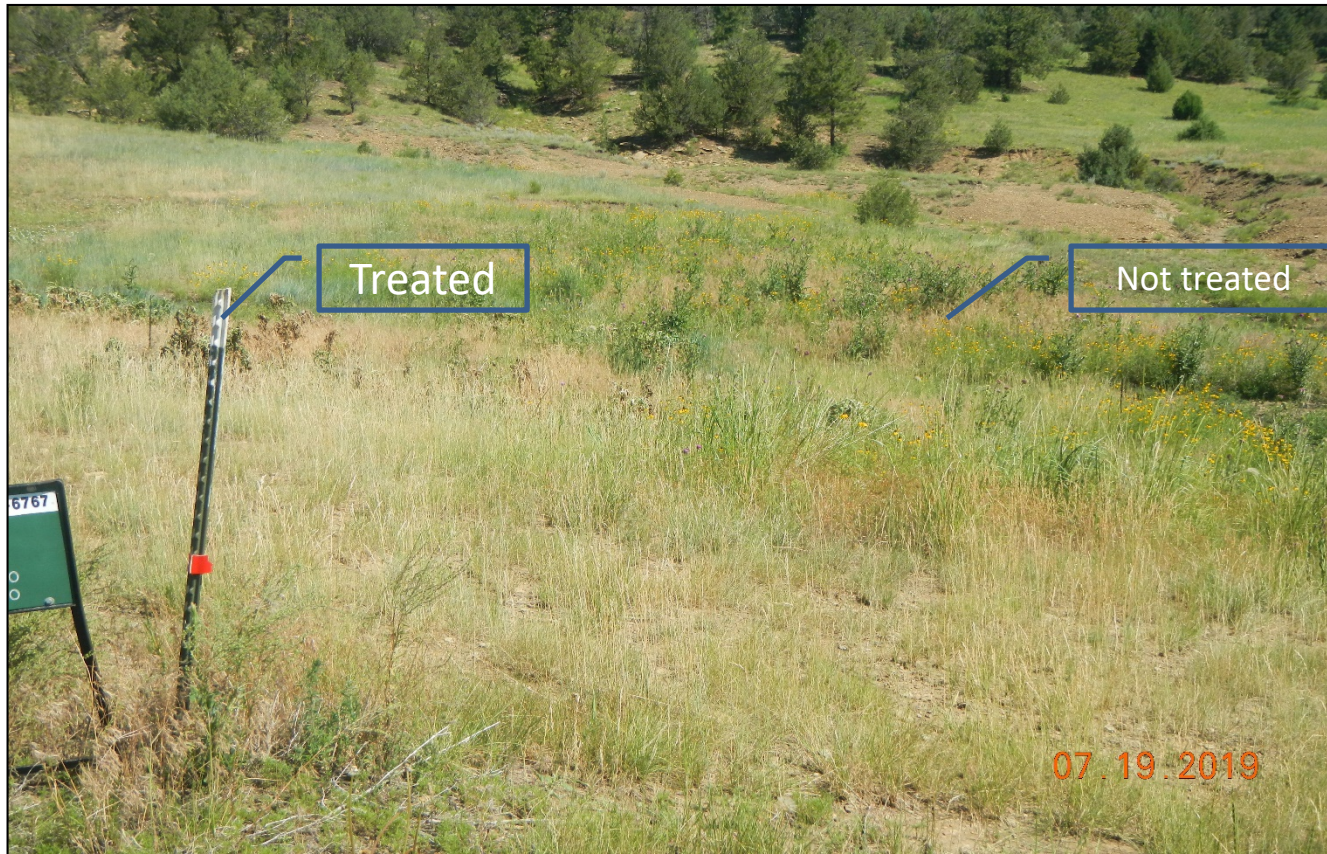
**Photo 5.** There is List B noxious weeds growing at the location. (Musk thistle shown in photo). Some of the noxious weeds were treated and others were not.

Corrective action was not completed since previous inspection.

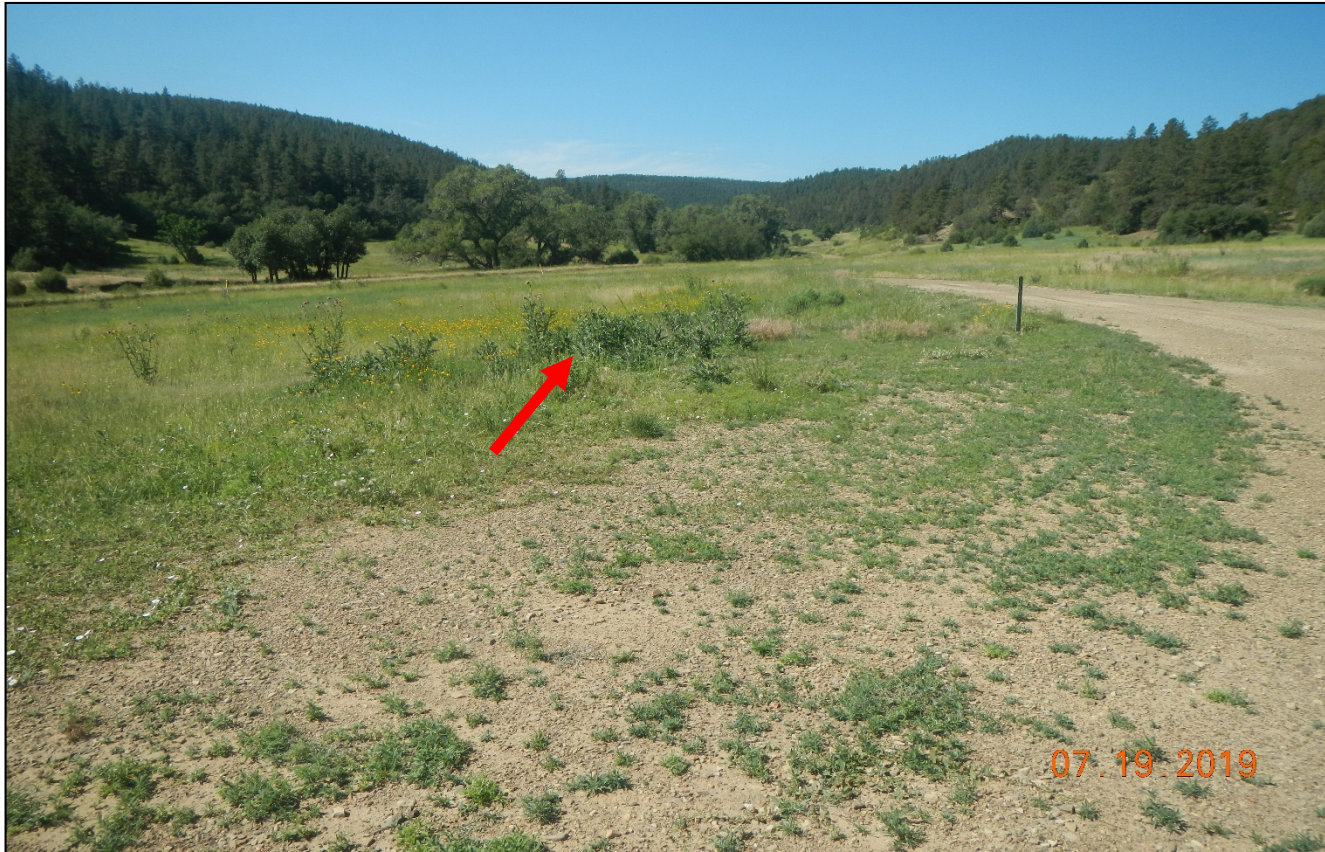
**Photo 6.** Noxious weeds have not been controlled at the location and have developed seed heads

Corrective action was not performed since previous inspection.
