Final Reclamation Inspection

Operator: SRC ENERGY INC- #10311

Location ID: 305977

Inspection Photos
Location Name: MOEN J #8-10
Location ID: 305977

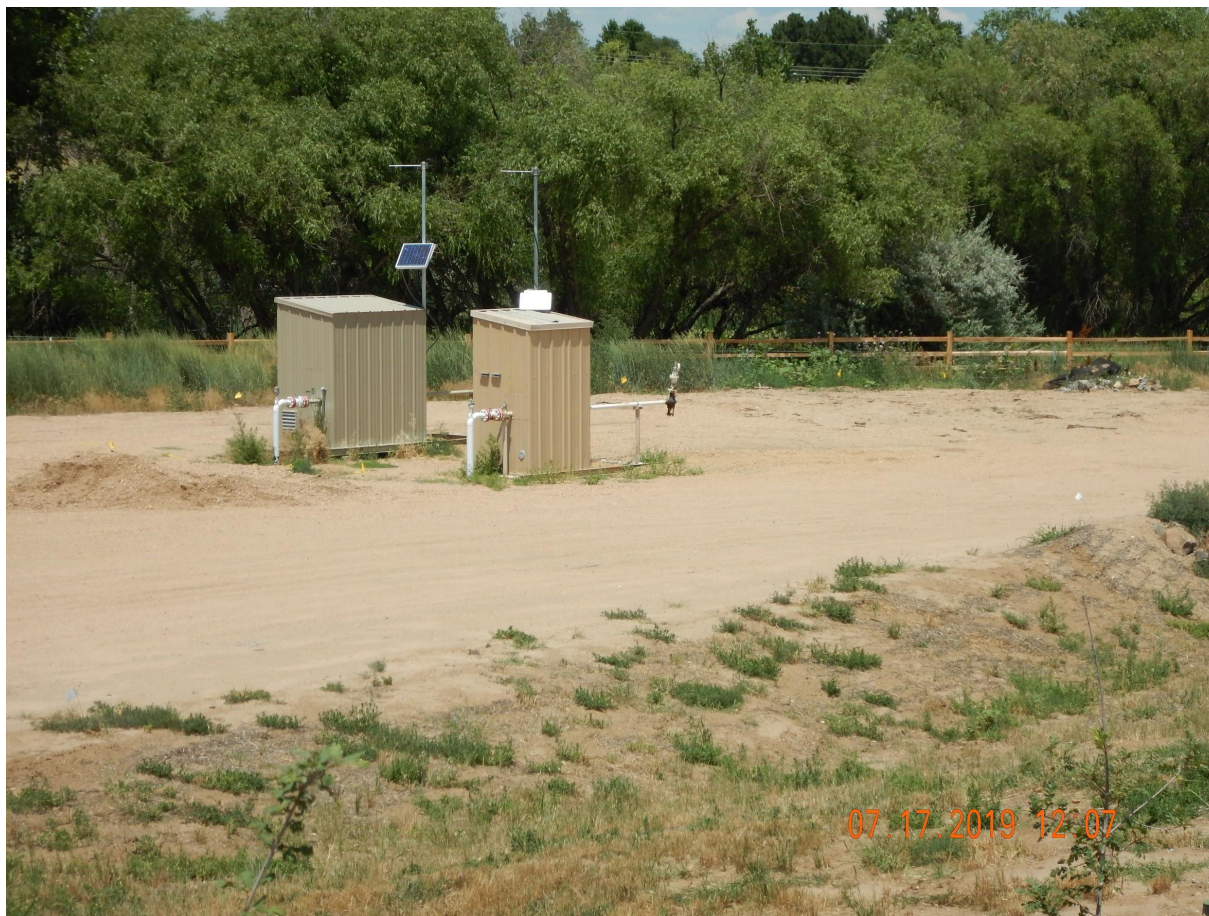
Photo 1. Photo taken of the tank battery, facing North. Photo illustrates equipment that remains at the tank battery location after plugging all associated wells. Operator shall comply with the Rule 1004 standards regarding Final Reclamation activities.
