Inspection Photos
Location Name: APACHE CANYON 10-3
API#: 05-071-06126
INSP. #: 695101311

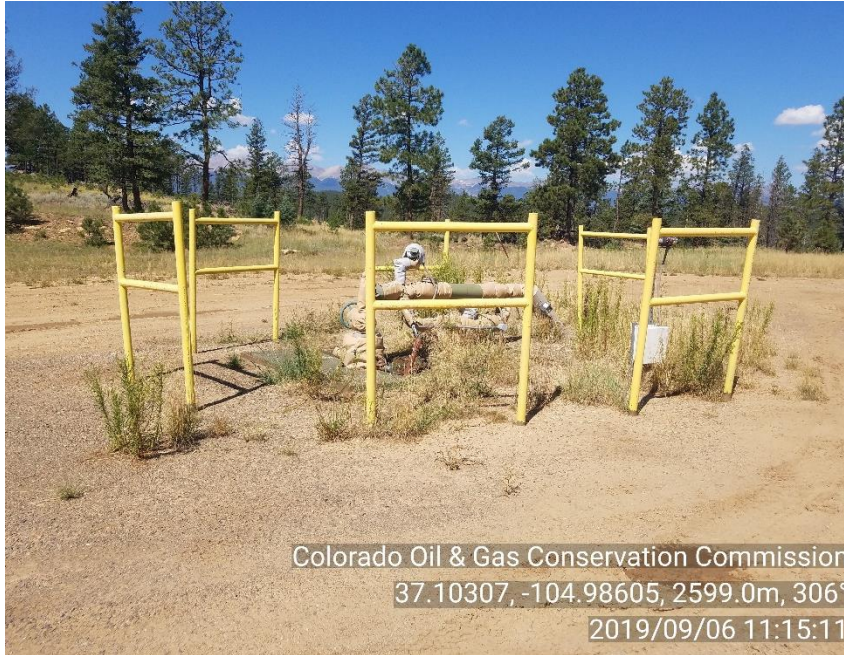
PHOTO 1: WELLHEAD/ WEEDS AROUND WELLHEAD. CUT WEEDS AND MAINTAIN WEEDS AROUND EQUIPMENT IN ACCORDANCE WITH RULE 603.f. CA DATE 10-6-19

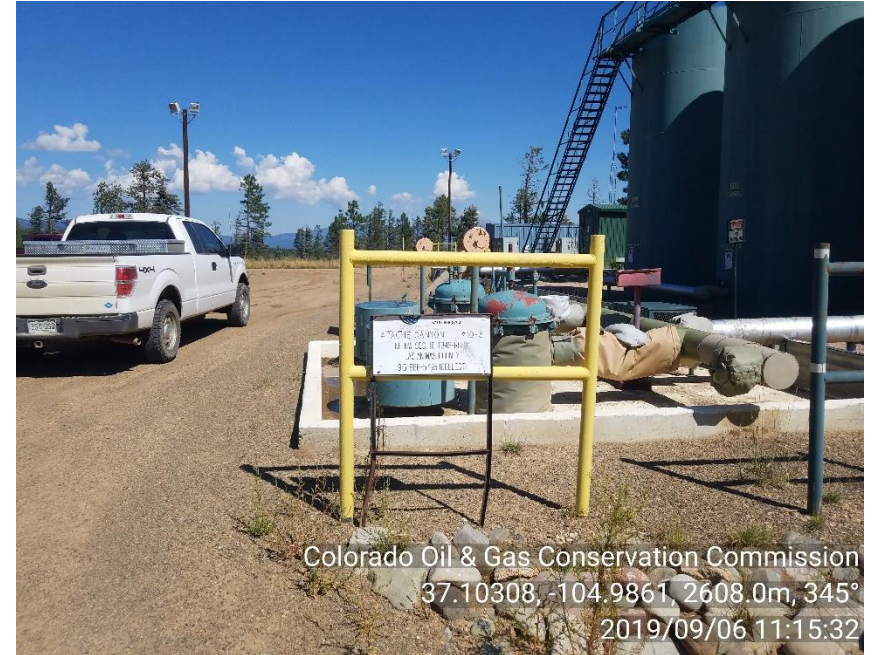
PHOTO 2: WELL SIGN/ 911 NOT INCLUDED WITH EMERGENCY CONTACT ON LOCATION SIGN. INCLUDE 911 AS AN EMERGENCY CONTACT ON LOCATION SIGNS. COMPLY WITH RULE 210.b. CA DATE 10-6-19

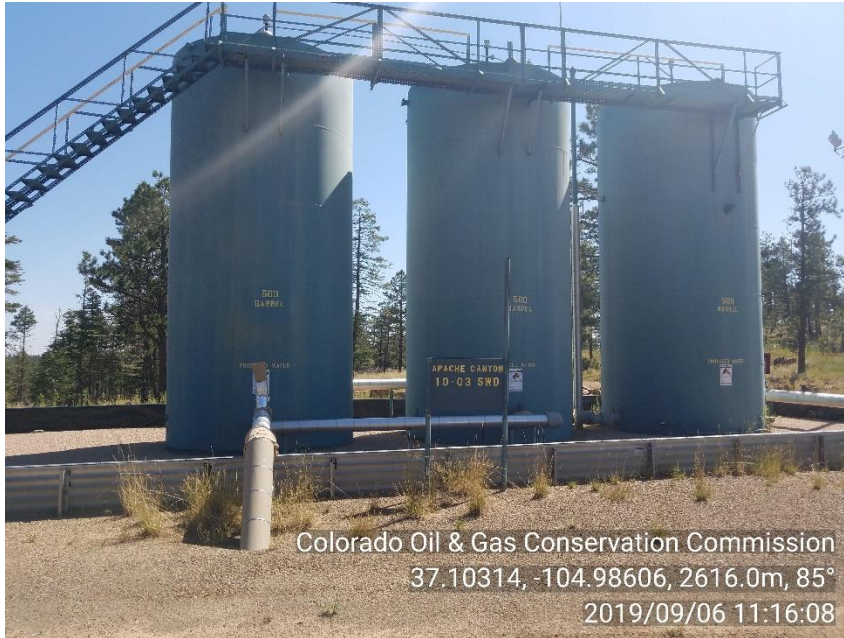
PHOTO 3: TANK BATTERY

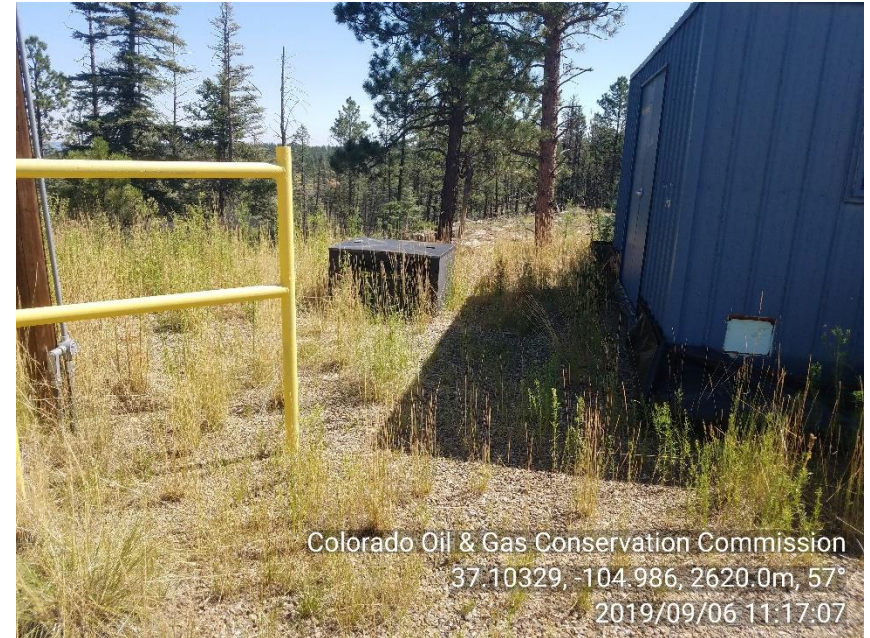
PHOTO 4: WEEDS AROUND PUMP HOUSE. CUT WEEDS AND MAINTAIN WEEDS AROUND EQUIPMENT IN ACCORANCE WITH RULE 603.f. CA DATE 10-6-19

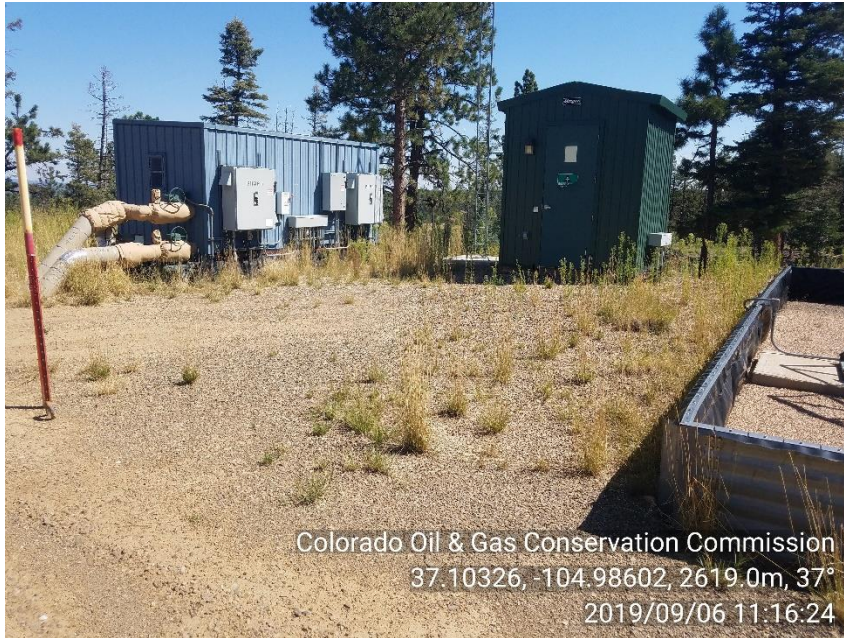
PHOTO 5: WEEDS AROUND TANK BATTERY CONTAINMENT.
CUT WEEDS AND MAINTAIN WEEDS AROUND EQUIPMENT
IN ACCORANCE WITH RULE 603.f. CA DATE 10-6-19
