APACHE CANYON 20-01 API# 05-071-06223 – TIMBER CREEK  
OGCC OPERATOR NUMBER 10672 - DATE: SEPTEMBER 20, 2019  
CORRECTIVE ACTIONS COMPLETED REGARDING COGCC FIR DOCUMENT # 689901226

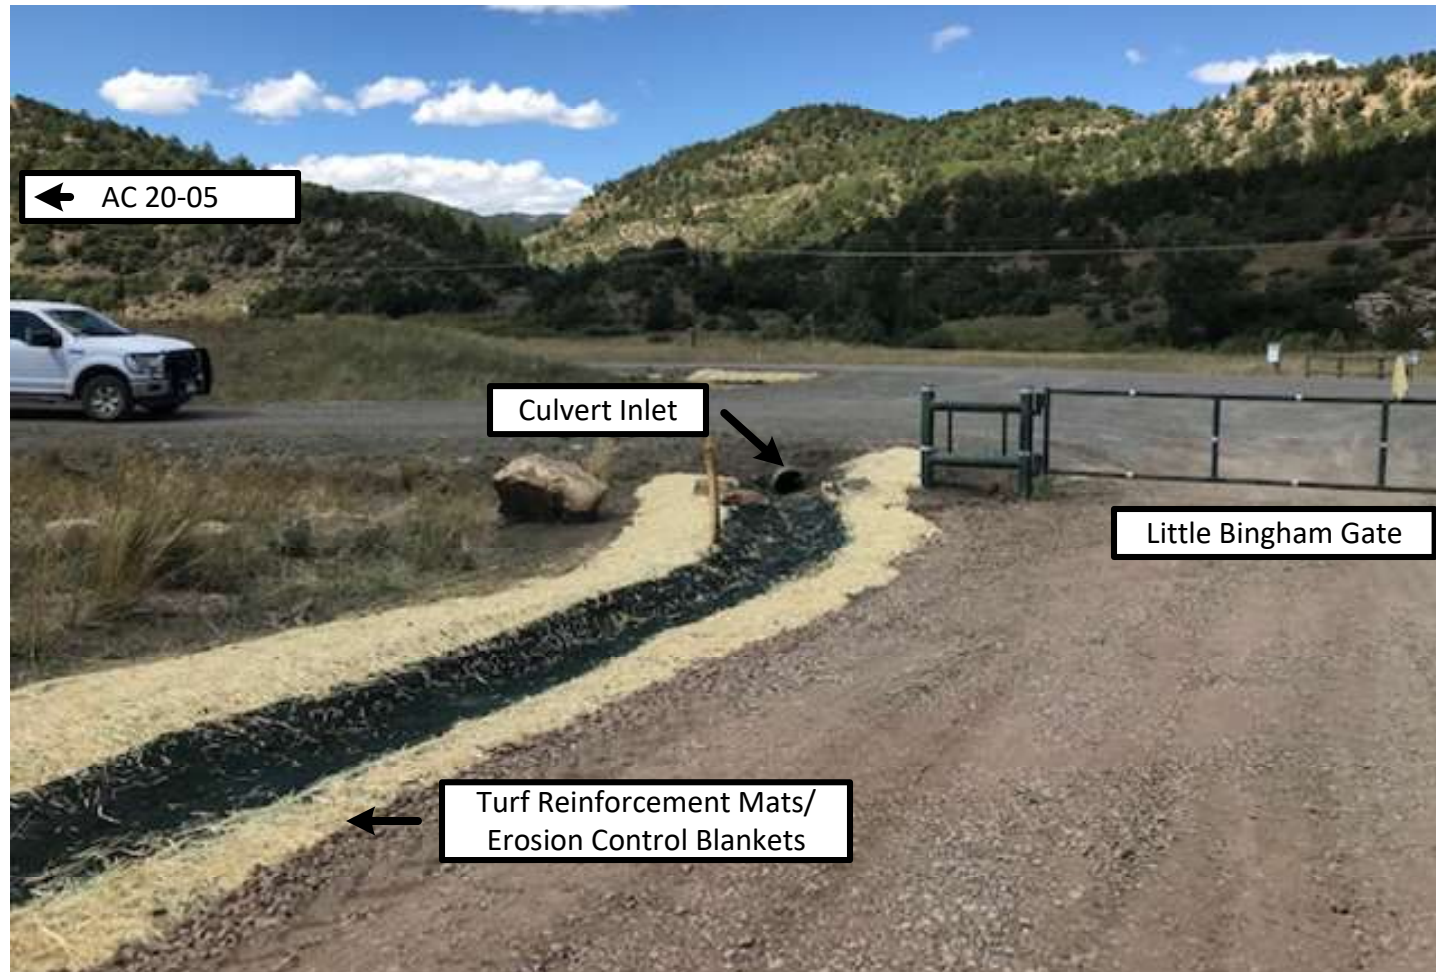
Photo 1: On Little Bingham facing toward South Fork Lease road. The previous attempt to minimize sediment was to stabilize the well pad surface with road base. After further investigation, the sediment appears to be coming from the bar ditch on Little Bingham. The bar ditch was dominated to direct run off to the culvert inlet. The sediment at the culvert inlet was removed. Turf reinforcement mats were installed in the bar ditch to reduce the potential for erosion. Erosion control were installed where the soil was disturbed on both sides of the bar ditch to reduce the potential for sediment discharge. An approved CPW seed mix was used to establish vegetation.

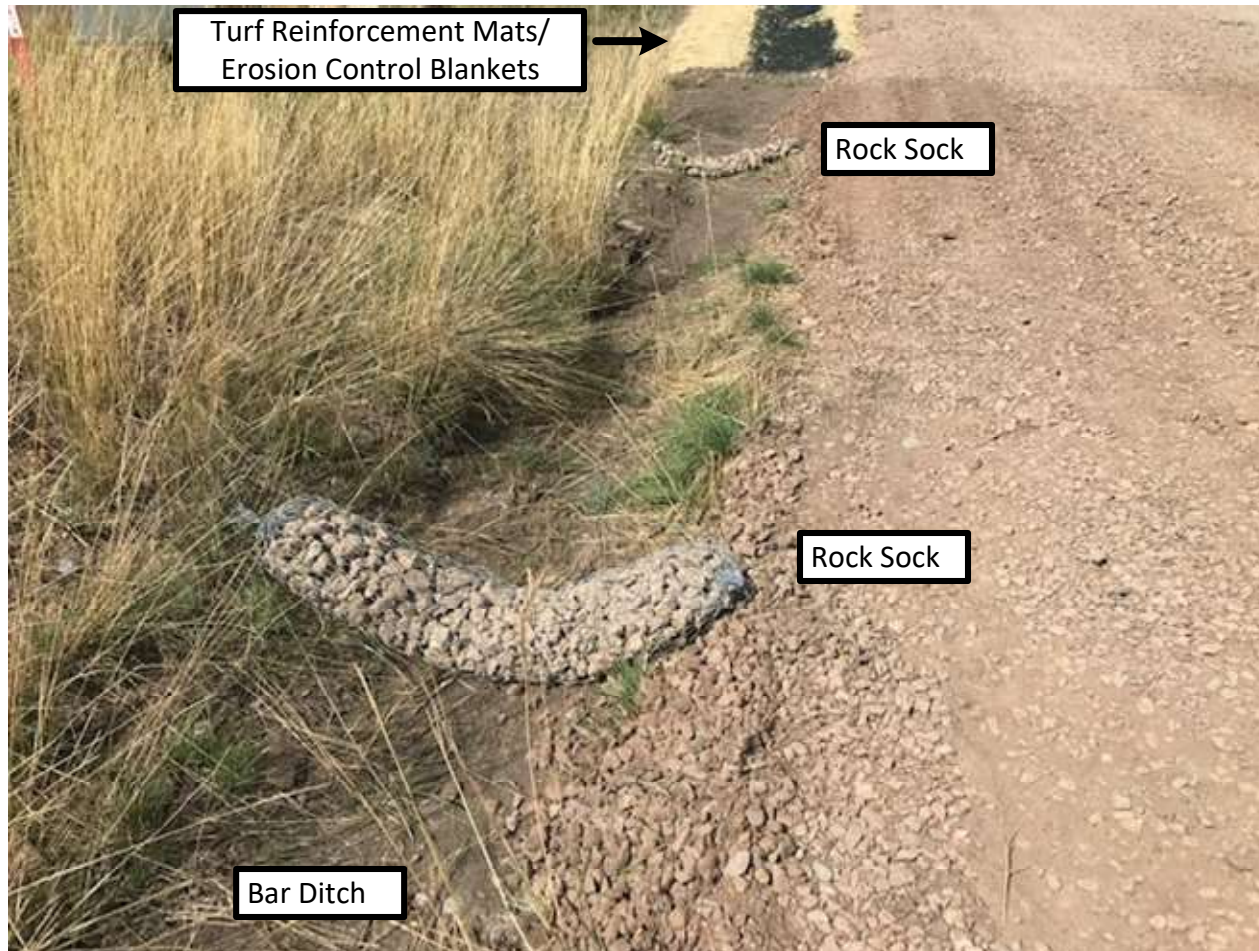
Photo 2: In the undisturbed portion of the bar ditch, (3) sets of rock socks were installed up gradient of the turf reinforcement mats to filter out sediment. Rock socks are made from 1" chicken wire filled with gravel.

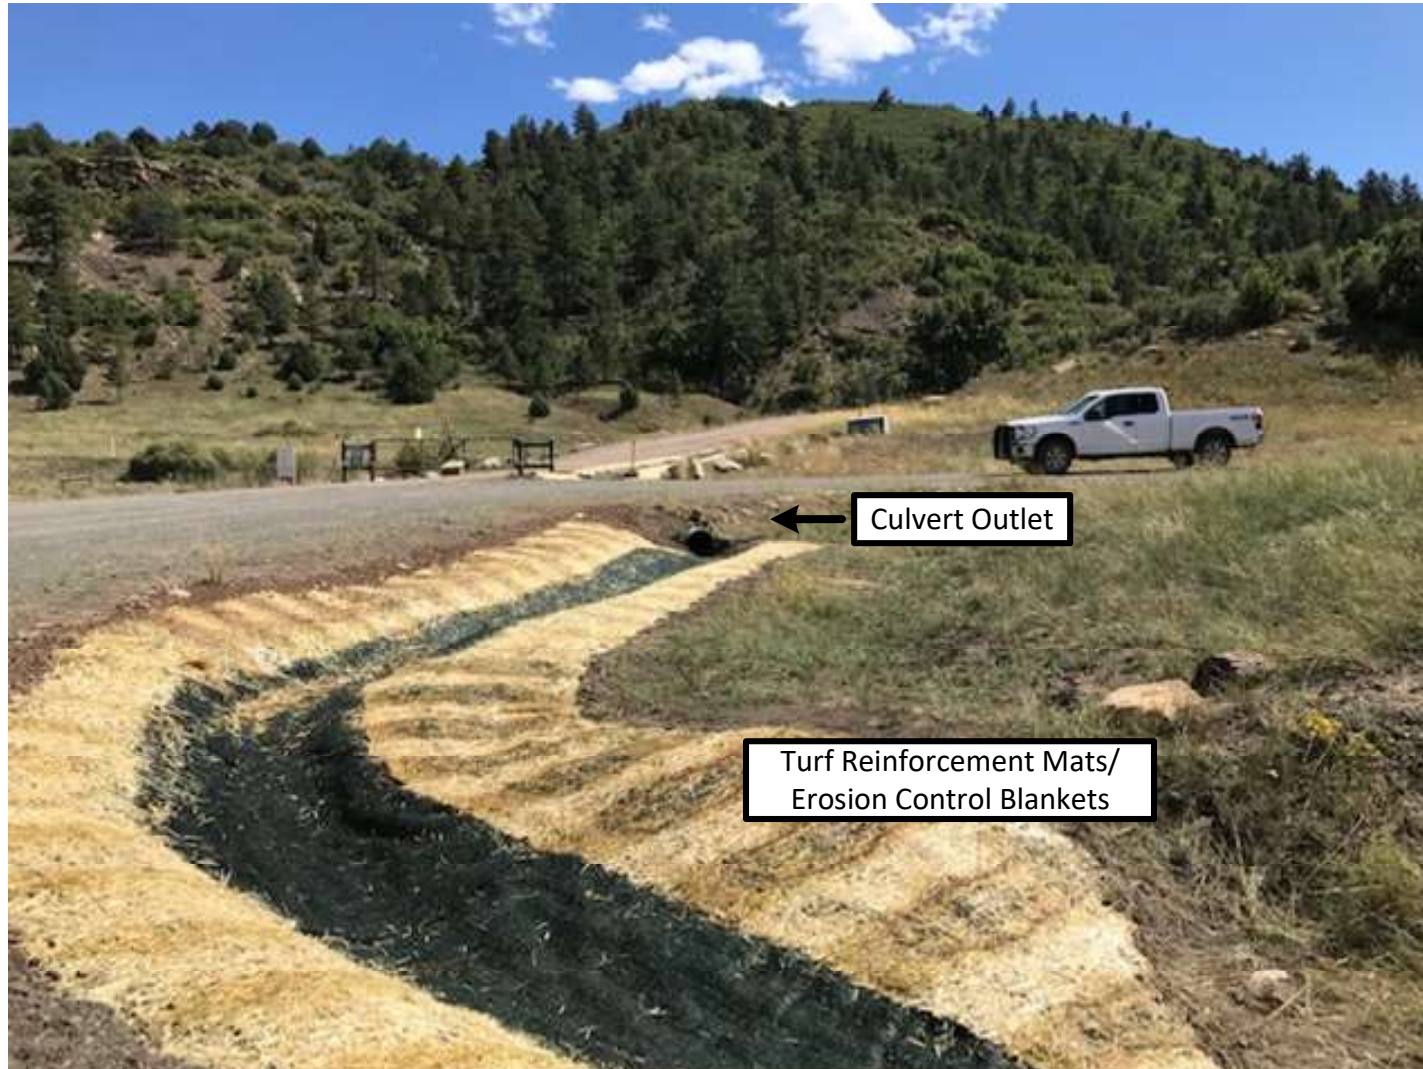
Photo 3: On Little Bingham facing toward the entrance to AC 20-01. The bar ditch was dominated to direct run off to the culvert inlet on the South Fork Lease Road. Turf reinforcement mats were installed in the bar ditch and erosion control were installed where the soil was disturbed on both sides of the bar ditch. An approved CPW seed mix was used to establish vegetation.

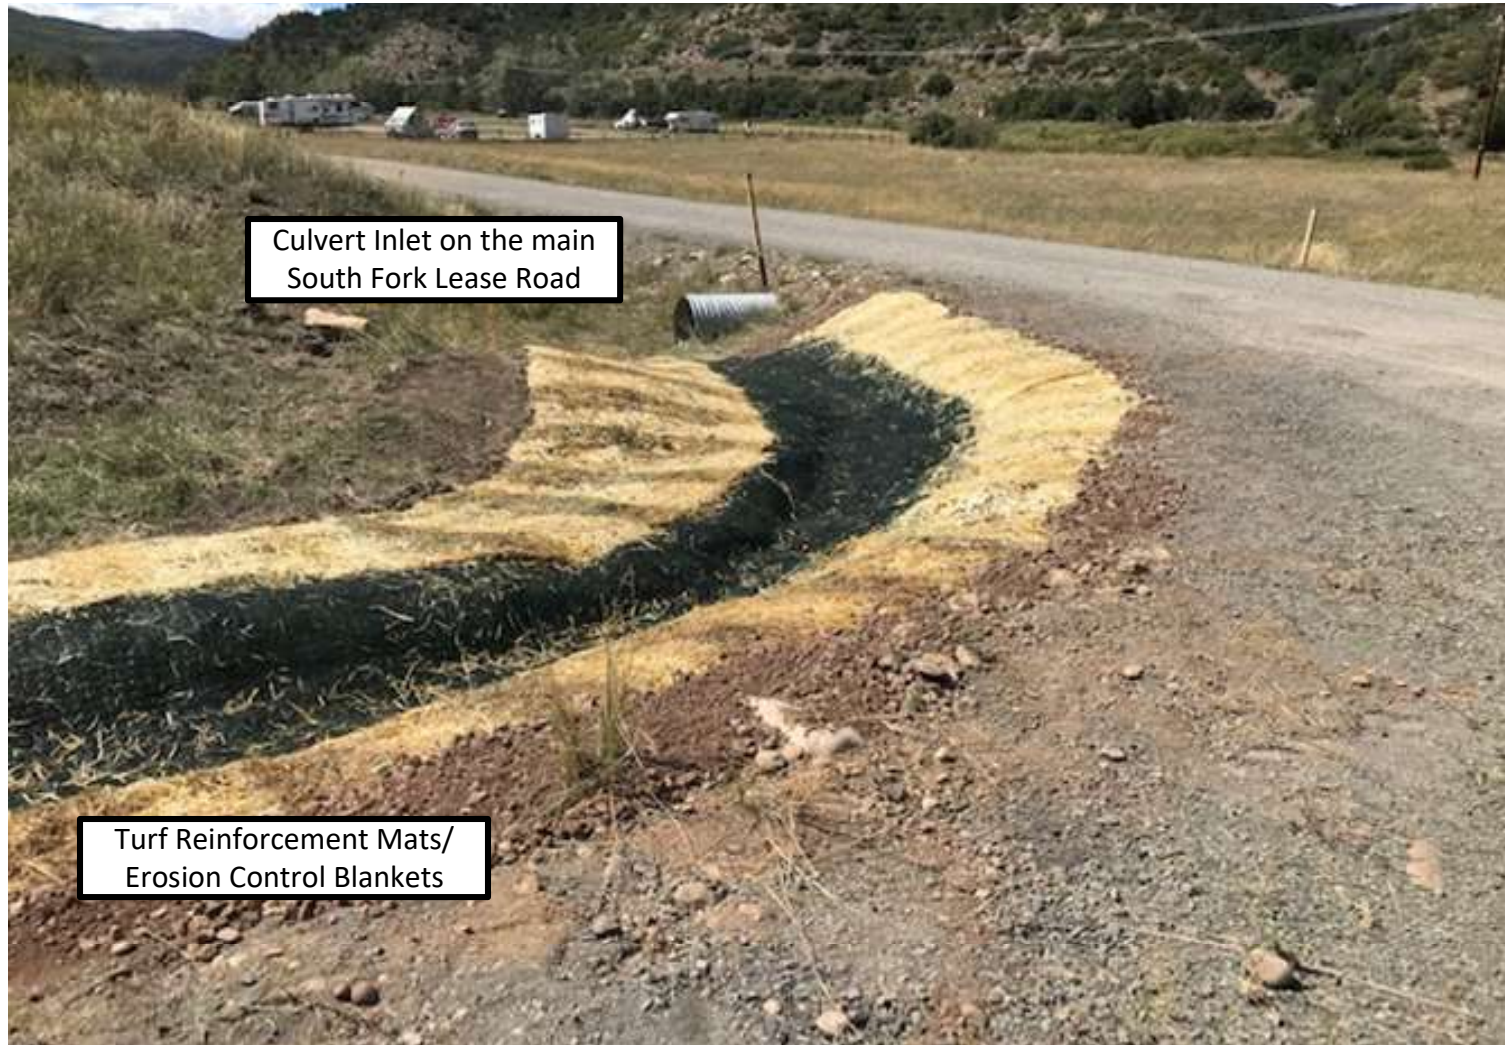
Photo 4: Turf reinforcement mats were installed in the bar ditch to reduce the potential for erosion. Erosion control were installed where the soil was disturbed on both sides of the bar ditch to reduce the potential for sediment discharge. An approved CPW seed mix was used to establish vegetation.
