Inspection Photos  
Location Name: ALABASTER 11-8 FOLLOWUP  
API#: 05-071-08642  
INSP. #: 695102283

## Inspection Photos

Location Name: ALABASTER 11-8 FOLLOWUP

API#: 05-071-08642

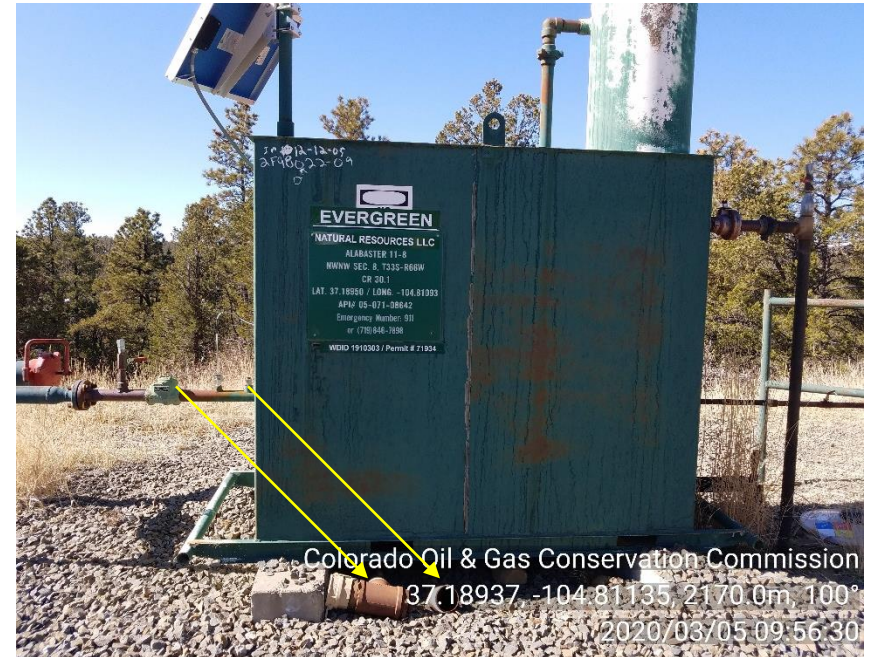
PHOTO 2: WELL SIGN/ UNUSED EQUIPMENT STORED ON LOCATION (THERE ARE SEVERAL PIECES OF PIP FITTING & HOSED ETCL AROUND LOCATION). **COMPLY WITH GENERAL HOUSE KEEPING RULES 603.f. CA DATE 4-5-20.**

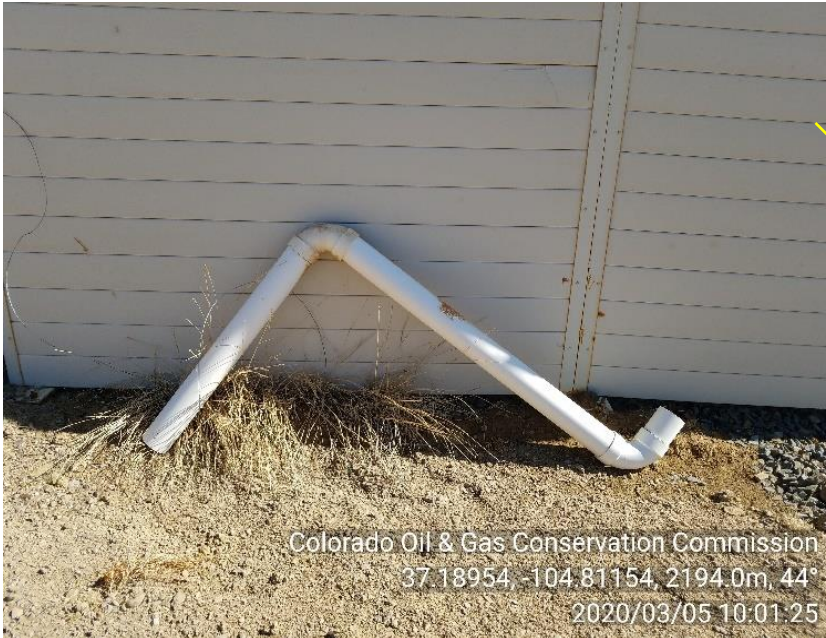
**PHOTO 5: UNUSED EQUIPMENT STORED ON LOCATION (THERE ARE SEVERAL PIECES OF PIP FITTING & HOSED ETCL AROUND LOCATION). **COMPLY WITH GENERAL HOUSE KEEPING RULES 603.f. CA DATE 4-5-20.****

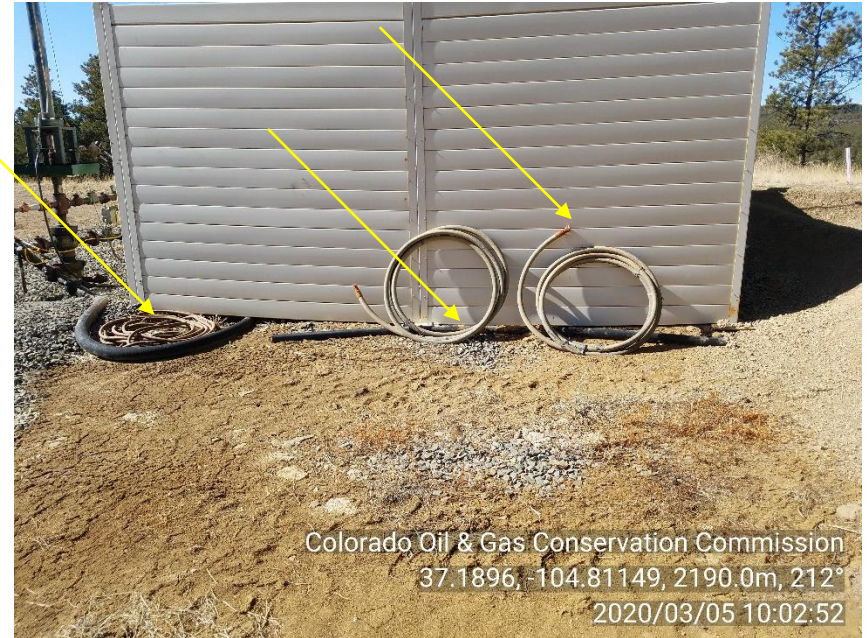
**PHOTO 6: UNUSED EQUIPMENT STORED ON LOCATION (THERE ARE SEVERAL PIECES OF PIP FITTING & HOSED ETCL AROUND LOCATION). **COMPLY WITH GENERAL HOUSE KEEPING RULES 603.f. CA DATE 4-5-20.****

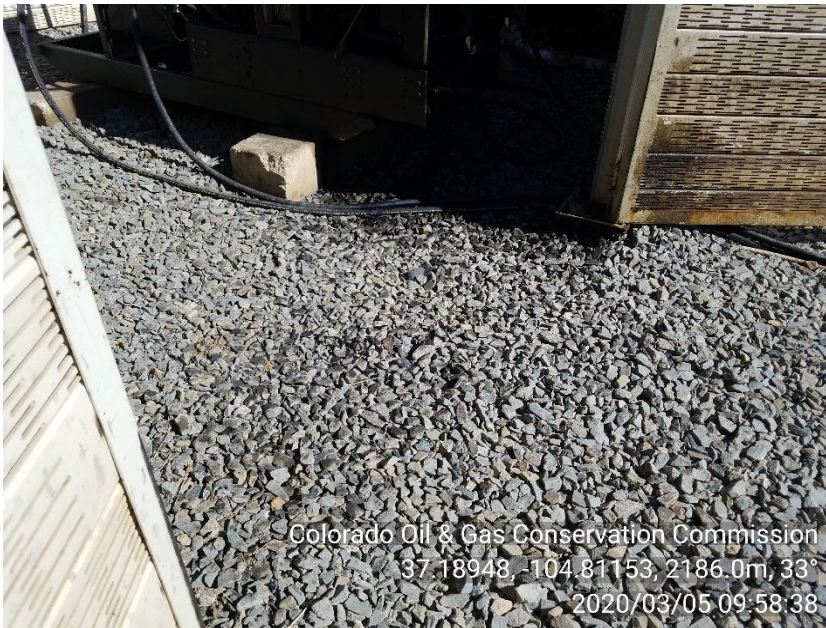
**PHOTO 7: IMPACTED SOIL/GRAVEL NEAR PRIME MOVER ENGINE SKID. Conduct maintenance on equipment (ie REPAIR LEAKS ON ALL EQUIPMENT), cleanup stained material and review self inspection processes. CA DATE 4-5-20**

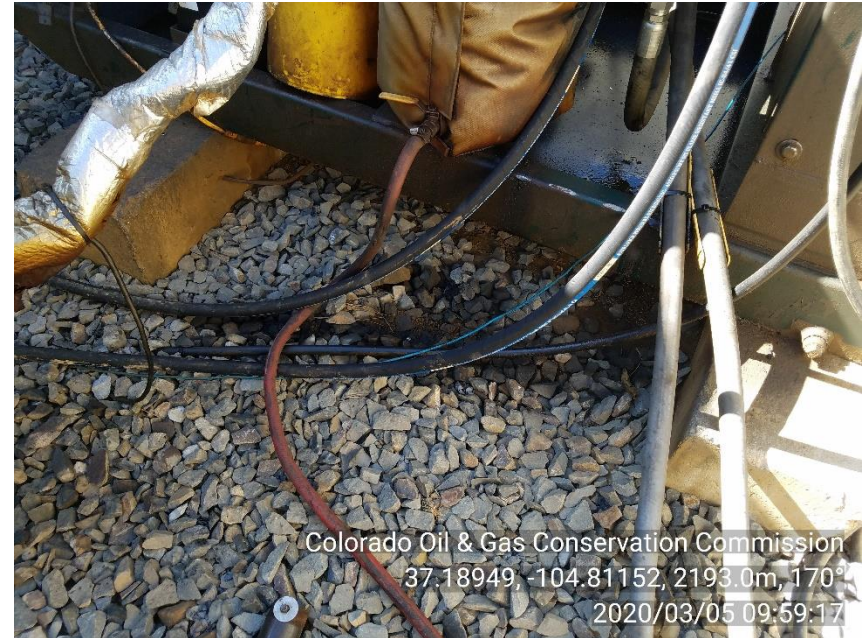
**PHOTO 8: IMPACTED SOIL/GRAVEL NEAR PRIME MOVER ENGINE SKID. Conduct maintenance on equipment (ie REPAIR LEAKS ON ALL EQUIPMENT), cleanup stained material and review self inspection processes. CA DATE 4-5-20**

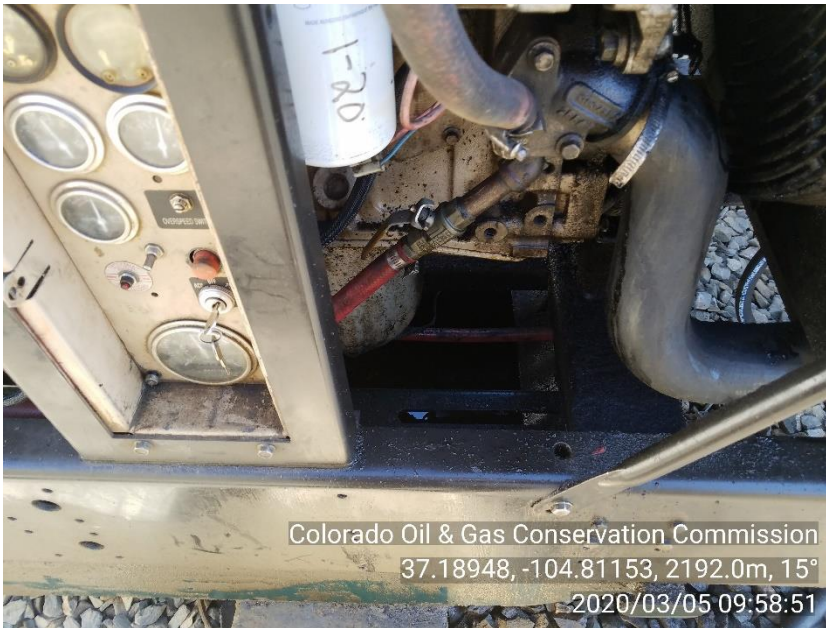
**PHOTO 9: APEARS TO BE ENGINE OIL IN PRIME MOVER ENGINE SKID. **Comply with general provisions of the oil and gas act for wildlife protection. CA DATE 4-5-19.****

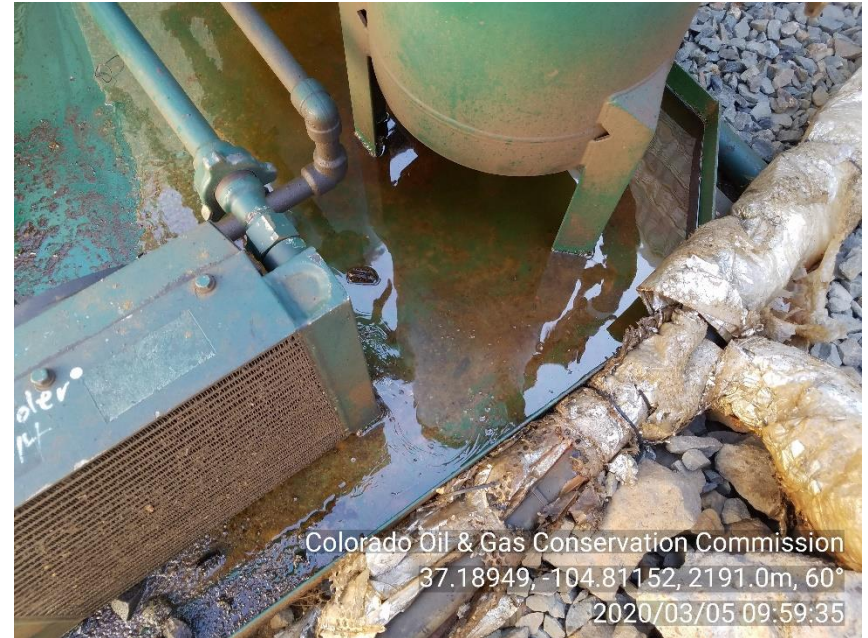
**PHOTO 10: OILY WATER IN COMPRESSOR SKID. **Comply with general provisions of the oil and gas act for wildlife protection. CA DATE 4-5-19.****
