Inspection Photos  
Location Name: LORENCITO 7-17  
API#: 05-071-07982  
INSP. #: 695102885

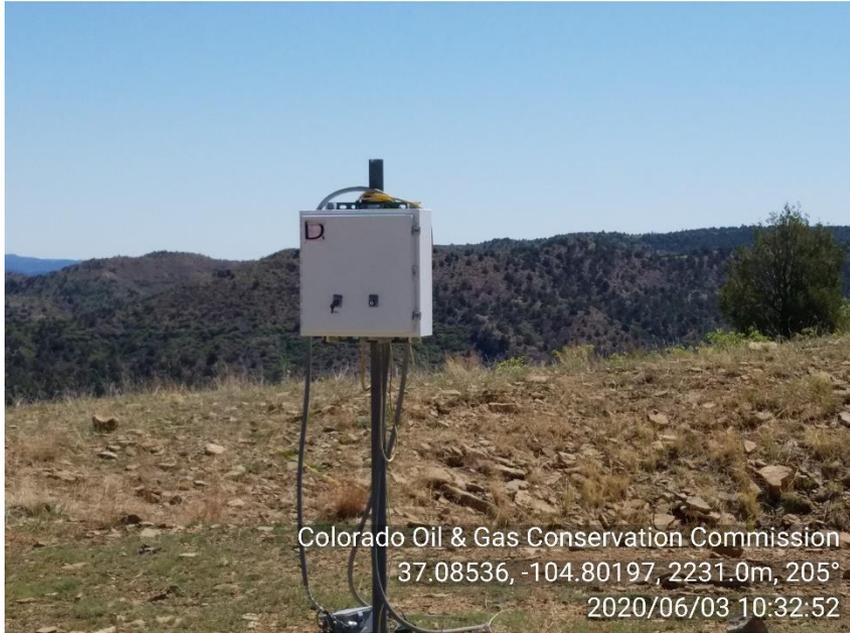
**PHOTO 3: UNUSED EQUIPEMNT STORED ON LOCATION.  
REMOVE UNUSED EQUIPMENT COMPLY WITH RULE 603.f.  
CA DATE 9-3-20**

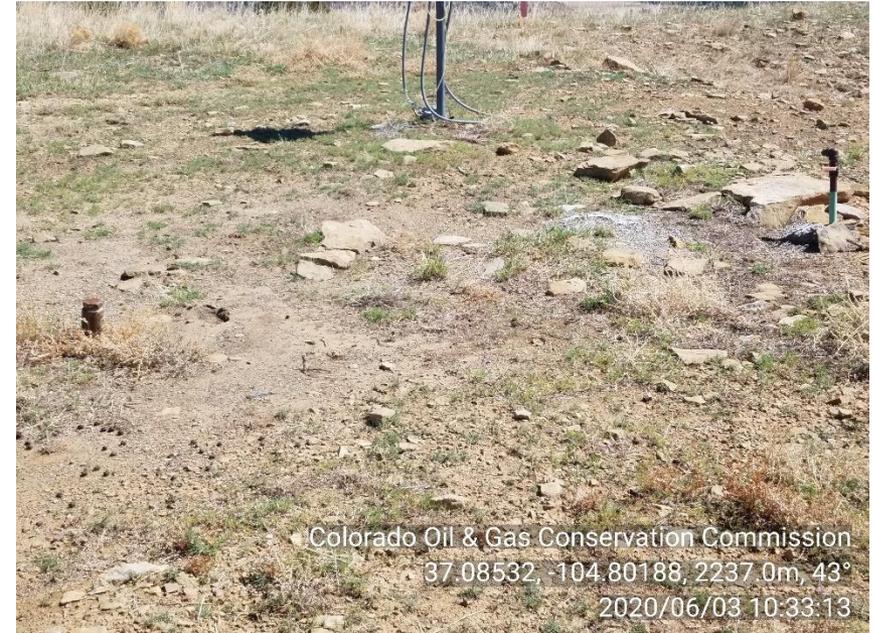
**PHOTO 4: UNUSED EQUIPMENT (ONE 2" RISER AND ONE 1"  
RISER). REMOVE UNUSED EQUIPMENT COMPLY WITH NTO  
AND RULE 603.f. ca date 9-3-20**
